Barrow Coastal Inspections 2020

Barrow Borough Council

May 2021

Title	Barrow Coast Protection Inspections
Creator/Author	Craig Bell/Mark Ellis, Capita
Publisher	Barrow Borough Council, Town Hall, Duke Street, Barrow-in-Furness. LA14 2LD
Date of Publication	01/06/2021
Contact	Chris Jones, Barrow Borough Council
Subject – keyword	Survey and monitoring – coastal defence inspections
Description/Abstract	Report detailing the results of an inspection of coast defences along Barrow Borough Council's coastline completed in 2021
Identifier	CS063836/002
Coverage – spatial	Barrow Borough Council coastline – from Peasholmes Lane A5087 to Mere Beck, Askam-in-Furness
Coverage – temporal	2018
Format	documentDigital
Type	Report
Subject – category	Coastal Defence
Subject – project	Cell 11 Regional Monitoring Strategy
Language	English
Rights – copyright	Map data copyright Ordnance Survey licence
Rights – disclosability	Yes
Rights – FOIA	Yes
Postal Address	Barrow Borough Council, Town Hall, Duke Street, Barrow-in-Furness

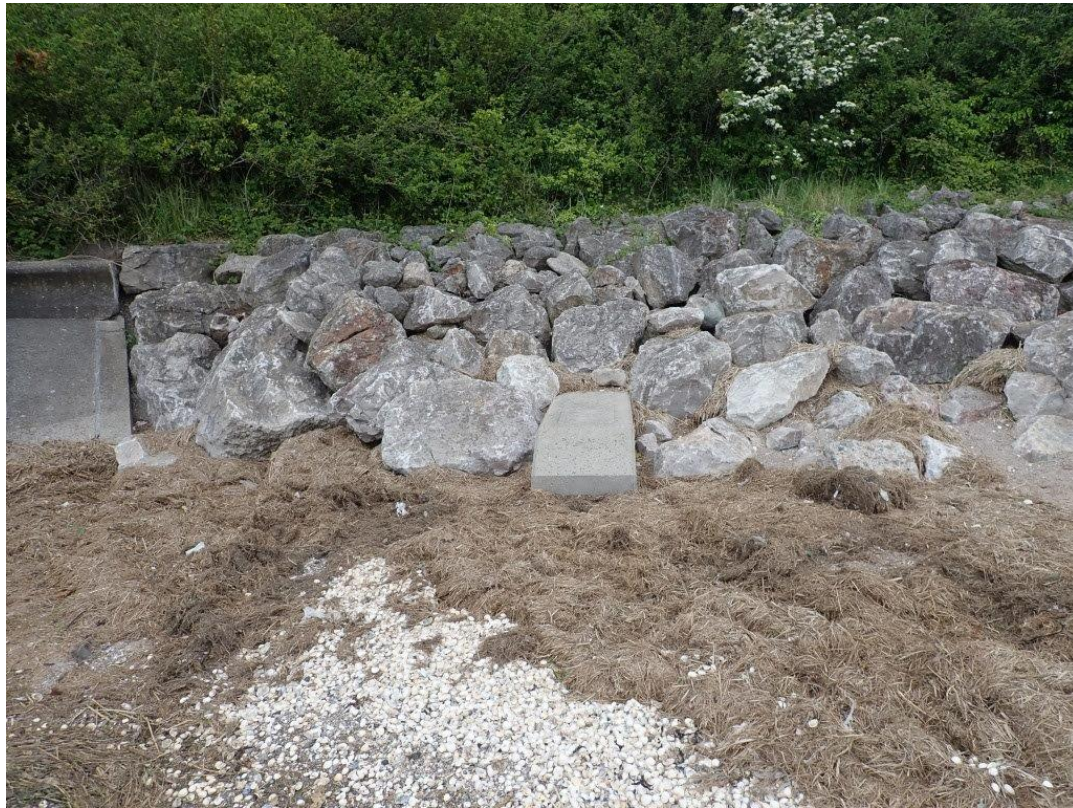
Drainage outlet at southwest end of asset

NFCDD Element and Survey Data								
Inspector	C. Bell						Date	14/05/2021
Element	Type	Sub-type	Material	Revetment	Slope	Width	Condition	Weighting
1	CB	-	-	-	-	-	-	-
2	CS	Foreshore	Sand	-	-	-	3	1
3	FI	Revetment	Rock Armour	-		-	2	8
4	C	Revetment	Rock Armour	-	0	-	2	8
Residual Life		5-10	Urgency	Normal		Overall Condition		2
						Data Quality		1
<p>Comments and Recommendations</p> <p>The asset has been split into two sections to indicate the condition of the two separate materials used in this defence. Over recent years sections of the defence have been replaced in phases commencing from the Peasholmes Lane end hence the need to split the survey. The foreshore has reduced vegetation.</p> <p>Still a relatively new construction, overall the rock armour remains densely packed and in good condition, with only minor displacement occurring to isolated small areas of rock. A minor weakness exists at the joint to the joining concrete revetment, and the drainage outlet at the southwest end of the asset is blocked.</p>

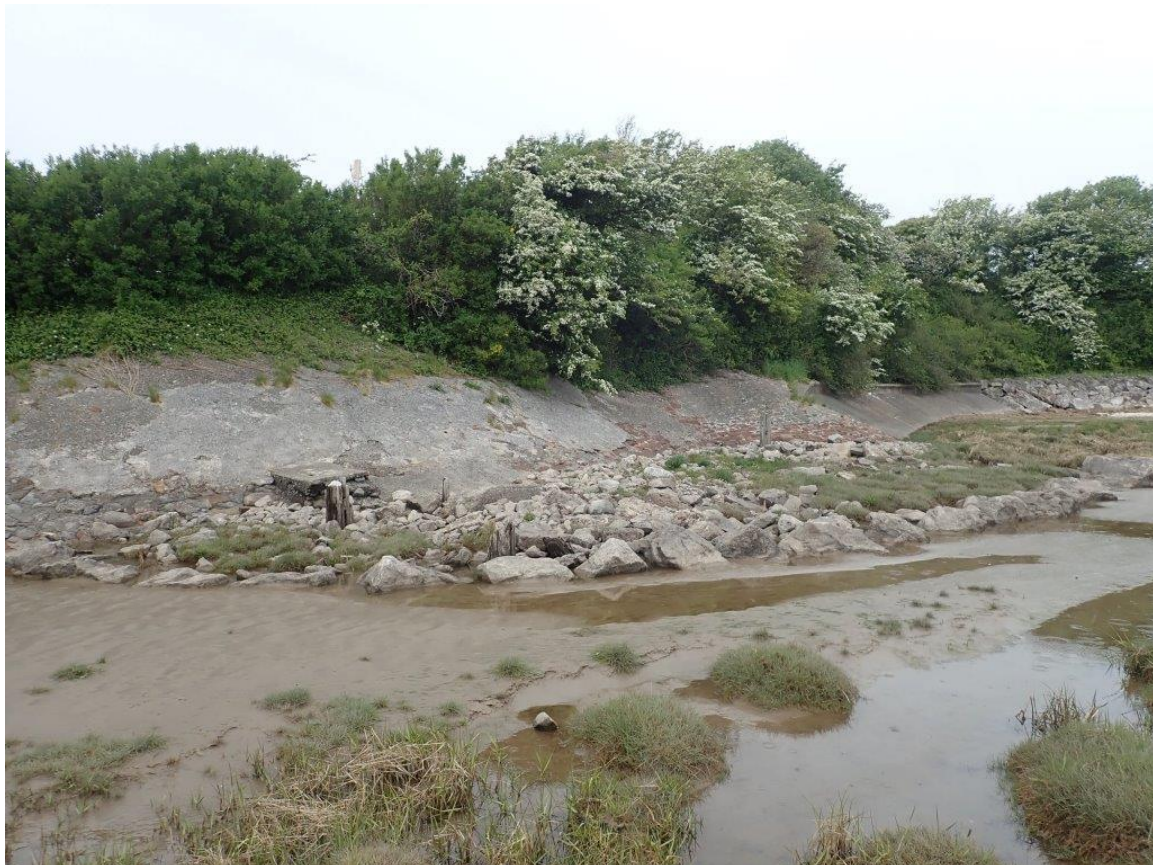
NFCDD Element and Survey Data								
Inspector	C. Bell						Date	14/05/2021
Element	Type	Sub-type	Material	Revetment	Slope	Width	Condition	Weighting
1	CB	-	-	-	-	-	-	-
2	CS	Foreshore	Sand	-	-	-	3	1
3	FI	Revetment	Concrete	-		-	4	8
4	C	Revetment	Concrete	-	0	-	4	8
Residual Life		0-5	Urgency	Medium		Overall Condition		4
						Data Quality		1
Comments and Recommendations The remaining old concrete section of the revetment is in a poor condition with areas showing defects that would lead to accelerated wash out if not repaired.								
Indicative sketch of cross-section

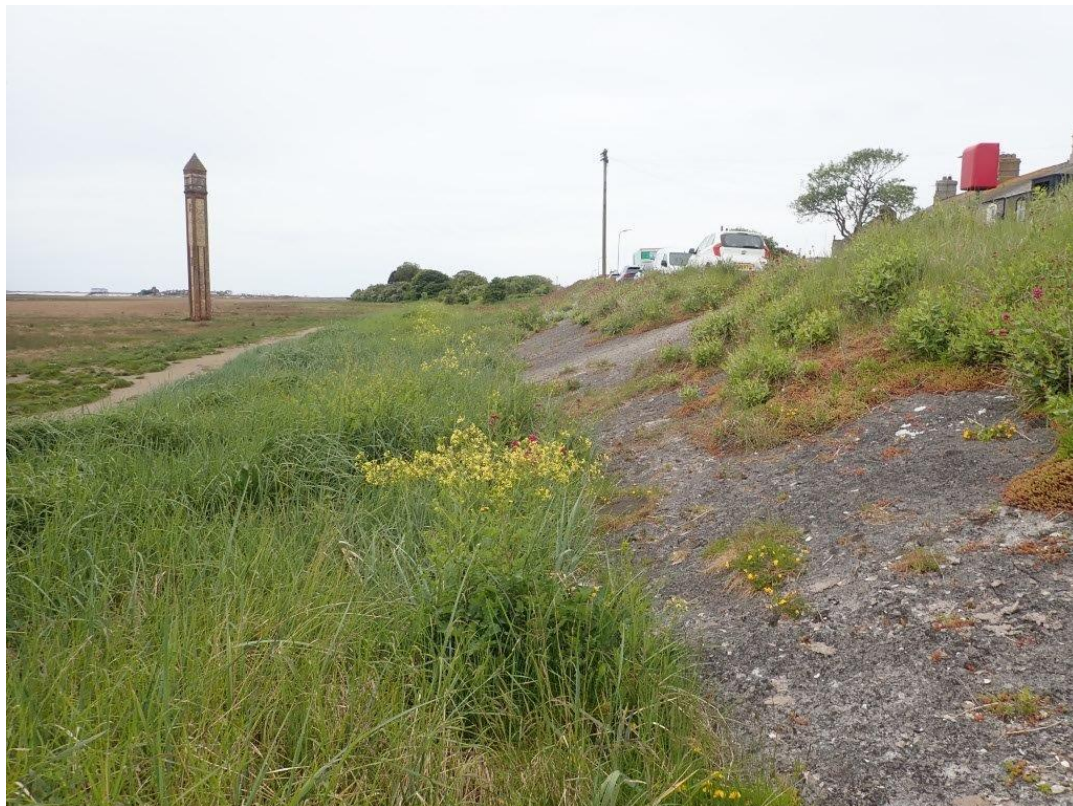
NFCDD Element and Survey Data								
Inspector	C. Bell						Date	14/05/2021
Element	Type	Sub-type	Material	Revetment	Slope	Width	Condition	Weighting
1	CB	-	Mud flat	-	-	-	2	2
2	CS	Foreshore	Salt marsh	-		20m	2	2
3	FS	Foreshore	Sand	-	5 -10 deg	10m	2	2
4	FI	Revetment	Poured concrete	Concrete	35 deg	3m	3	5
5	B	Berm	Turf	-		5m	3	5
Residual Life		5-10	Urgency	No repairs		Overall Condition		3
						Data Quality		1
Comments and Recommendations <p>The foreshore is heavily vegetated due to being sheltered by Foulney Island and its causeway. A wide and shallow salt marsh protects the revetment, with heavy vegetation protecting both the toe and the upper part of the revetment. No urgent repairs are necessary, however there are areas of spalled and cracked concrete evident in areas not protected by vegetation.</p>								
Indicative sketch of cross-section <p>The sketch shows a cross-section of the coastal profile. Point 1 is the mud flat at the water's edge. Point 2 is the salt marsh area. Point 3 is the sand area. Point 4 is the concrete revetment structure, shown as a slope. Point 5 is the berm, shown as a horizontal line at the top of the revetment.</p>

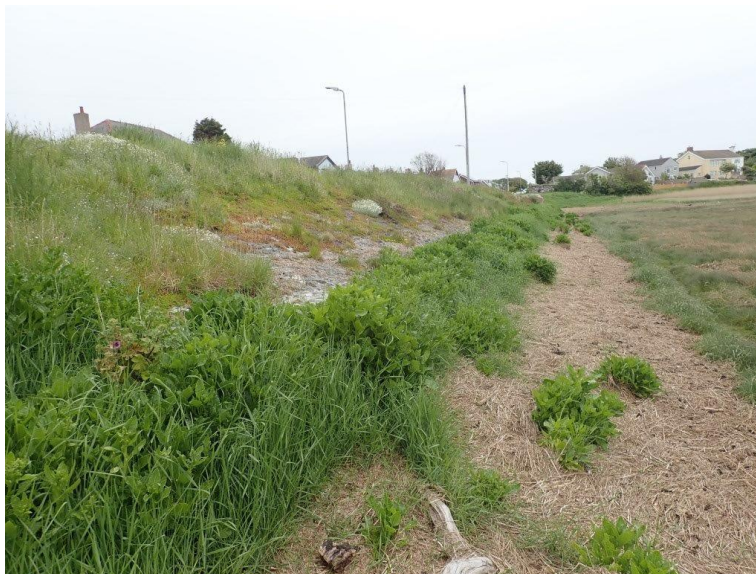
Outfall from floodgate

NFCDD Element and Survey Data								
Inspector	C. Bell						Date	14/05/2021
Element	Type	Sub-type	Material	Revetment	Slope	Width	Condition	Weighting
1	CB	-	Mud flat	-	-	-	3	2
2	CS	Foreshore	Salt marsh	-		100m	2	2
3	FG	Flood gate	Timber				4	4
4	FI	Revetment	Poured concrete	Concrete	35 deg	3m	3	5
5	B	Berm	Turf	-		3m	3	5
Residual Life		5-10	Urgency	No repairs		Overall Condition		3
						Data Quality		1

The revetment remains heavily vegetated, up to 90% in parts. Spalling and cracking of the concrete is evident in areas not protected by vegetation, however no urgent repairs are required.

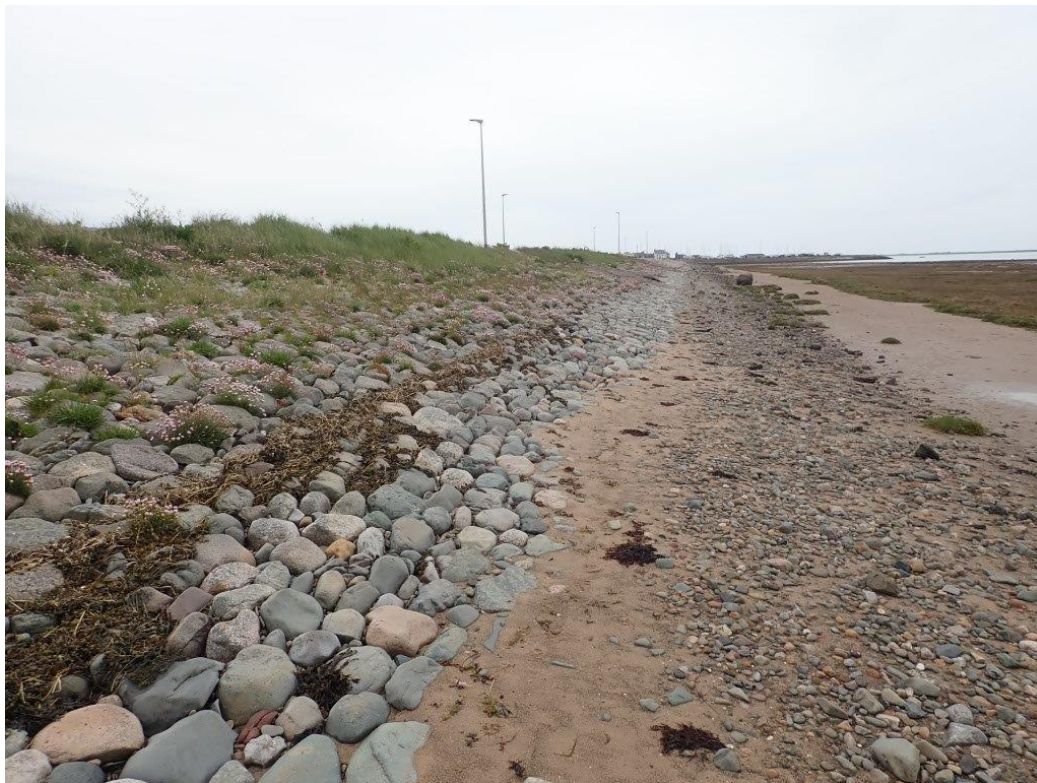
NFCDD Element and Survey Data								
Inspector	C. Bell						Date	14/05/2021
Element	Type	Sub-type	Material	Revetment	Slope	Width	Condition	Weighting
1	CB	-	Mud flat	-	-	-	-	-
2	CS	Foreshore	Salt marsh	-	-	-	2	1
3	FI	Revetment	Grouted stone	-	-	-	2	8
4	C	Revetment	Grouted stone	-	-	-	2	8
5	B	Road	-	-	-	-	-	-
Residual Life		5-10	Urgency	No repairs		Overall Condition		2
						Data Quality		1
Comments and Recommendations The revetment is made of mixed sections; bituminised aggregate, cobbles and asphalt. The overall condition of the revetment remains fair with some small areas of cobbles lost in isolated locations leading to slight washout. Vegetation is becoming established at the top of the revetment. There are enough areas of deterioration for some remedial work to be worthwhile as notified following previous assessments. However no remedial work appears to have been carried out in recent years since notification.

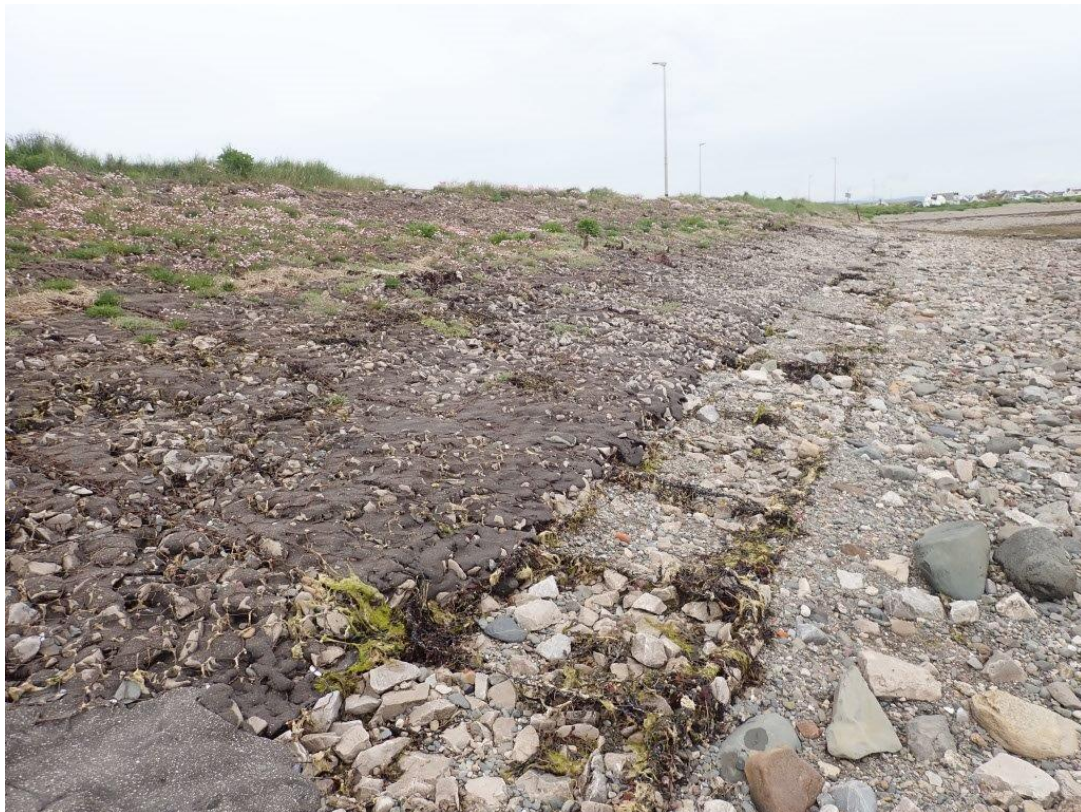
NFCDD Element and Survey Data								
Inspector	C. Bell						Date	14/05/2021
Element	Type	Sub-type	Material	Revetment	Slope	Width	Condition	Weighting
1	CB	-	Mud flat	-	-	-	-	-
2	CS	Foreshore	Salt marsh	-	-	-	2	1
3	FI	Revetment	Grouted stone	-	-	-	3	8
4	C	Revetment	Grouted stone	-	-	-	3	8
5	B	Road	-	-	-	-	-	-
Residual Life		5-10	Urgency	No repairs		Overall Condition		3
						Data Quality		1
Comments and Recommendations								
Various poured concrete repairs have been carried out in recent years to areas where cobbles had been lost and washed out. Areas of stone loss still remain in some areas of the revetment, however these areas do not appear to have deteriorated significantly over the last few years, and no urgent repairs are required at this stage. There continues to be increased vegetation growth towards the top of the revetment.								
Looking towards Roa Island.

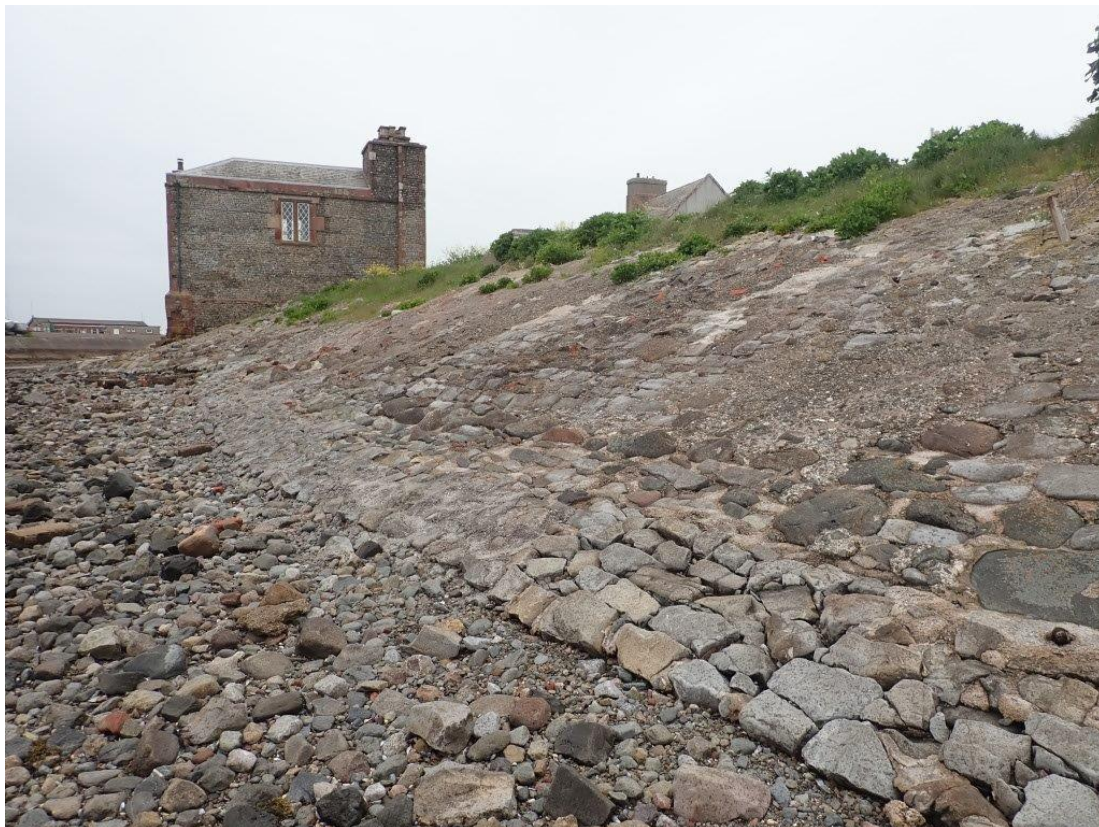
NFCDD Element and Survey Data								
Inspector	C. Bell						Date	14/05/2021
Element	Type	Sub-type	Material	Revetment	Slope	Width	Condition	Weighting
1	CB	Mud Flat	1	-	-	-	-	-
2	CS	Shingle Foreshore	2	-	-	-	2	2
3	FI	Cobble and Masonry Revetment	3	-	-	-	2	8
4	B	Berm	4	-	-	-	3	8
5	FI	Domestic Wall	5	-	-	-	-	-
Residual Life		10	Urgency	No repairs		Overall Condition		2
						Data Quality	1	
Comments and Recommendations <p>The revetment is made of cobbles and masonry. Reinstatement of pointing between the cobbles was carried out in 2012 to reinforce the structure of the revetment. There are still small areas with minor pointing loss at other sections of the defence but there does not appear to have been any major deterioration since the previous inspection. Some washout has occurred at the toe of the revetment in recent years, this should continue to be monitored over the coming years, as remedial works may be required.</p>

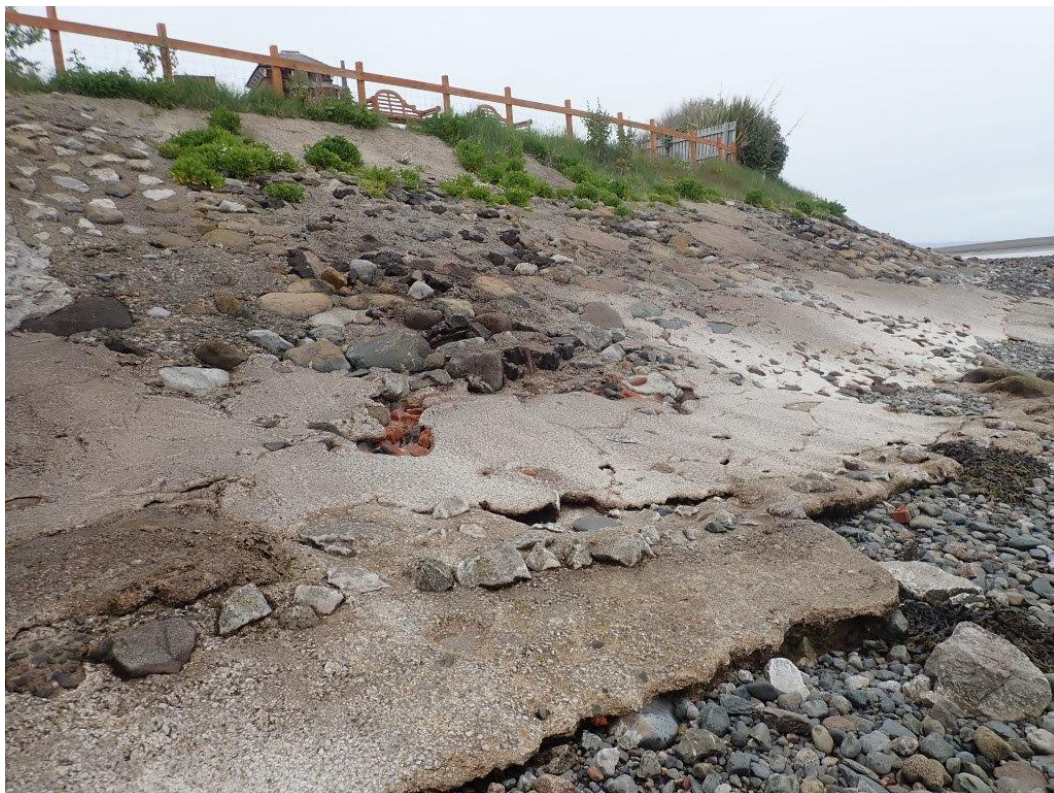
NFCDD Element and Survey Data								
Inspector	C. Bell						Date	14/05/2021
Element	Type	Sub-type	Material	Revetment	Slope	Width	Condition	Weighting
1	CB	Mudflat	1	-	-	-	-	-
2	FI	Revetment	2	-	-	-	2	1
3	C	Revetment	3	-	-	-	3	8
4	B	Berm	4	-	-	-	3	8
5	FI	Brick and masonry wall	5	-	-	-	-	-
Residual Life		0-5	Urgency	No repairs		Overall Condition		3
						Data Quality		1
Comments and Recommendations Access steps and a small section of the revetment adjoining the steps have been reconstructed in recent years. The previous void at the toe of the revetment adjacent to the steps has been backfilled with mass concrete, and the handrail has also been repaired again in recent years. Numerous patch repairs have also been carried out in recent years, although there is still some undercutting at the toe of the revetment, however no urgent repairs are required at this stage and no major deterioration appears to have occurred since the last inspection.

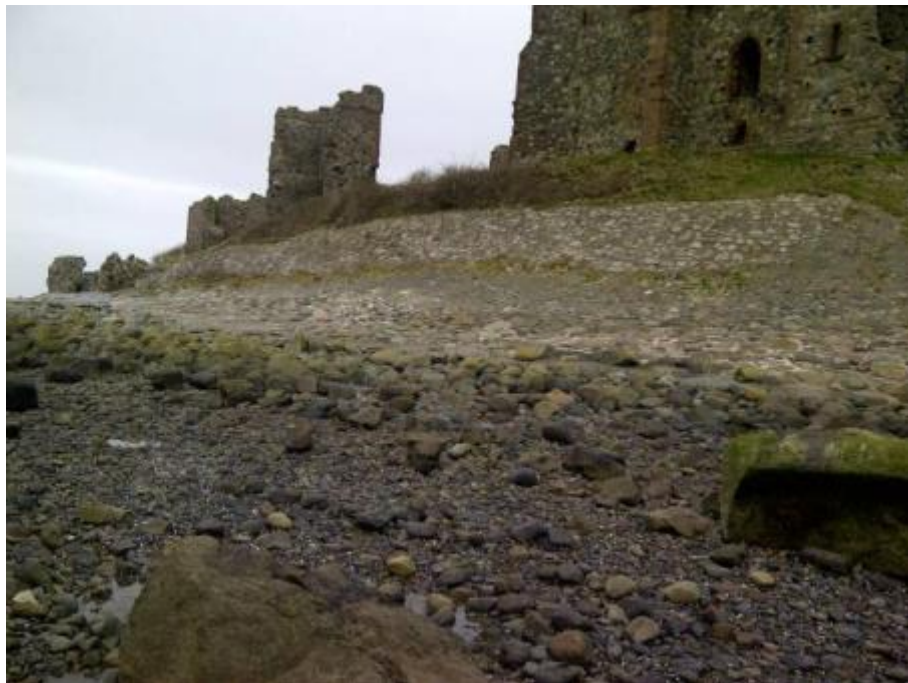
Section 5

NFCDD Element and Survey Data								
Inspector	A. Buck						Date	04/07/2013
Element	Type	Sub-type	Material	Revetment	Slope	Width	Condition	Weighting
1	CB	-	Mud flat	-	-	-	-	-
2	CS	Foreshore	Shingle	-	-	-	2	1
3	FI	Revetment	Grouted stone				4	8
4	FI	Revetment	Turf	-	-	-	4	8
5	C		Turf	-	-	-		
Residual Life		0-5	Urgency	Repairs		Overall Condition		4
						Data Quality		1
Comments and Recommendations Asset is originally grouted stone with poured concrete repairs. Some sections (partially) replaced by gabions. Original castle walls have collapsed over defences in 2 sections. Asset divided for convenience into 5 sections (see photos above) to reflect this. Section 1: significant loss of stone to 2 areas (1 & 5 metres wide). Undercutting at toe and loss of stone to both sides adjacent to jetty. Repairs necessary. Section 2: 2 gabion baskets showing stone loss (1 significant, 1 small loss). Several basket wire breaks. Repairs necessary to prevent deterioration/unwinding of gabion baskets. Section 3: gabion baskets well packed and aligned. Several basket wire breaks – but generally free from corrosion. Cracks and occasional missing stone to grouted stone area. Repairs necessary to prevent deterioration/unwinding of gabion baskets. Section 4: collapsed castle wall masonry with small area of gabion baskets behind. Evidence of burrowing to rear of gabion baskets. Section 5: minor undercutting at toe of grouted stone revetment. Collapsed castle wall masonry at limit of asset. 04/07/13 Gabion baskets in section 2 showing further deterioration. 4 gabion baskets all showing significant stone loss

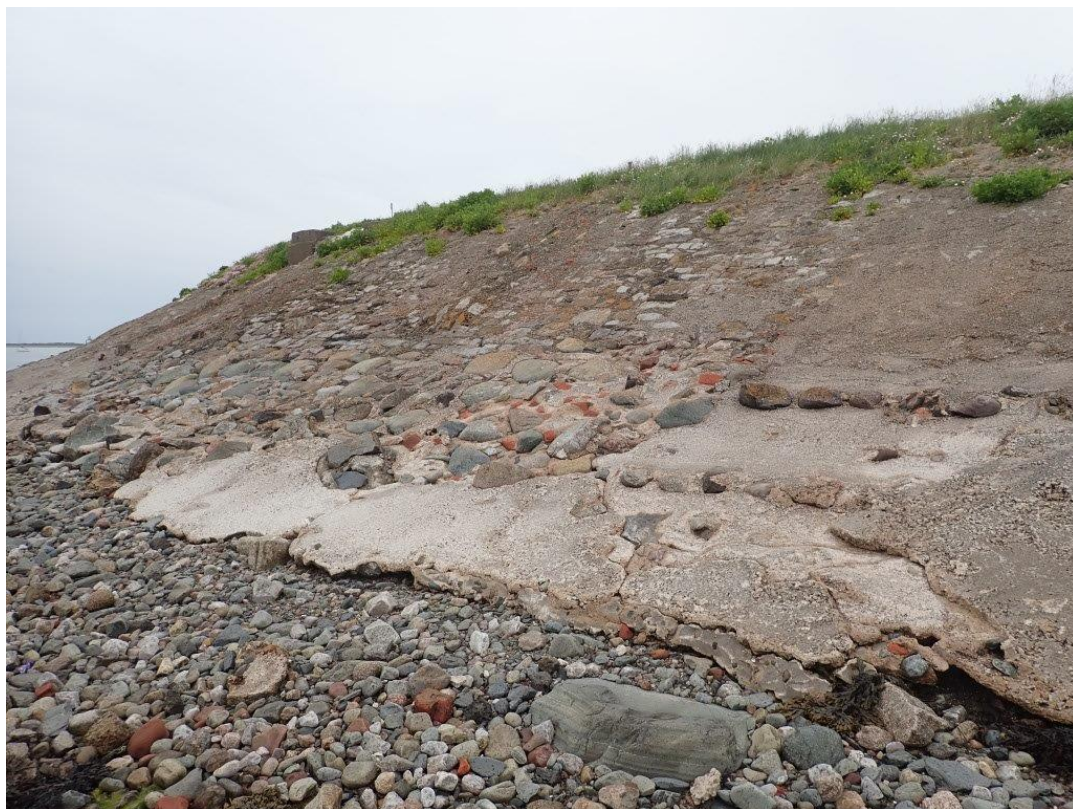
NFCDD Element and Survey Data								
Inspector	C. Bell						Date	14/05/2021
Element	Type	Sub-type	Material	Revetment	Slope	Width	Condition	Weighting
1	CB	-	Mud flat	-	-	-	-	-
2	CS	Foreshore	Shingle	-	-	-	2	2
3	FS	Revetment	Concrete/cobble	-	-	-	3	8
4	C	Revetment	Concrete/cobble				3	8
Residual Life		5-10	Urgency	No repairs		Overall Condition		3
						Data Quality	1	
Comments and Recommendations There is some cracking and minor undercutting at the toe, however as with previous inspections, there appears to be no substantive deterioration over recent years, with no urgent repairs currently required.								
Indicative sketch of cross-section

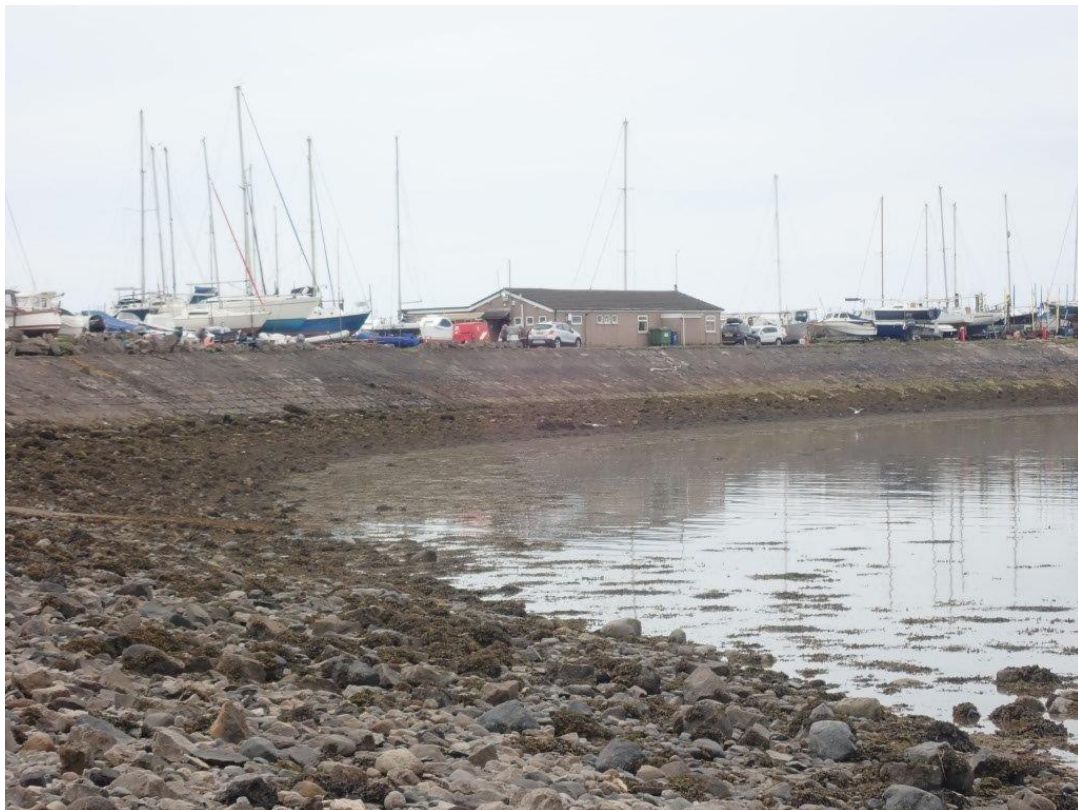
NFCDD Element and Survey Data								
Inspector	C. Bell						Date	14/05/2021
Element	Type	Sub-type	Material	Revetment	Slope	Width	Condition	Weighting
1	CB	-	Mud flat	-	-	-	-	-
2	CS	Foreshore	Shingle	-	-	-	2	2
3	FS	Revetment	Concrete	-	-	-	3	8
4	C	Revetment	Concrete				3	8
Residual Life		5-10	Urgency	No repairs		Overall Condition		3
						Data Quality	1	
Comments and Recommendations <p>The concrete revetment remains in a good condition overall, with only minor cracking and some minor damage to the toe in places, however now substantial deterioration appears to have occurred over recent years. There are also small areas of minor stone loss and loss of pointing. The club have experienced some damage to their own slipway in previous years; however the revetment remains in good condition.</p>								
Indicative sketch of cross-section

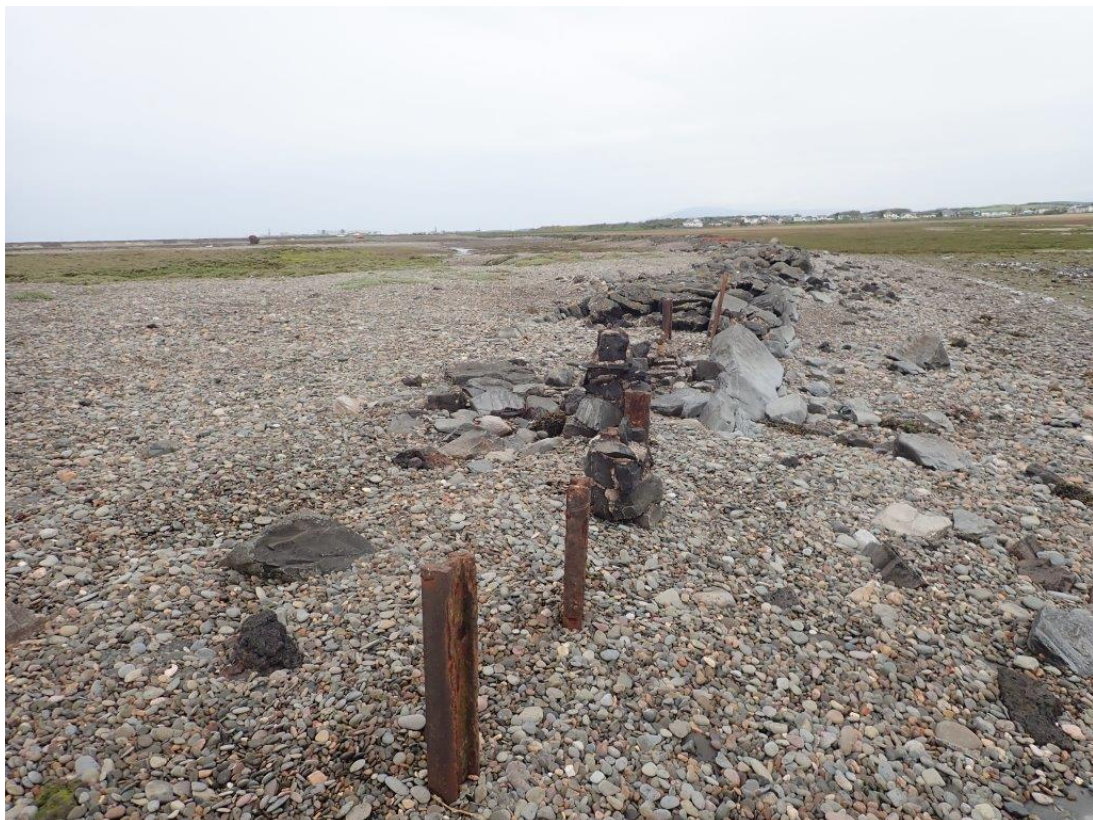
NFCDD Element and Survey Data								
Inspector	C. Bell						Date	14/05/2021
Element	Type	Sub-type	Material	Revetment	Slope	Width	Condition	Weighting
1	CS	Foreshore	Shingle	-	-	-	2	1
2	FI	Embankment	Stone	-	-	-	4	8
3	B	Berm	Stone	-	-	-	4	8
4	FO	Embankment	Stone				4	8
5	CS	Saltmarsh	Saltmarsh				2	2
Residual Life		1-5	Urgency	Medium		Overall Condition		4
						Data Quality		1
Comments and Recommendations Sections of the revetment remain in a reasonable condition, however there are areas where the revetment has collapsed, providing little to no protection. There is evidence of some minor areas of concrete repair carried out to the berm previously. There is a section at the south-eastern end of approximately 190m that is buried in the shingle ridge. Despite no signs of any major deterioration since the previous inspection, there appears to have been a continued build up of shingle in places. It is recommended that annual inspections of this asset continue to monitor deterioration, including any erosion of the saltmarsh.

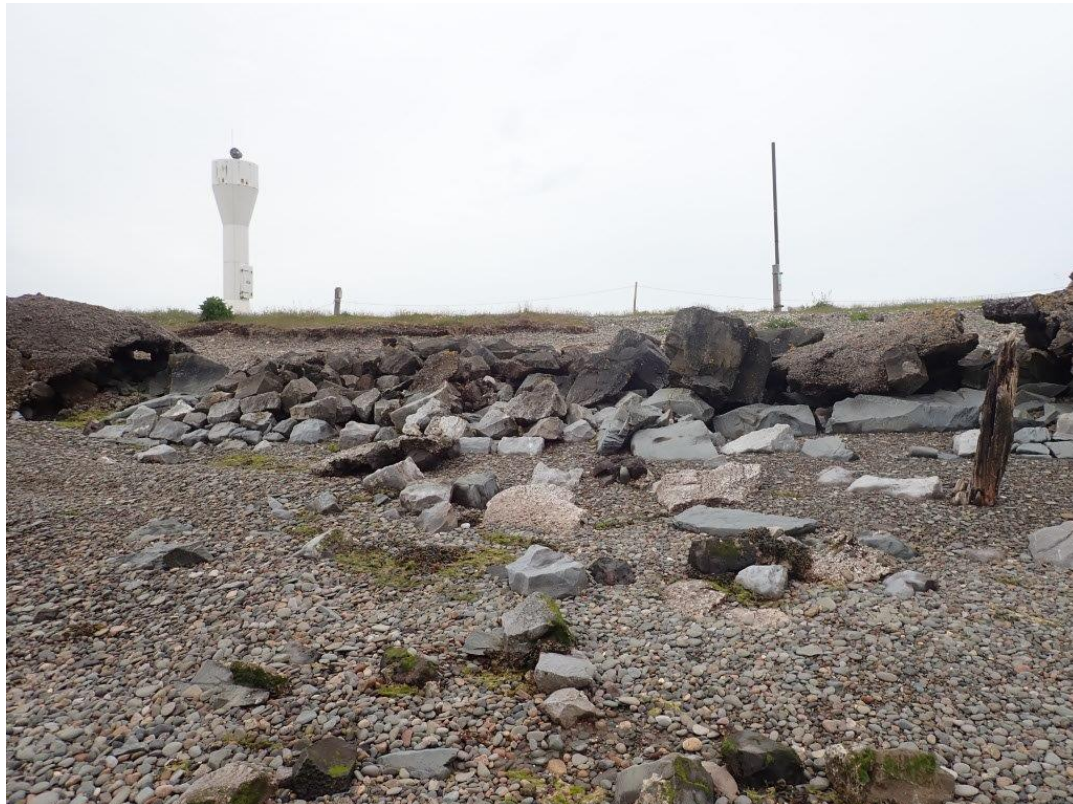
NFCDD Element and Survey Data								
Inspector	C. Bell						Date	14/05/2021
Element	Type	Sub-type	Material	Revetment	Slope	Width	Condition	Weighting
1	CS	Foreshore	Shingle	-	-	-	2	1
2	FI	Revetment	Concrete/Stone	-	-	-	4	8
3	C	Revetment	Concrete/Stone	-	-	-	4	8
Residual Life		1-5	Urgency	Medium		Overall Condition		4
						Data Quality		1
<p>Comments and Recommendations</p> <p>This section of the defence is a concrete and stone revetment against the shingle bank that forms the north-eastern side of Foulney Island. The defence is in poor condition with washed out sections of concrete.</p> <p>The defence should be inspected annually to monitor its condition as it helps to maintain the integrity of Foulney Island and the protection it gives to the saltmarsh.</p>								
<p>Indicative sketch of cross-section (looking towards Foulney Island)</p>

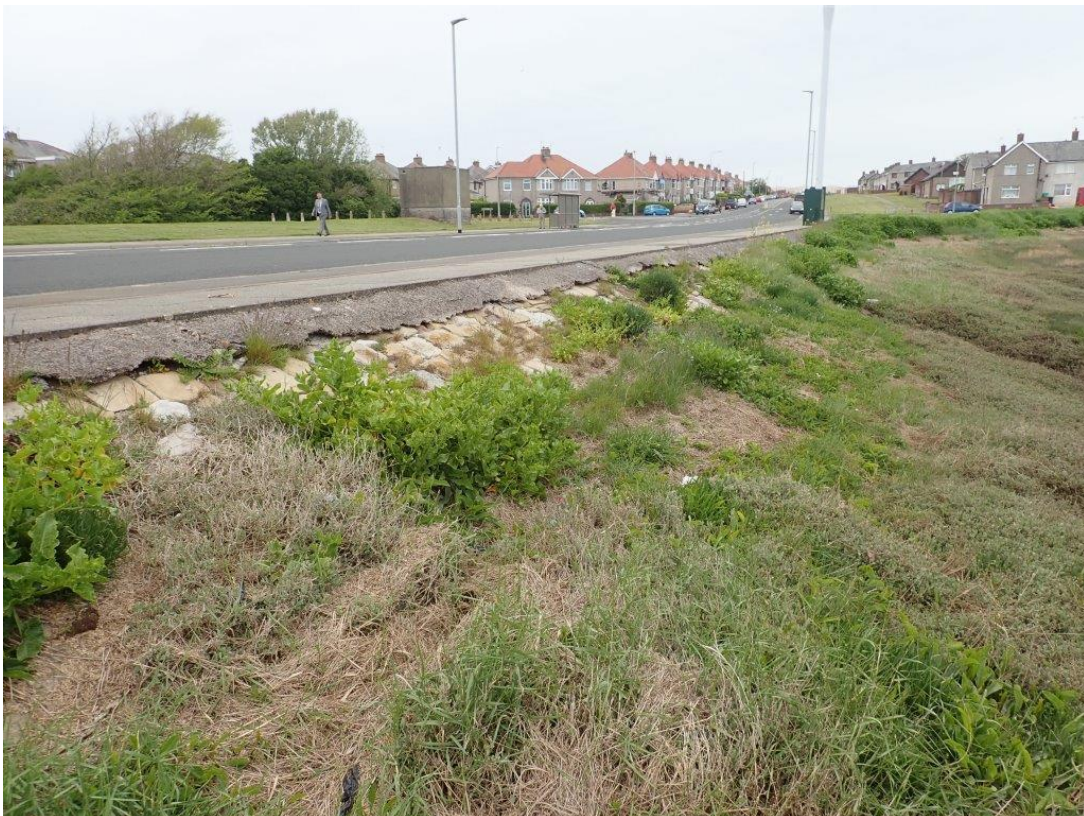
NFCDD Element and Survey Data								
Inspector	C. Bell						Date	28/05/2021
Element	Type	Sub-type	Material	Revetment	Slope	Width	Condition	Weighting
1	CB	-	Mud flat	-	-	-	2	2
2	FS	Salt Marsh		-		100m+	2	2
3	FI	Revetment	Blockwork		35 deg	4m	3	6
Residual Life		10-20	Urgency				Overall Condition	3
						Data Quality	1	
Comments and Recommendations This asset includes Outfalls and gates that are listed separately below. The embankment is now almost entirely covered in heavy vegetation and protected by a well-developed saltmarsh.								
Indicative sketch of cross-section

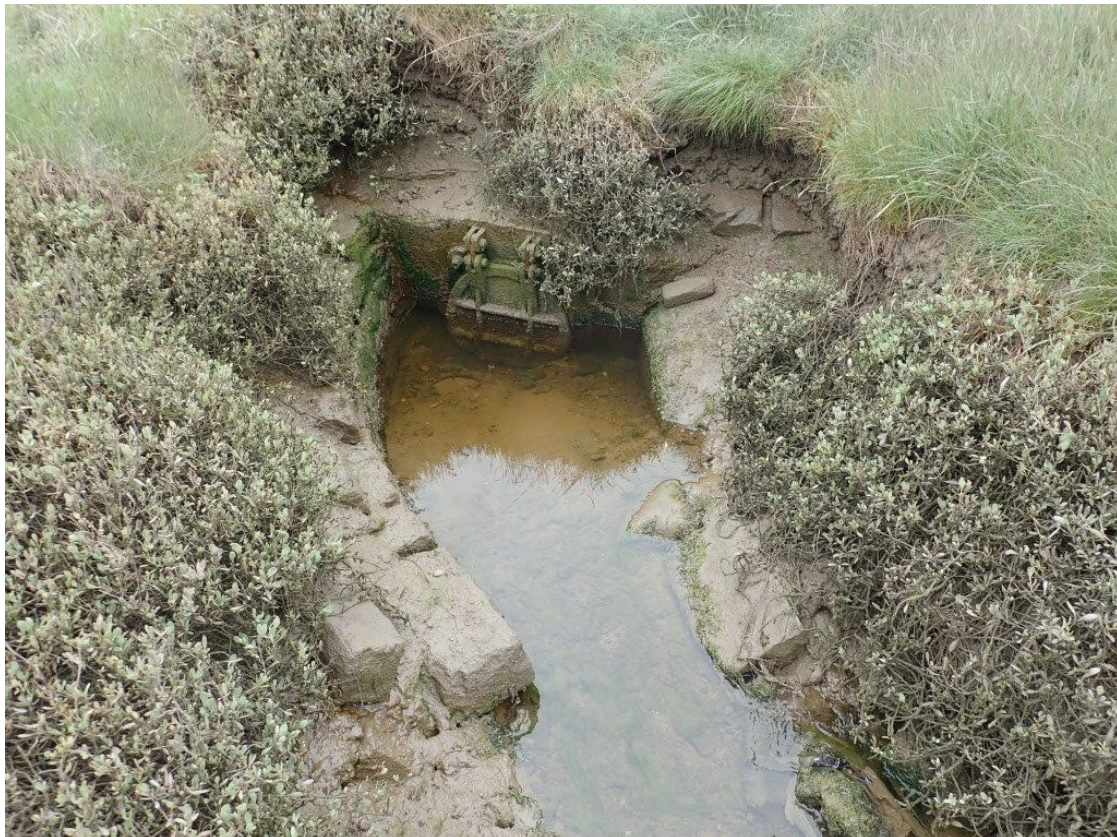
NFCDD Element and Survey Data								
Inspector	C. Bell						Date	28/05/2021
Element	Type	Sub-type	Material	Revetment	Slope	Width	Condition	Weighting
1	FG1	Flood gate	Flap Valve				3	8
2	FI	Head Wall	Concrete			1.5m	2	8
3	WW1	Wing Wall	Block work				3	6
4	WW2	Wing Wall	Block work				3	6
5		Outfall	Silt				3	7
6		Culvert	unseen				3	7
Residual Life		10-20	Urgency				Overall Condition	3
							Data Quality	3

This flood gate is a 300mm dia pipe which is restricted by mud and silt. The condition of the culvert has not been seen but there is evidence of satisfactory water flow. Dye testing of a ditch on Shearwater Crescent a number of years ago proved water from Sandy Gap Lane and the ditch discharges here. The flood gate remains unable to open fully due to the presence of sediment but does appear to be able to seal. During the time of the inspection the gate was almost closed, and due to the volume of sediment in the channel it is unclear how effective the gate is at this time.

A camera survey of the pipe in November 2013 showed the pipes to be in good condition but there was an issue with cross contamination that was reported to UU. It remains unknown whether any action has been taken regarding this.

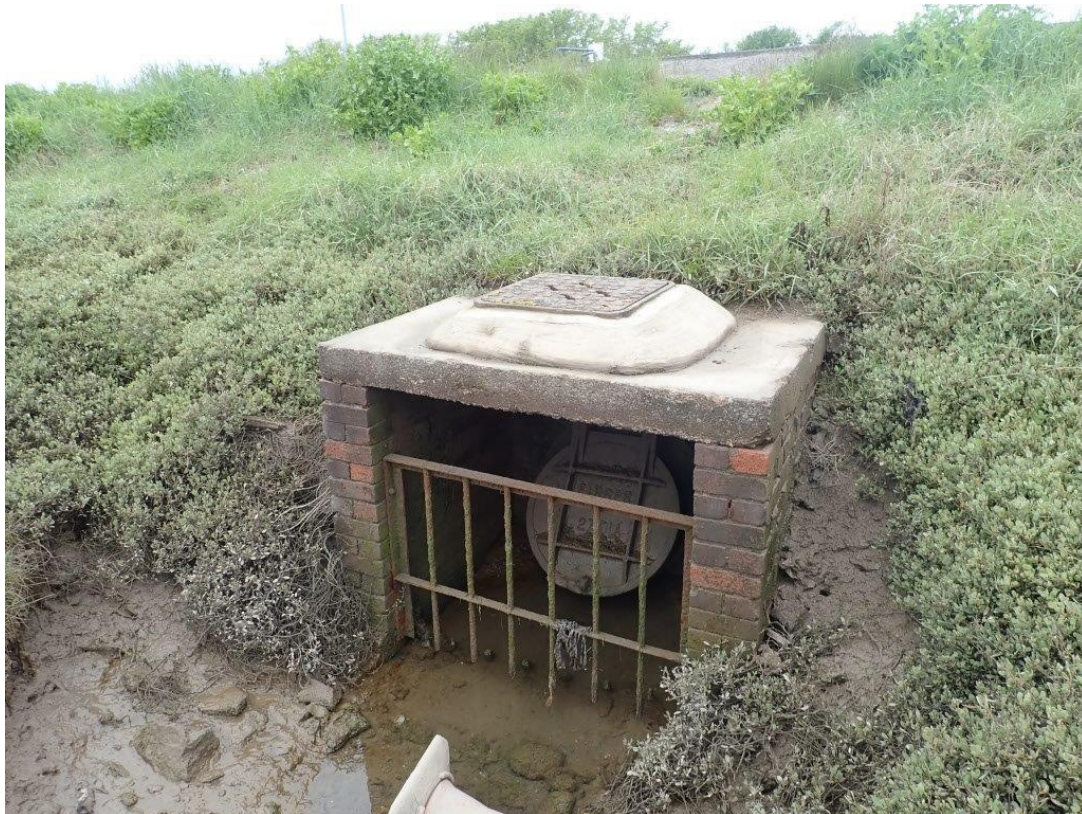
NFCDD Element and Survey Data								
Inspector	C. Bell						Date	28/05/2021
Element	Type	Sub-type	Material	Revetment	Slope	Width	Condition	Weighting
1	FG1	Flood gate	Flap Valve with debris screen				2	8
2	FI	Head Wall	Brick			1.5m	2	8
3	WW1	Wing Wall	Brick				3	6
4	WW2	Wing Wall	Brick				3	6
5		Outfall	Mud				3	7
6		Culvert	unseen				3	7
Residual Life		10-20	Urgency				Overall Condition	3
							Data Quality	3
Comments and Recommendations <p>The flood gate is generally in fair condition and although it was cleared of silt a number of years ago there is further build up. There seems to be very low flow coming from the pipe, however UU arranged a camera survey in November 2013, the results of which showed the pipework to be free, running and in good condition. It is unknown whether any further surveys have taken place since 2013. The previously dislodged manhole cover that sits on top of the head wall has been reset since the last inspection.</p>

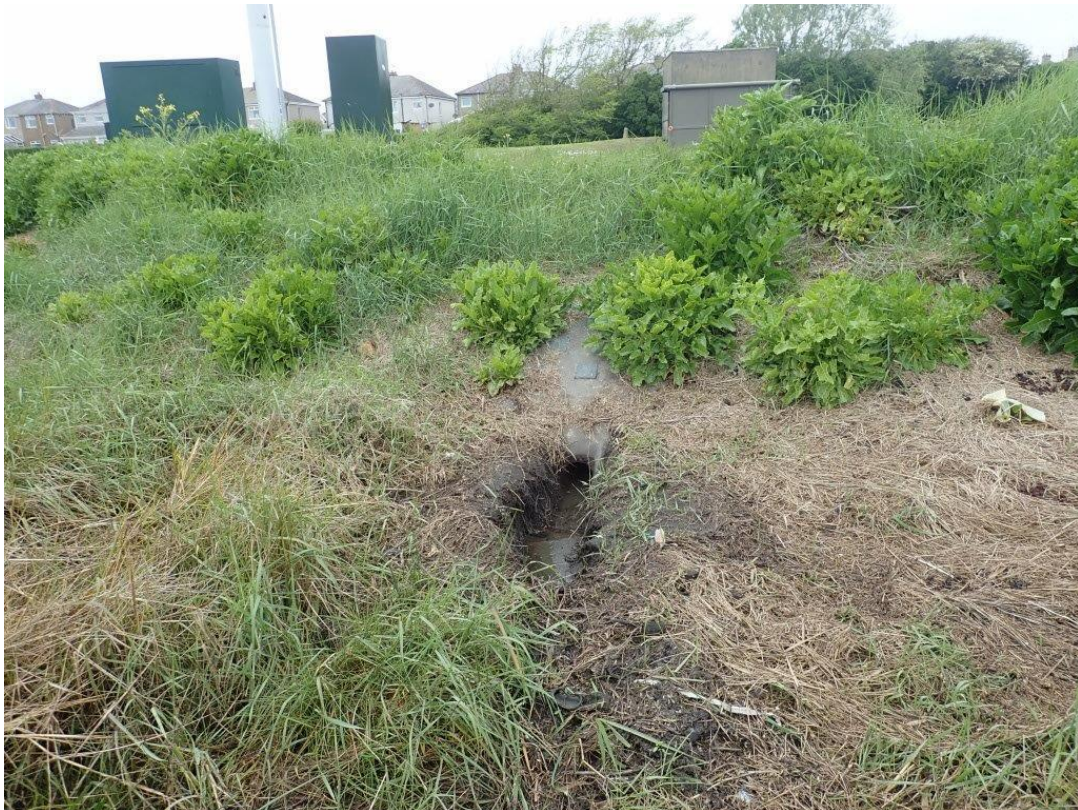
NFCDD Element and Survey Data								
Inspector	C. Bell						Date	28/05/2021
Element	Type	Sub-type	Material	Revetment	Slope	Width	Condition	Weighting
1	Culvert	Head Wall	Concrete			1m	2	8
2		Outfall	Concrete				2	7
3		Culvert	unseen				2	7
Residual Life		10-20	Urgency				Overall Condition	2
						Data Quality	3

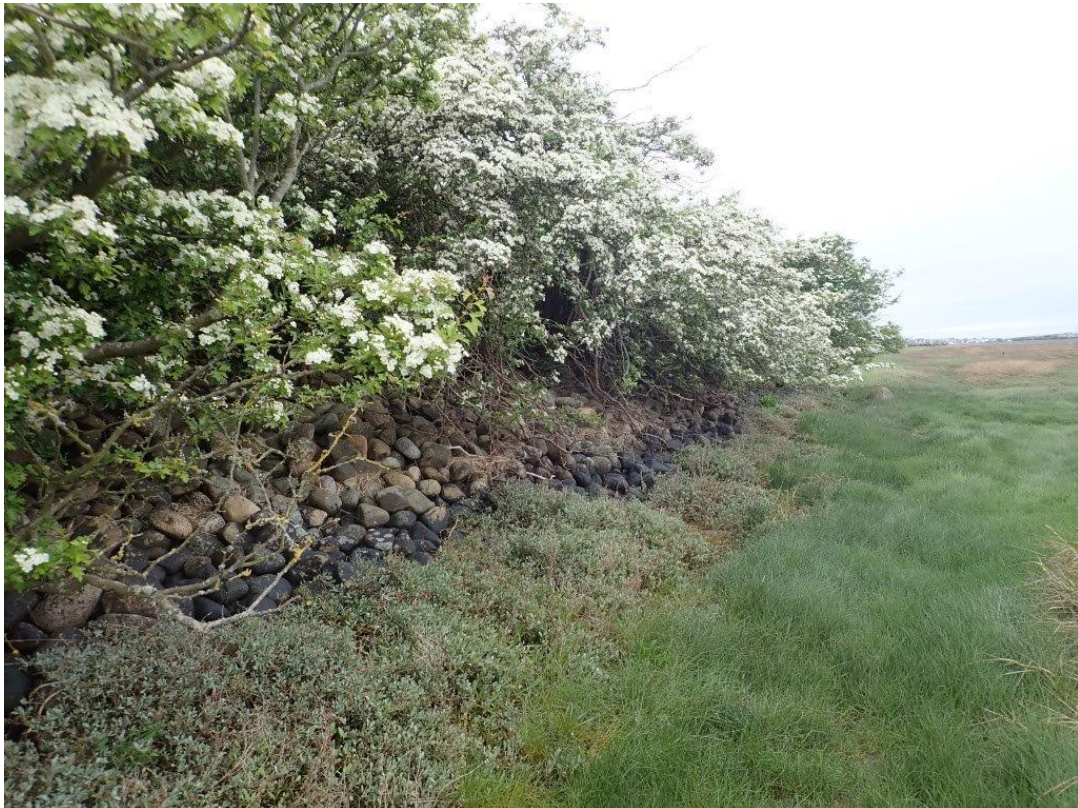
NFCDD Element and Survey Data								
Inspector	C. Bell						Date	28/05/2021
Element	Type	Sub-type	Material	Revetment	Slope	Width	Condition	Weighting
1	CB	-	Mud flat	-	-	-	-	-
2	CS	Foreshore	Saltmarsh	-	-	-	2	1
3	FI	Embankment	Clay/cobbles	Grass	75	-	3	8
4	C	Embankment	Clay/cobbles	Grass	0	2	3	8
5	FO	Embankment	Clay/cobbles	Grass	75		3	8
Residual Life		10-20	Urgency	Routine		Overall Condition		3
						Data Quality		1
Comments and Recommendations <p>The embankment remains heavily vegetated, with small trees growing, and is protected by a very mature salt marsh. The embankment has been flood protection for the road at high tide and is not really necessary as an erosion defence due to being on the sheltered side of the island. There appears to have been no significant deterioration since the previous inspection.</p>								
Indicative sketch of cross-section

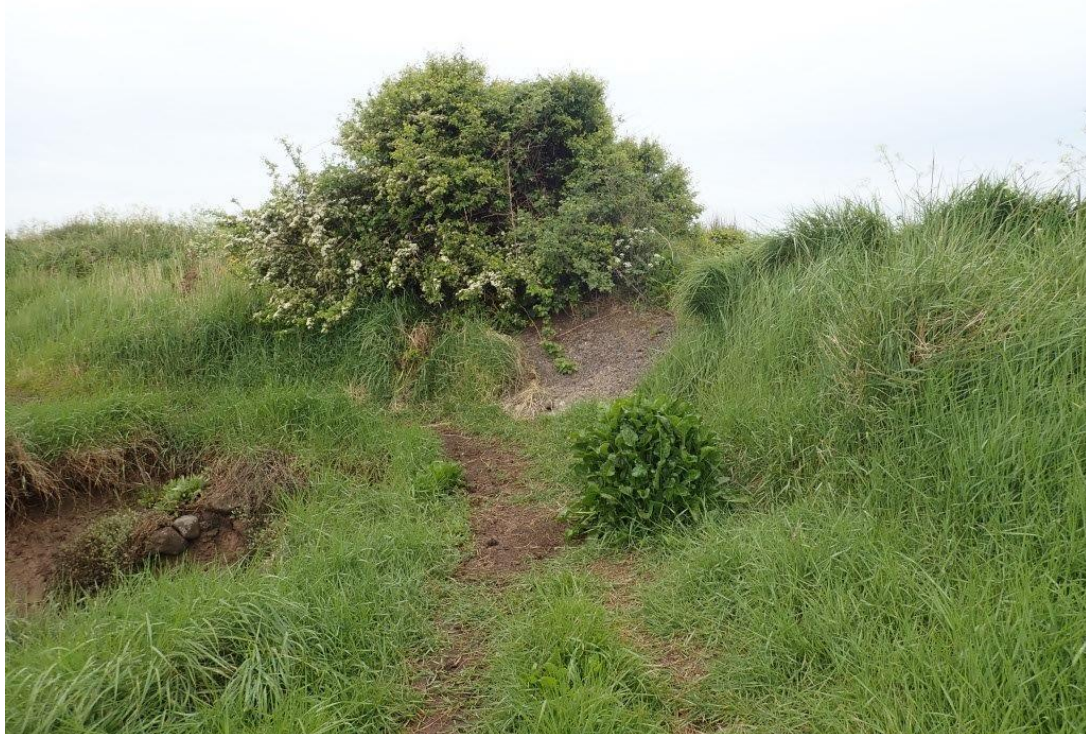
NFCDD Element and Survey Data								
Inspector	C. Bell						Date	28/05/2021
Element	Type	Sub-type	Material	Revetment	Slope	Width	Condition	Weighting
1	CB	-	-	-	-	-	-	-
2	CS	Foreshore	Saltmarsh	-	-	-	2	1
3	FI	Embankment	Masonry	-	-	-	3	8
4	C	Embankment	Masonry	-	-	-	3	8
5	FO	Embankment	Masonry	-	-	-	3	8
Residual Life		10-20	Urgency	Routine		Overall Condition		3
						Data Quality		1
Comments and Recommendations <p>The area being protected by this asset is low grade farmland, and there is heavy vegetation on the foreshore protecting the defence. The embankment is heavily covered in vegetation due to its protected location, as a result it is almost impossible to see any exposed masonry.</p>								
Indicative sketch of cross-section

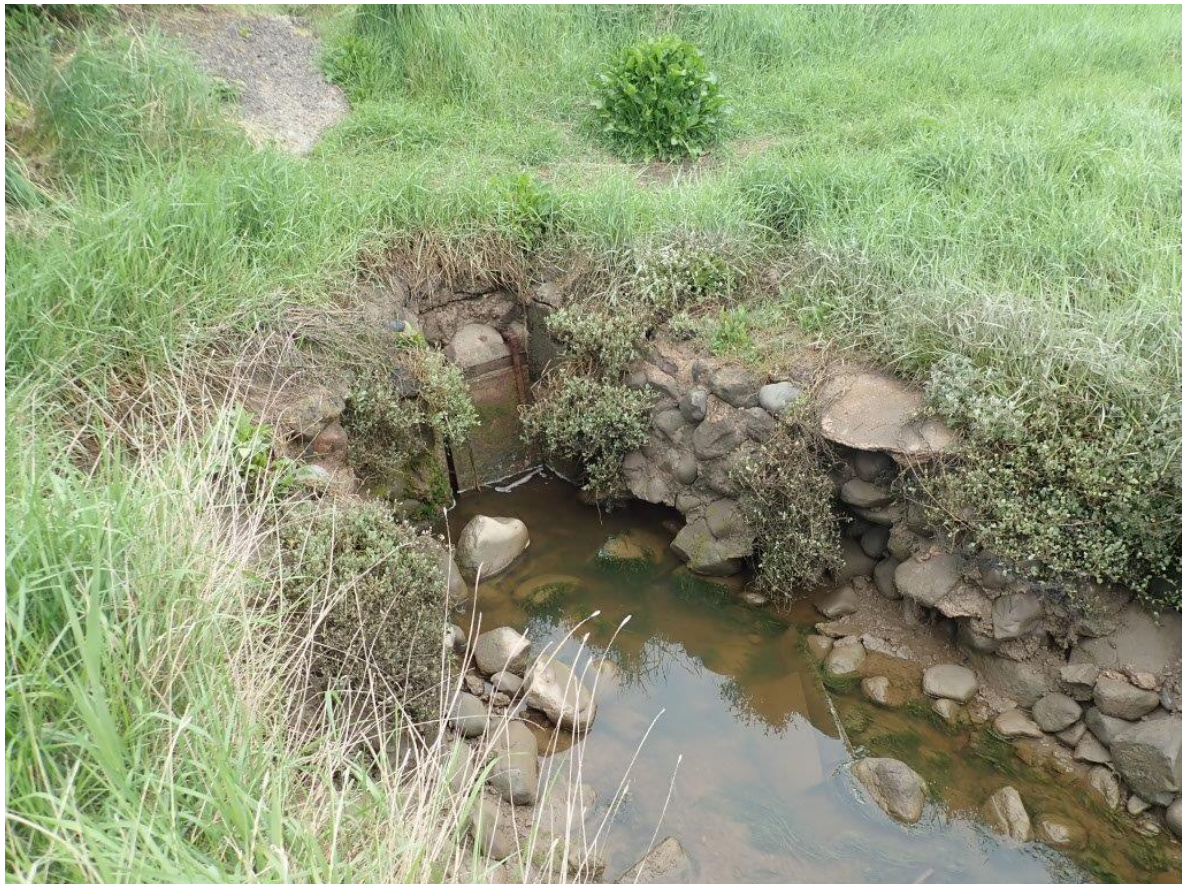
NFCDD Element and Survey Data								
Inspector	C. Bell						Date	28/05/2021
Element	Type	Sub-type	Material	Revetment	Slope	Width	Condition	Weighting
1	CS	Foreshore	Saltmarsh	-	-	-	2	1
2	FG1	Flood gate	Wooden Flap Valve				3	8
3	FI	Head Wall	Block work			1m	3	8
4	WW1	Wing Wall	Cobbles				4	6
5	WW2	Wing Wall	Cobbles				4	6
6		Outfall	shingle				3	6
7		Culvert	stonework				2	6
Residual Life		10-20	Urgency	Routine		Overall Condition		3
						Data Quality		1
Comments and Recommendations								
<p>The wing walls are collapsing but the culvert and outfall appears to still be flowing. There has been further washout of cobbles on the southern side of the defence in recent years, although no significant deterioration appears to have occurred since the last inspection. The gate is of very lightweight material but due to the protection from a mature salt marsh there is little pressure on this asset. There is little evidence of flooding behind the embankment from high tide.</p> <p>As recommended following previous inspections; the need to register this asset is still to be reviewed due to the low priority of the land protected, being low grade farmland and heavy vegetation on the foreshore, meaning that there is little risk.</p>
