Barrow Coastal Inspections 2020

Barrow Borough Council

May 2021

Title	Barrow Coast Protection Inspections
Creator/Author	Craig Bell/Mark Ellis, Capita
Publisher	Barrow Borough Council, Town Hall, Duke Street, Barrow-in-Furness. LA14 2LD
Date of Publication	01/06/2021
Contact	Chris Jones, Barrow Borough Council
Subject – keyword	Survey and monitoring – coastal defence inspections
Description/Abstract	Report detailing the results of an inspection of coast defences along Barrow Borough Council's coastline completed in 2021
Identifier	CS063836/002
Coverage – spatial	Barrow Borough Council coastline – from Peasholmes Lane A5087 to Mere Beck, Askam-in-Furness
Coverage – temporal	2018
Format	documentDigital
Type	Report
Subject – category	Coastal Defence
Subject – project	Cell 11 Regional Monitoring Strategy
Language	English
Rights – copyright	Map data copyright Ordnance Survey licence
Rights – disclosability	Yes
Rights – FOIA	Yes
Postal Address	Barrow Borough Council, Town Hall, Duke Street, Barrow-in-Furness

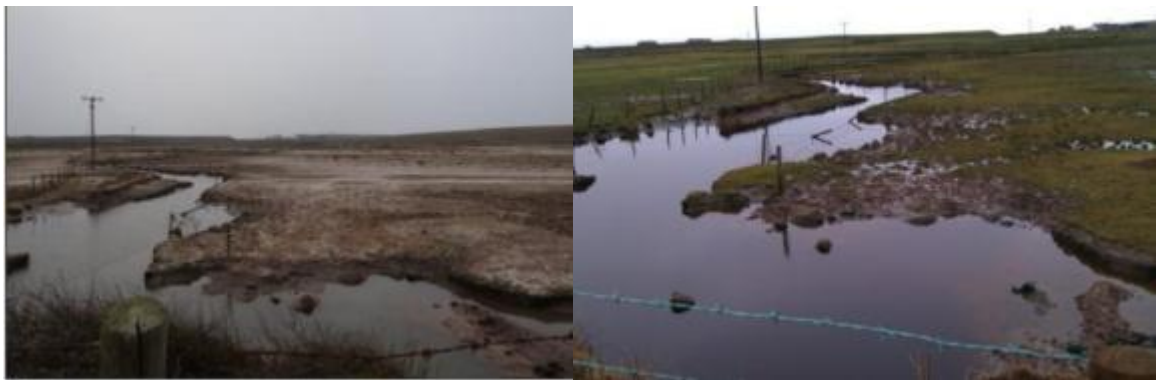
The farmer's field was damaged by the original floodgate failing and the brown area over the originally green field marks the pasture destroyed by the tide. This is now recovering but a soil survey showed that it was not suitable for grazing. It is unknown if this is still the case. The road has also been overtopped by tidal surges leaving the field waterlogged.

NFCDD Element and Survey Data								
Inspector	C. Bell						Date	28/05/2021
Element	Type	Sub-type	Material	Revetment	Slope	Width	Condition	Weighting
1	CS	Foreshore	Saltmarsh	-	-	-	3	1
2	FG1	Flood gate	Aluminium and plastic				2	8
3	FI	Head Wall	Brick work			2m	3	8
4	WW1	Wing Wall	Loose block work				4	6
5	WW2	Wing Wall	Brickwork				3	6
6		Outfall	Mud and shingle				3	6
7		Culvert	Concrete and aluminium cladding				2	6
Residual Life		5-10	Urgency				Overall Condition	3
						Data Quality	3	
Comments and Recommendations A new floodgate valve was installed in recent years but, as noted in previous inspections, superficial repairs to the loose block work on the wing wall are required, however there does not appear to have been any significant deterioration since the last inspection. On the farmer’s field side there is also some water ingress around the floodgate. The Farmer and Highways were previously asked to confirm any ownership of the embankment with a view to further repair, however it remains unknown if any progress has been made on this.

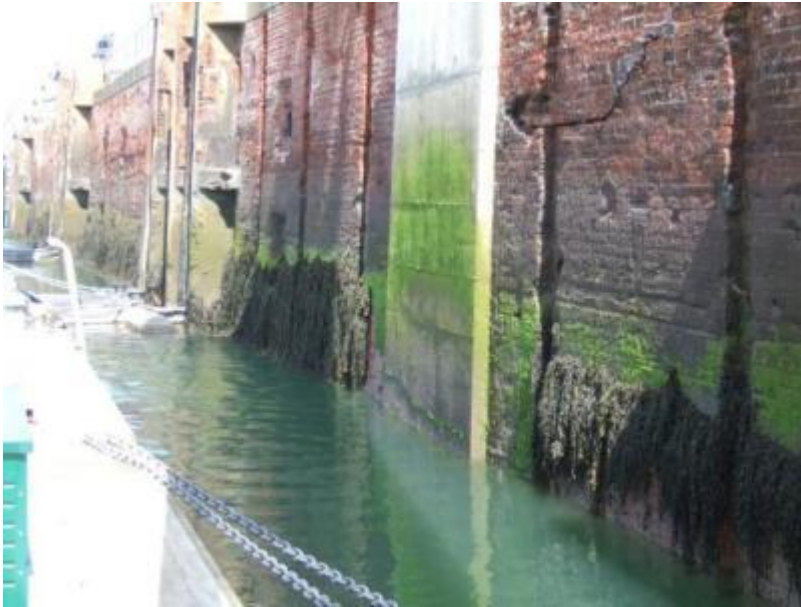
Detail of fractured wall
