Barrow Coastal Inspections 2020

Barrow Borough Council

May 2021

Title	Barrow Coast Protection Inspections
Creator/Author	Craig Bell/Mark Ellis, Capita
Publisher	Barrow Borough Council, Town Hall, Duke Street, Barrow-in-Furness. LA14 2LD
Date of Publication	01/06/2021
Contact	Chris Jones, Barrow Borough Council
Subject – keyword	Survey and monitoring – coastal defence inspections
Description/Abstract	Report detailing the results of an inspection of coast defences along Barrow Borough Council's coastline completed in 2021
Identifier	CS063836/002
Coverage – spatial	Barrow Borough Council coastline – from Peasholmes Lane A5087 to Mere Beck, Askam-in-Furness
Coverage – temporal	2018
Format	documentDigital
Type	Report
Subject – category	Coastal Defence
Subject – project	Cell 11 Regional Monitoring Strategy
Language	English
Rights – copyright	Map data copyright Ordnance Survey licence
Rights – disclosability	Yes
Rights – FOIA	Yes
Postal Address	Barrow Borough Council, Town Hall, Duke Street, Barrow-in-Furness

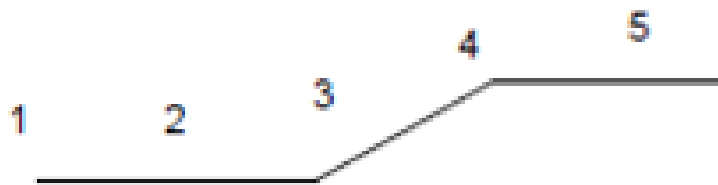
NFCDD Element and Survey Data								
Inspector	C. Bell						Date	14/05/2021
Element	Type	Sub-type	Material	Revetment	Slope	Width	Condition	Weighting
1	CB	-	Mud flat	-	-	-	-	-
2	CS	Foreshore	Salt marsh	-	-	-	2	1
3	FI	Revetment	Grouted stone	-	-	-	2	8
4	C	Revetment	Grouted stone	-	-	-	2	8
5	B	Road	-	-	-	-	-	-
Residual Life		5-10	Urgency	No repairs		Overall Condition		2
						Data Quality		1
Comments and Recommendations The revetment is made of mixed sections; bituminised aggregate, cobbles and asphalt. The overall condition of the revetment remains fair with some small areas of cobbles lost in isolated locations leading to slight washout. Vegetation is becoming established at the top of the revetment. There are enough areas of deterioration for some remedial work to be worthwhile as notified following previous assessments. However no remedial work appears to have been carried out in recent years since notification.

Looking away from Roa Island.

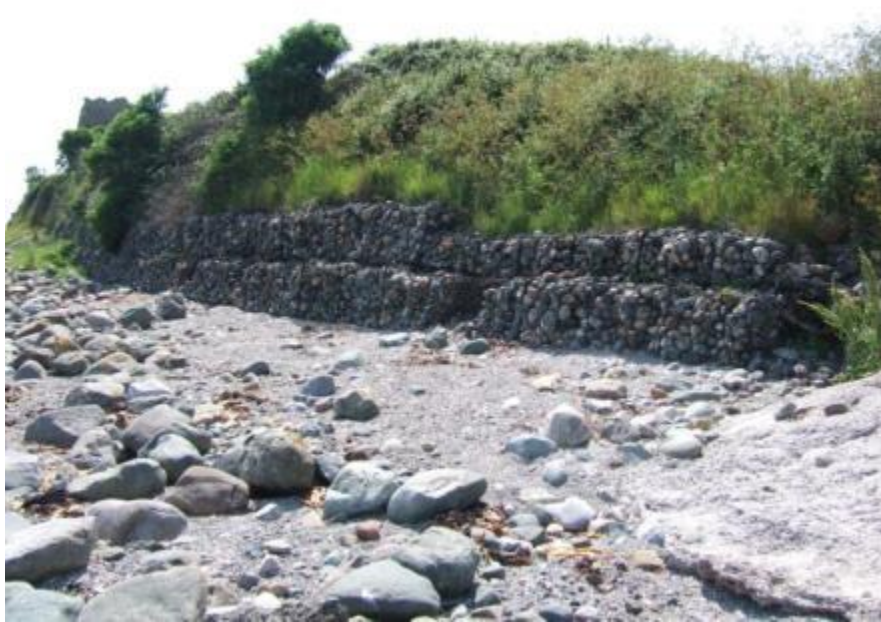
Section 2

Risk Assessment			
Risk Score	24	Assessment	Medium
Change from previous assessment		First assessment 08/03/2012. 04/07/2013: Gabion baskets in section 2 showing further deterioration.

NFCDD Element and Survey Data								
Inspector	A. Buck						Date	04/07/2013
Element	Type	Sub-type	Material	Revetment	Slope	Width	Condition	Weighting
1	CB	-	Mud flat	-	-	-	-	-
2	CS	Foreshore	Shingle	-	-	-	2	1
3	FI	Revetment	Grouted stone				4	8
4	FI	Revetment	Turf	-	-	-	4	8
5	C		Turf	-	-	-		
Residual Life		0-5	Urgency	Repairs		Overall Condition		4
						Data Quality		1
Comments and Recommendations Asset is originally grouted stone with poured concrete repairs. Some sections (partially) replaced by gabions. Original castle walls have collapsed over defences in 2 sections. Asset divided for convenience into 5 sections (see photos above) to reflect this. Section 1: significant loss of stone to 2 areas (1 & 5 metres wide). Undercutting at toe and loss of stone to both sides adjacent to jetty. Repairs necessary. Section 2: 2 gabion baskets showing stone loss (1 significant, 1 small loss). Several basket wire breaks. Repairs necessary to prevent deterioration/unwinding of gabion baskets. Section 3: gabion baskets well packed and aligned. Several basket wire breaks – but generally free from corrosion. Cracks and occasional missing stone to grouted stone area. Repairs necessary to prevent deterioration/unwinding of gabion baskets. Section 4: collapsed castle wall masonry with small area of gabion baskets behind. Evidence of burrowing to rear of gabion baskets. Section 5: minor undercutting at toe of grouted stone revetment. Collapsed castle wall masonry at limit of asset. 04/07/13 Gabion baskets in section 2 showing further deterioration. 4 gabion baskets all showing significant stone loss

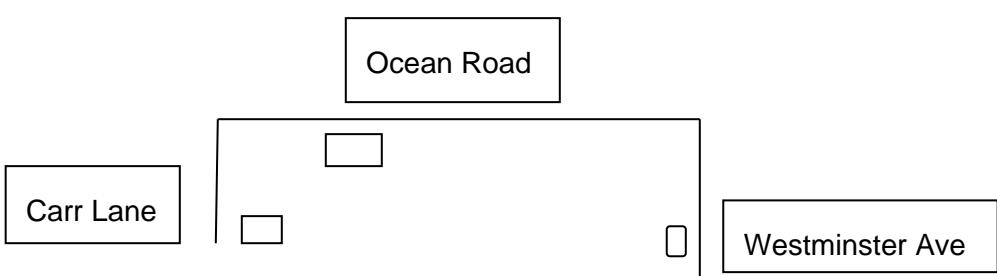
<p>FG2 nearest Ocean Road</p>

NFCDD Element and Survey Data								
Inspector	C. Bell						Date	28/05/2021
Element	Type	Sub-type	Material	Revetment	Slope	Width	Condition	Weighting
1	FG1	Flood gate	Flap Valve with debris screen				2	8
2	FI	Head Wall	Brick			1.5m	2	8
3	WW1	Wing Wall	Brick				3	6
4	WW2	Wing Wall	Brick				3	6
5		Outfall	Mud				3	7
6		Culvert	unseen				3	7
Residual Life		10-20	Urgency				Overall Condition	3
							Data Quality	3
Comments and Recommendations <p>The flood gate is generally in fair condition and although it was cleared of silt a number of years ago there is further build up. There seems to be very low flow coming from the pipe, however UU arranged a camera survey in November 2013, the results of which showed the pipework to be free, running and in good condition. It is unknown whether any further surveys have taken place since 2013. The previously dislodged manhole cover that sits on top of the head wall has been reset since the last inspection.</p>

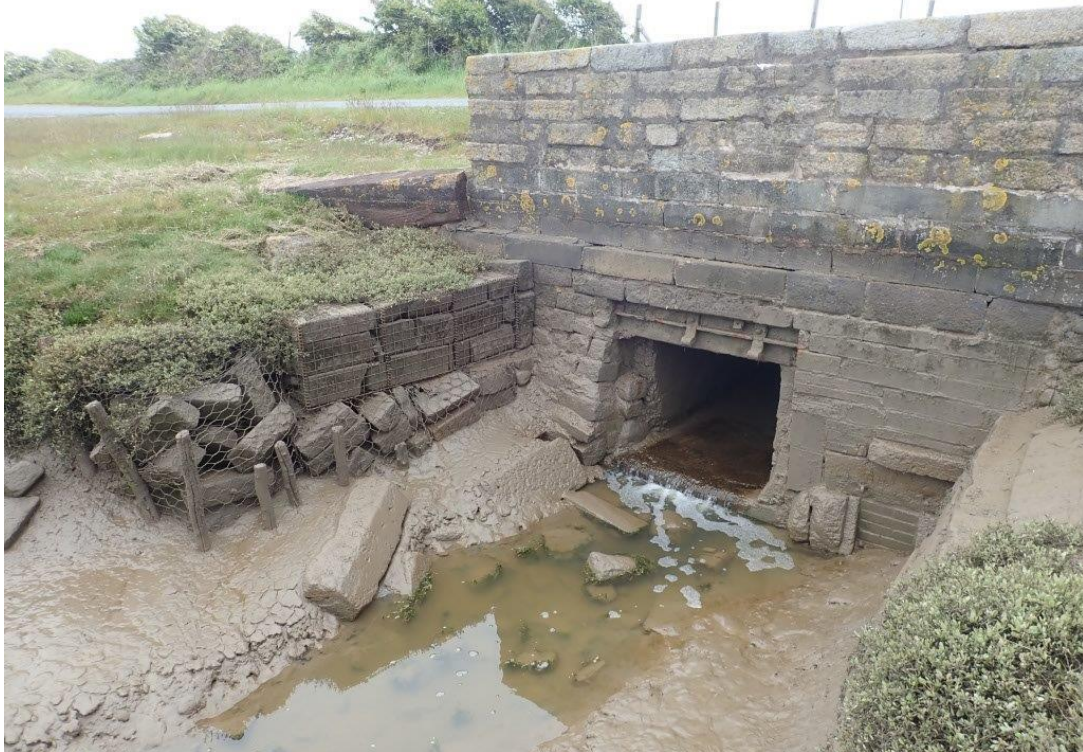
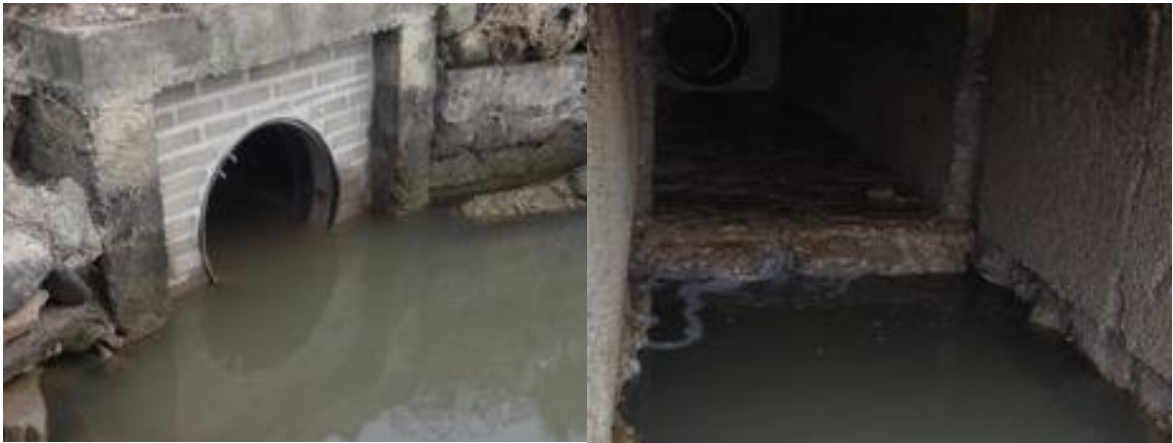
Photo

A new flood valve was fitted in January 2013 that is concealed in the culvert.

The effectiveness is demonstrated by the water remaining in the upstream channel, even at high tide. There is some increase in water level due to the embankment being permeable. Highways and the farmer have previously been asked to confirm any ownership.

The farmer's field was damaged by the original floodgate failing and the brown area over the originally green field marks the pasture destroyed by the tide. This is now recovering but a soil survey showed that it was not suitable for grazing. It is unknown if this is still the case. The road has also been overtopped by tidal surges leaving the field waterlogged.

NFCDD Element and Survey Data								
Inspector	C. Bell						Date	28/05/2021
Element	Type	Sub-type	Material	Revetment	Slope	Width	Condition	Weighting
1	CS	Foreshore	Saltmarsh	-	-	-	3	1
2	FG1	Flood gate	Aluminium and plastic				2	8
3	FI	Head Wall	Brick work			2m	3	8
4	WW1	Wing Wall	Loose block work				4	6
5	WW2	Wing Wall	Brickwork				3	6
6		Outfall	Mud and shingle				3	6
7		Culvert	Concrete and aluminium cladding				2	6
Residual Life		5-10	Urgency				Overall Condition	3
						Data Quality	3	
Comments and Recommendations A new floodgate valve was installed in recent years but, as noted in previous inspections, superficial repairs to the loose block work on the wing wall are required, however there does not appear to have been any significant deterioration since the last inspection. On the farmer’s field side there is also some water ingress around the floodgate. The Farmer and Highways were previously asked to confirm any ownership of the embankment with a view to further repair, however it remains unknown if any progress has been made on this.

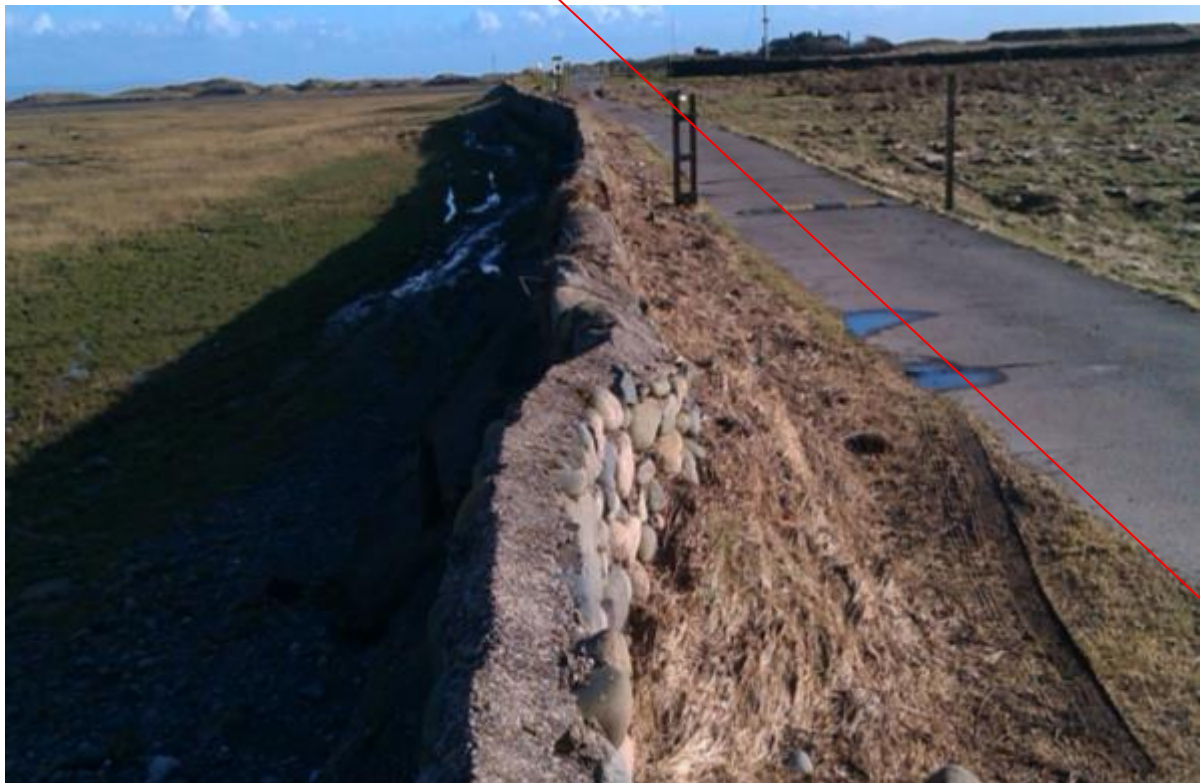
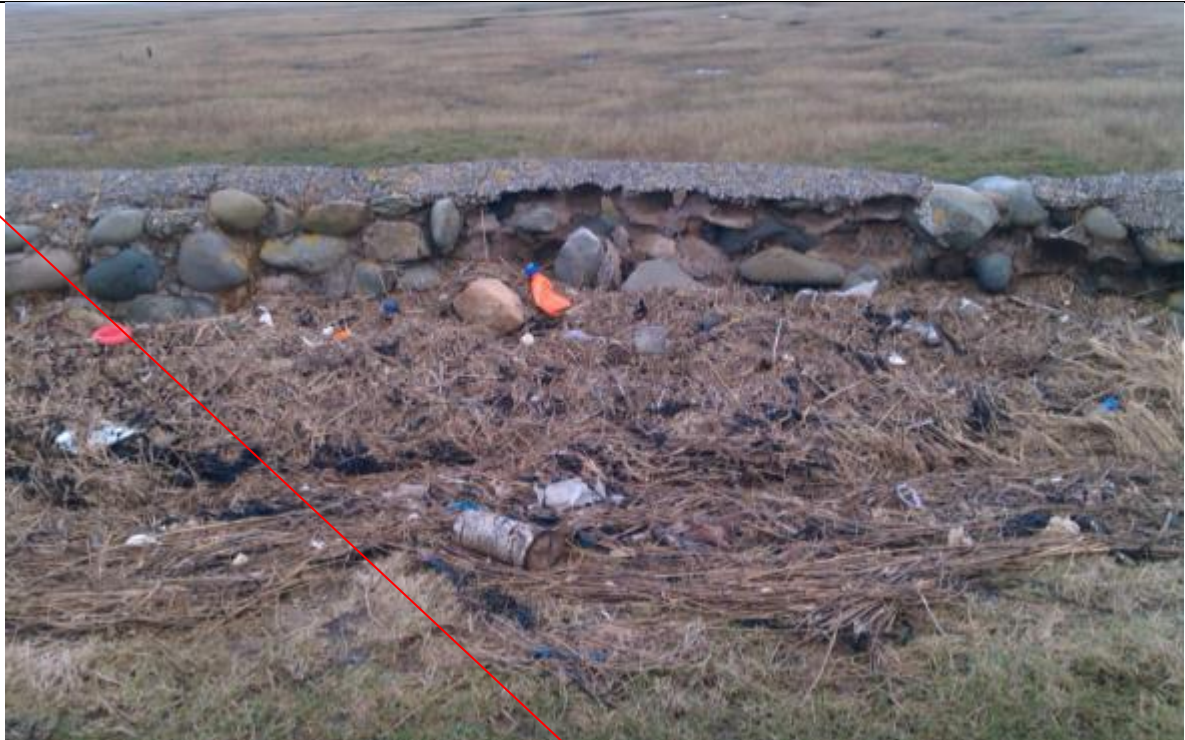
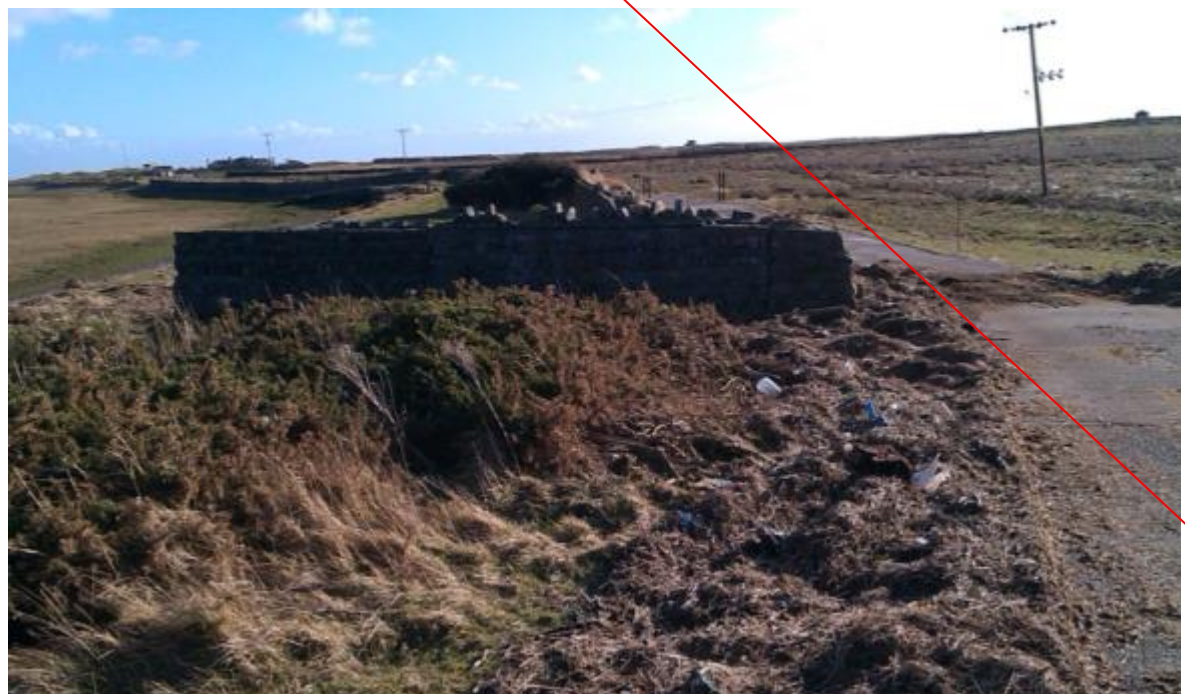
Photo

Risk Assessment			
Risk Score	8	Assessment	Low
Change from previous assessment		Cracked and deteriorated due to high tides.

NFCDD Element and Survey Data								
Inspector	R. Hennah						Date	11/02/2014
Element	Type	Sub-type	Material	Revetment	Slope	Width	Condition	Weighting
1	CB		Mud flat					
2	CS	Foreshore	Salt marsh			50m	2	2
3	FS	Foreshore	Cobble / shingle		10 deg	5m	3	2
4	FI	Toe	Concrete				3	5
5	FI	Wall	Cobble and mortar				4	6
6	C	Wall head	Concrete mortar				4	5
7	FO	Wall	Cobble and mortar				4	6
Residual Life		5-10	Urgency	Routine		Overall Condition		4
						Data Quality		1
Comments and Recommendations								
Following the recommendations made in 2014 this structure will no longer be inspected and is only included here for information.								
Indicative sketch of cross-section

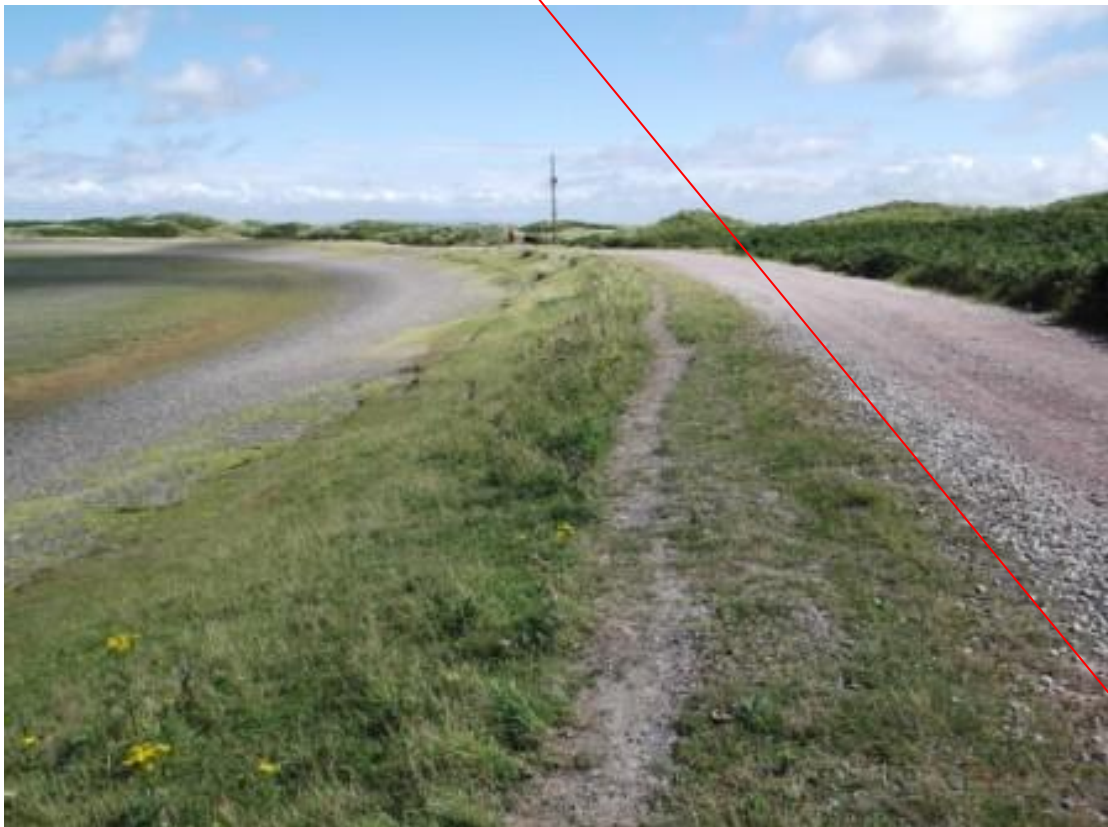
Photo

NFCDD Element and Survey Data								
Inspector	C. Bell						Date	06/08/2015
Element	Type	Sub-type	Material	Revetment	Slope	Width	Condition	Weighting
1	CB		Mud flat				2	2
2	FS	Foreshore	Shingle			30m	2	2
3	FI	Toe	Cobbles				4	3
4	FI	Revetment	Cobble wall				4	6
5	C	Revetment	Wall head				4	6
Residual Life		5-10	Urgency	Routine		Overall Condition		4
							Data Quality	1
Comments and Recommendations <p>The embankment has been undercut at the toe of some parts and does not appear to form any structured defence. The face of the embankment is rutted and part of the length has been eroded by movement of HGVs.</p> <p>It is recommended that this structure is no longer inspected.</p>								
Indicative sketch of cross-section

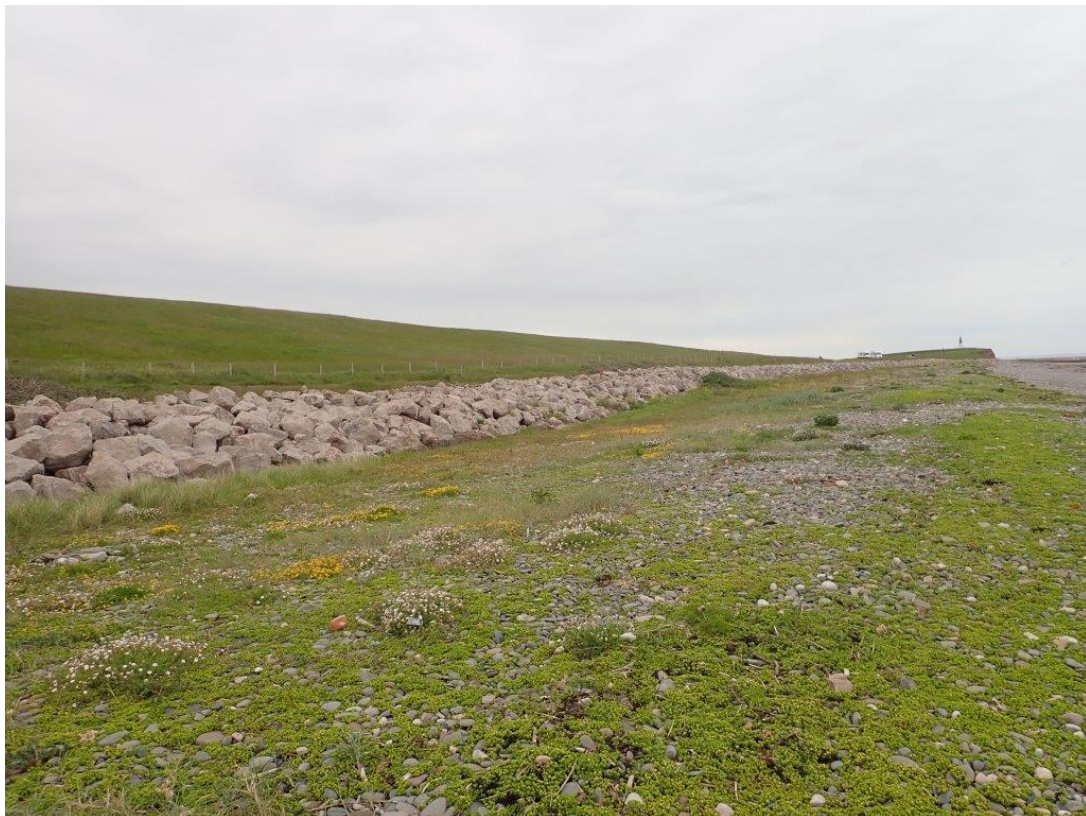
Photo

NFCDD Element and Survey Data								
Inspector	C. Bell						Date	28/05/2021
Element	Type	Sub-type	Material	Revetment	Slope	Width	Condition	Weighting
1	CB	-	Sand	-	-	-	-	-
2	CS	Foreshore	Shingle	-	-	-	3	1
3	FI	Foreshore	Grass	-	-	-	3	5
4	FI	Revetment	Rock	-	-	-	2	8
5	C	Revetment	Rock	-	-	-	2	8
6	FO	Revetment	Rock	-	-	-	2	8
Residual Life		50+	Urgency	Routine		Overall Condition		2
						Data Quality		
Comments and Recommendations								
Vegetation has now become established on the foreshore at the toe of the revetment. The rock armour remains in good condition, with no visible sign of deterioration in recent years. It is recommended that annual inspections continue, to monitor for any signs of deterioration.								
Indicative sketch of cross-section

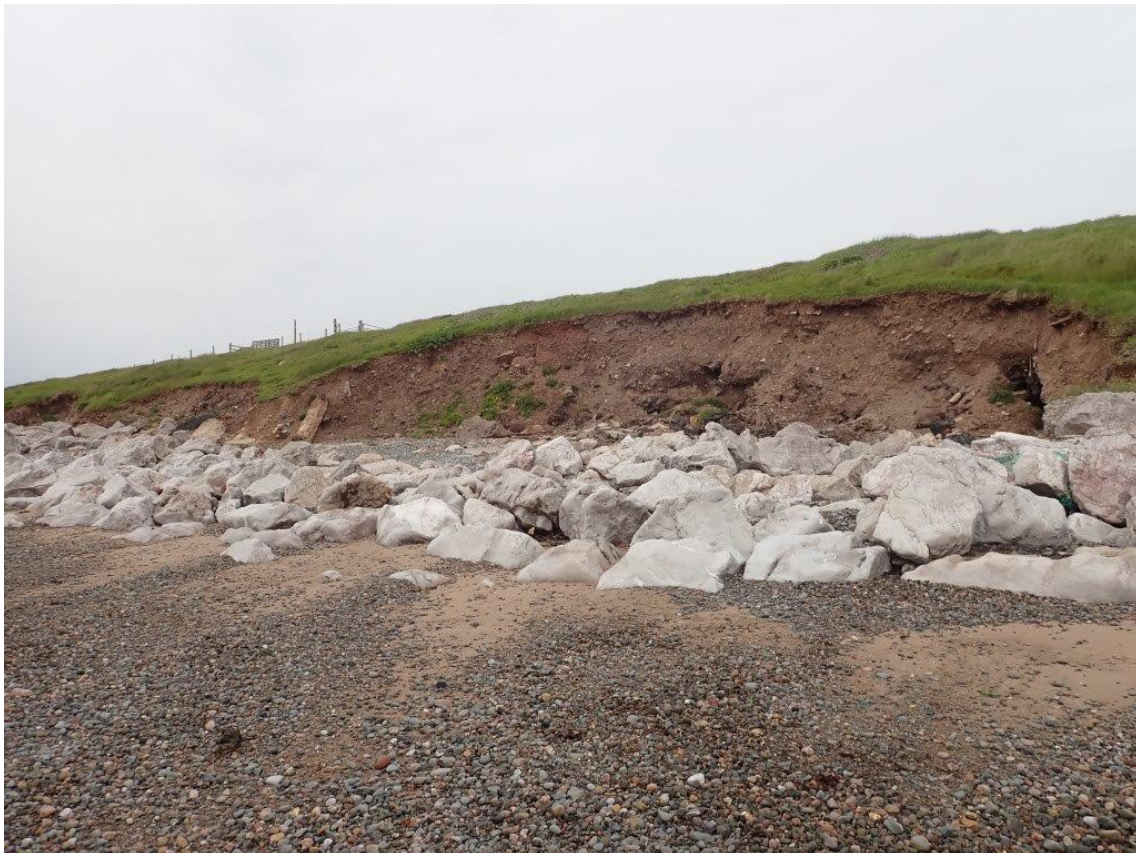
Photo

NFCDD Element and Survey Data								
Inspector	C. Bell						Date	28/05/2021
Element	Type	Sub-type	Material	Revetment	Slope	Width	Condition	Weighting
1	CB	-	Sand	-	-	-	-	-
2	CS	Foreshore	Shingle	-	-	-	3	1
3	FI	Revetment	Rock Armour	-	-	-	4	8
4	C	Revetment	Embankment	-	-	-	5	8
Residual Life		0-5	Urgency	Routine		Overall Condition		4
						Data Quality		1
Comments and Recommendations								
<p>There has been extensive loss of rocks and major movement. The Crest has settled below an effective height and there are large gaps between rocks remaining in the revetment. There has been acceleration in erosion of the embankment exposing household waste that is stored in the historic landfill site located behind the embankment. Studies have shown that the waste is not contaminated to a significant level, but unsightly. Monthly high tides have previously been overtopping the revetment along its length.</p> <p>Significant remedial work to reconstruct the defences are required if this asset is to be effective and an application for the £3 million required has previously been submitted to the Council’s management team with a minor option of carrying out patch repairs over the next 3 years for frequent smaller sums. However to date no works have been carried out.</p> <p>The land is owned by Mr Mulgrew who purchased the site in 2002, but it was previously used as a landfill tip by Cumbria County Council from 1974 until 2000. They have previously been contacted as the polluters for a response on their plans to prevent the material from escaping into open waters. It remains unknown if any action has been taken regarding this.</p>

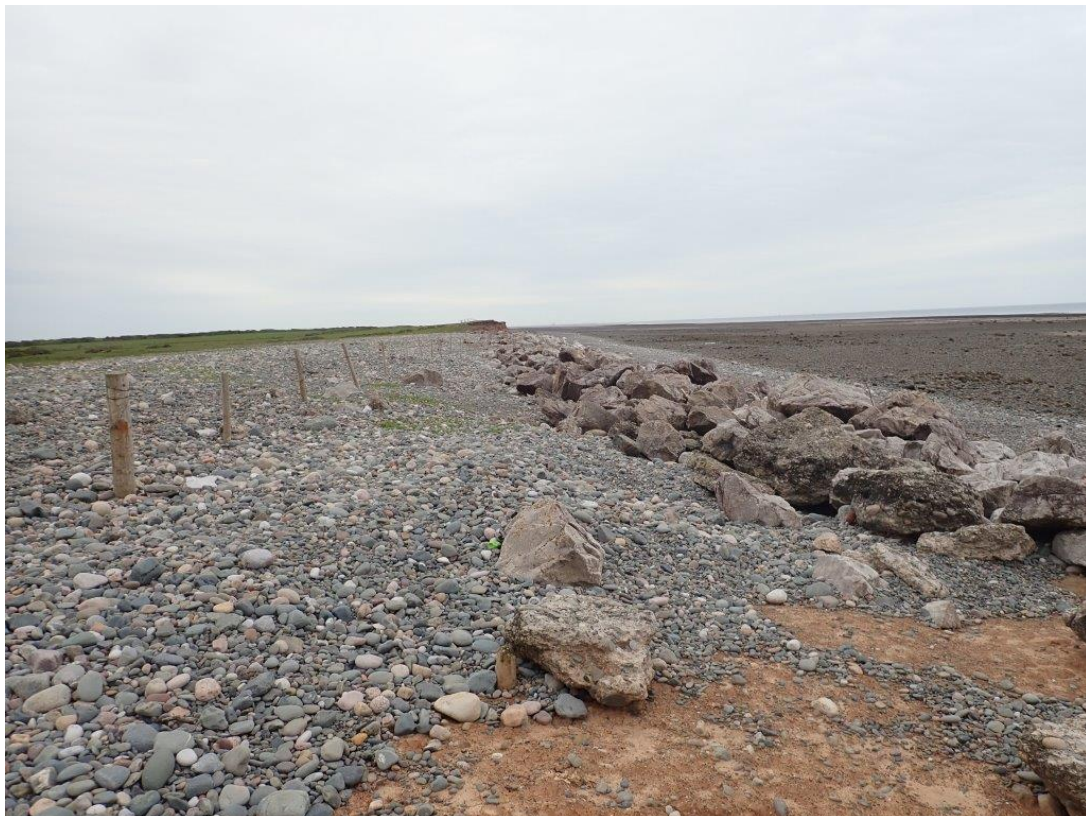
Photo

NFCDD Element and Survey Data								
Inspector	C. Bell						Date	28/05/2021
Element	Type	Sub-type	Material	Revetment	Slope	Width	Condition	Weighting
1	CB	-	-	-	-	-	-	-
2	CS	Foreshore	Shingle	-	-	-	3	1
3	FI	Revetment	Rock	-	-	-	3	8
4	C	Revetment	Rock	-	-	-	3	8
5	FO	Revetment	Rock	-	-	-	2	8
Residual Life		5-10	Urgency	Routine		Overall Condition		3
						Data Quality		1
Comments and Recommendations								
<p>Over a number of years this defence has been outflanked by erosion and now provides little protection.</p> <p>A large amount of shingle has built up at the defence, adding to its density. The well vegetated grass track behind the revetment indicates it is effective at preventing erosion at this location. However, flooding still occurs during storms as the defence is bypassed. In some areas vegetation has become established on the foreshore at the toe of the revetment.</p>								
Indicative sketch of cross-section

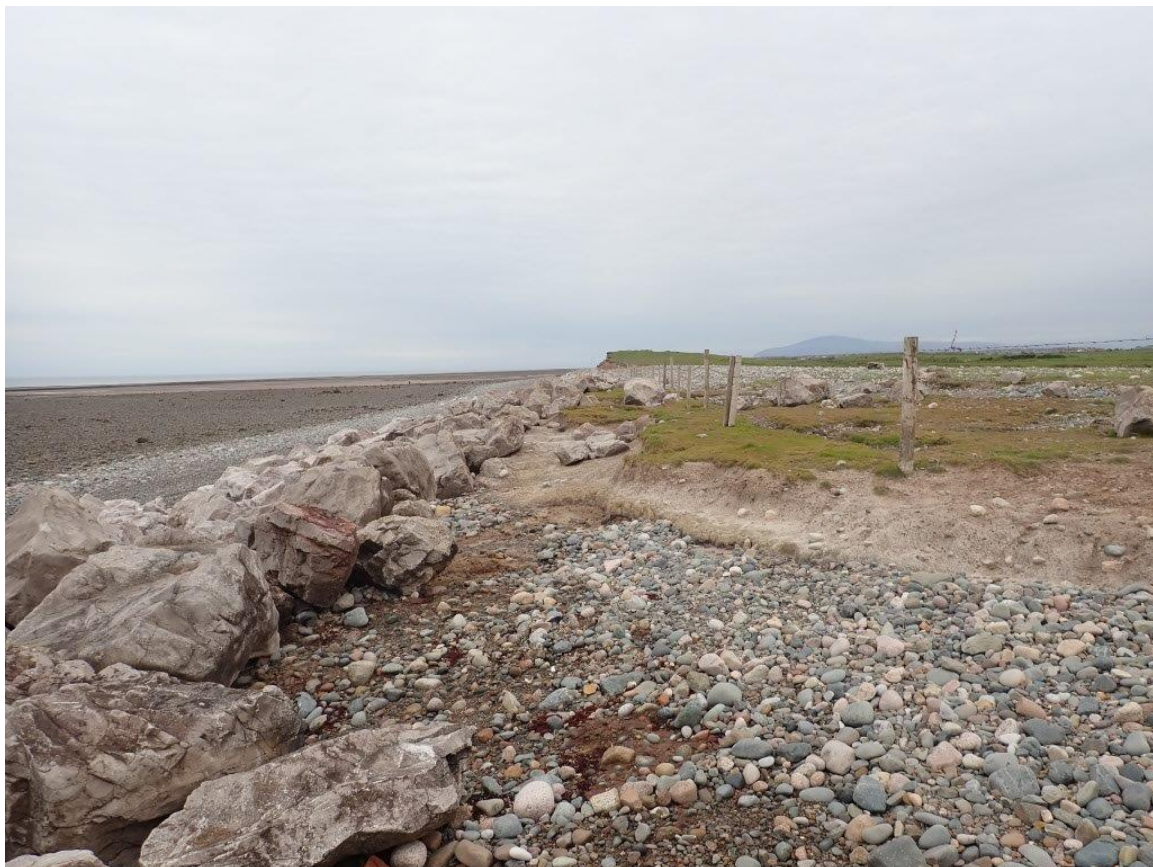
Photo

NFCDD Element and Survey Data								
Inspector	C. Bell						Date	28/05/2021
Element	Type	Sub-type	Material	Revetment	Slope	Width	Condition	Weighting
1	CB	-	-	-	-	-	-	-
2	CS	Foreshore	Pebble	-	-	-	3	1
3	FI	Revetment	Rock	-	-	-	4	8
4	C	Revetment	Rock	-	-	-	4	8
5	FO	Revetment	Rock	-	-	-	4	8
Residual Life		5-10	Urgency	Routine		Overall Condition		4
						Data Quality		1
Comments and Recommendations								
<p>This defence is located at the lowest point of the natural shoreline to prevent further erosion of the lowest lying land. The defence has not been damaged by the high tides but the build-up of shingle behind the defence illustrates how easily this defence is being over-topped. In the past, on occasions of tides over 10m, water has crossed Walney Island at this point and flooded the junction of Thorney Nook Lane, Carr Lane and Biggar village to a depth of over a metre.</p> <p>Over the years there has been some settlement of the revetment leaving sections with gaps and some stones on the foreshore but this does not appear to have deteriorated significantly over recent years. There does not appear to have been any further significant erosion to the land protected by this defence in recent years.</p>

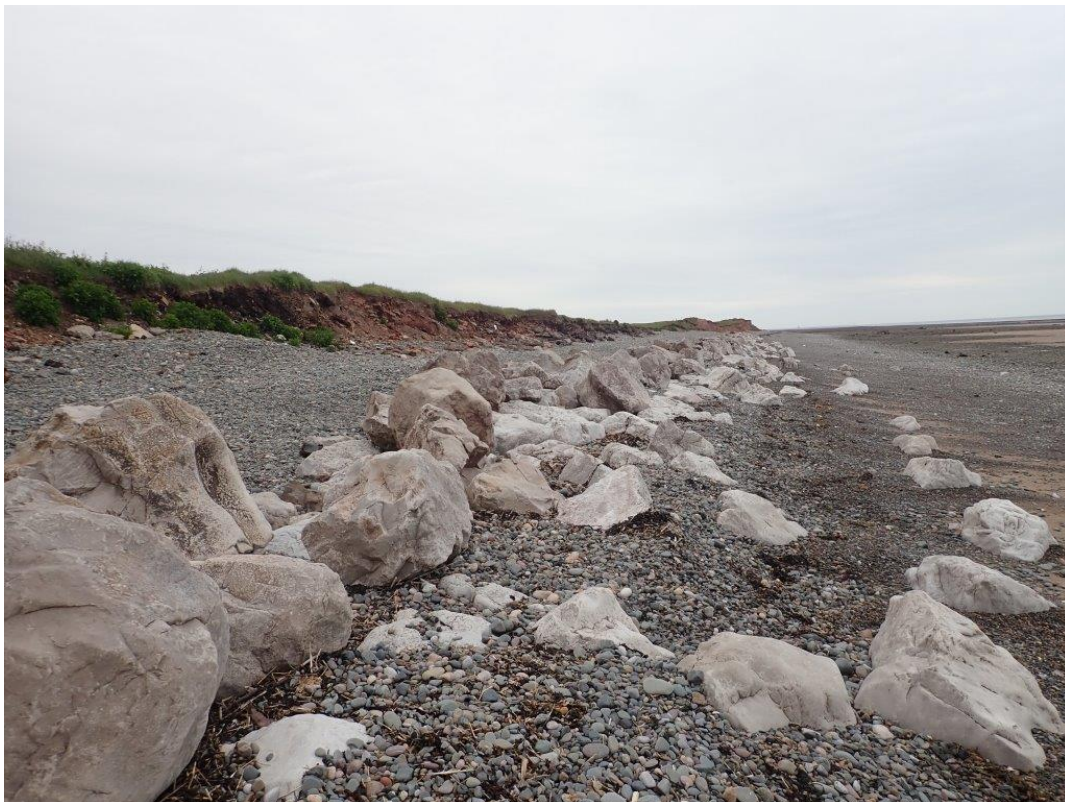
Photo

NFCDD Element and Survey Data								
Inspector	C. Bell						Date	28/05/2021
Element	Type	Sub-type	Material	Revetment	Slope	Width	Condition	Weighting
1	CB		Mud flat				3	2
2	CS	Foreshore	Shingle / sand		10 deg	20m	3	2
3	FI	Bund	Rock armour			2m	4	5
4	FS	Upper foreshore	Shingle		20	10m	3	5
Residual Life		5-10	Urgency	Routine		Overall Condition		4
						Data Quality		1
Comments and Recommendations <p>This embankment retains an old tip previously run by the County Borough of Barrow. Shingle in front of the embankment has now built up and is providing protection to the previously exposed material along almost the entire length of the defence. No significant changes appear to have occurred to the defence over recent years.</p> <p>Following storms it is occasionally necessary to reprofile the shingle to maintain protection to the face of the tip.</p>								
Indicative sketch of cross-section

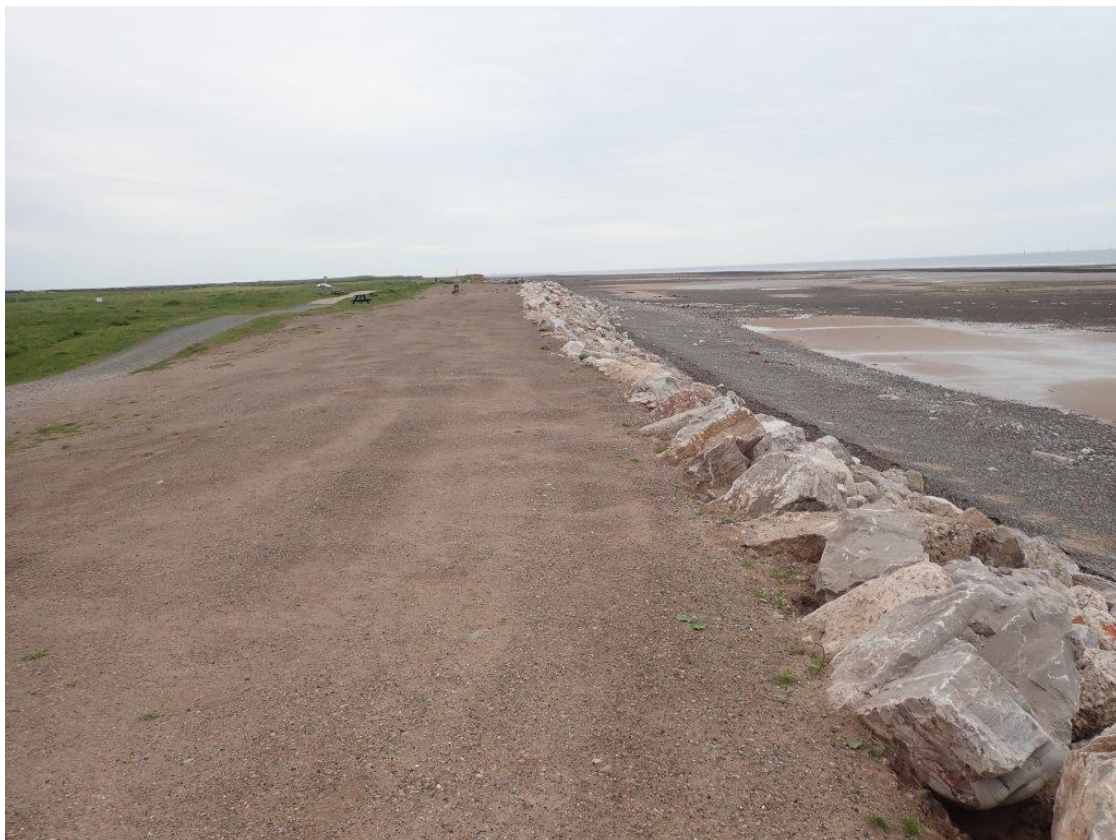
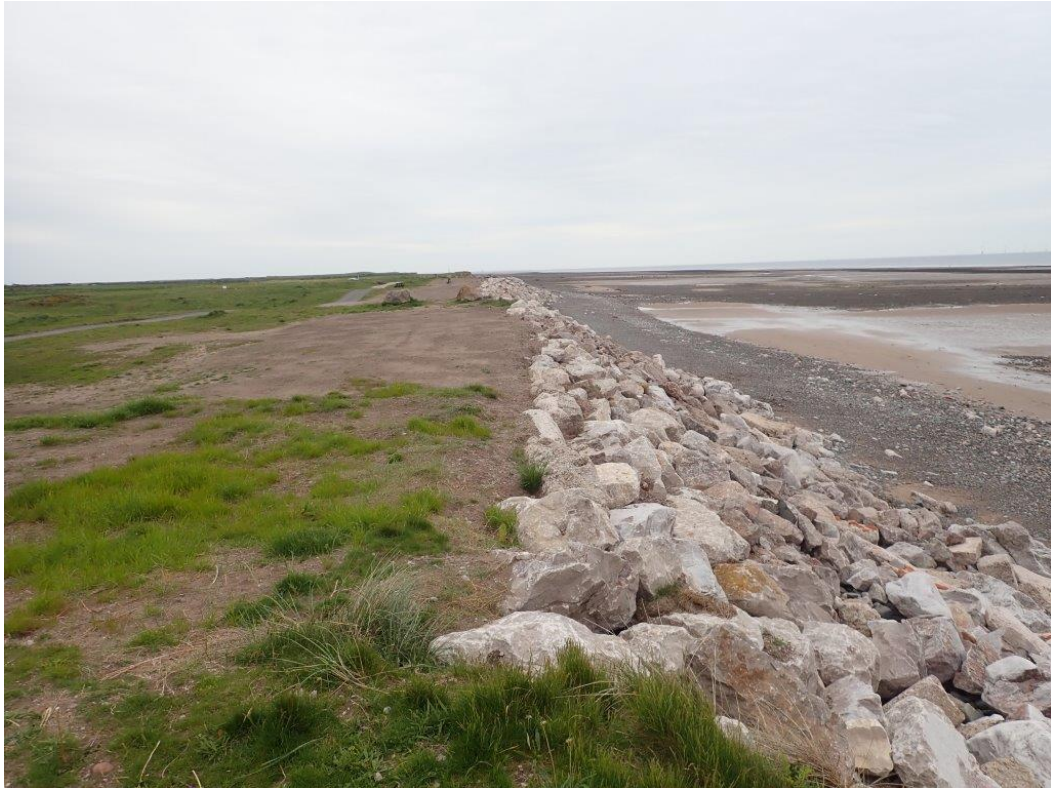
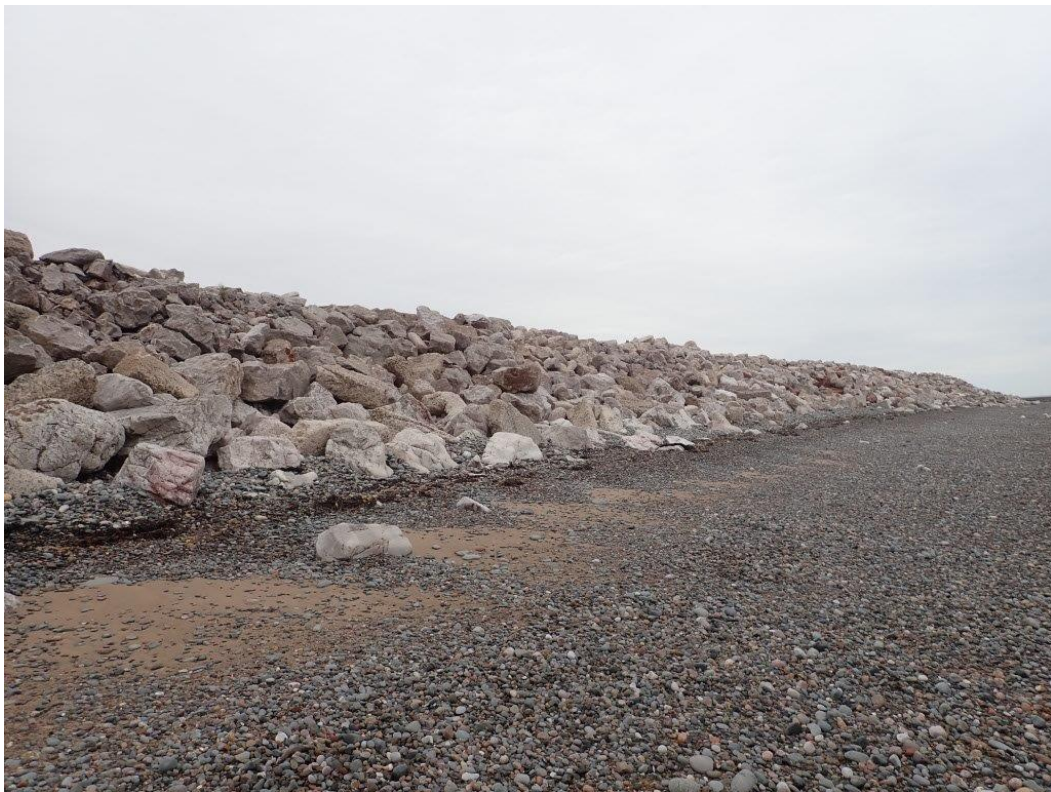
Photo

Risk Assessment			
Risk Score	8	Assessment	Low
Change from previous assessment		Significant improvement works taken place

NFCDD Element and Survey Data								
Inspector	C. Bell						Date	28/05/2021
Element	Type	Sub-type	Material	Revetment	Slope	Width	Condition	Weighting
1	CB	Sand	Mud flat				3	2
2	CS	Foreshore	Shingle / sand		15 deg	20m	3	2
3	FL	Revetment	Rock armour			6m	2	5
4	C	Collapsed	Embankment				2	5
Residual Life		10-20	Urgency	Routine		Overall Condition		2
						Data Quality		1
Comments and Recommendations Significant improvement works have taken place since the previous inspection. The previously eroded/collapsed embankment behind the rock armour has been backfilled and compacted with suitable fill material. Displaced/unsuitable sections of the rock armour appear to have been replaced with more suitable material. The rock armour is now providing protection to the embankment behind.								
Indicative sketch of cross-section

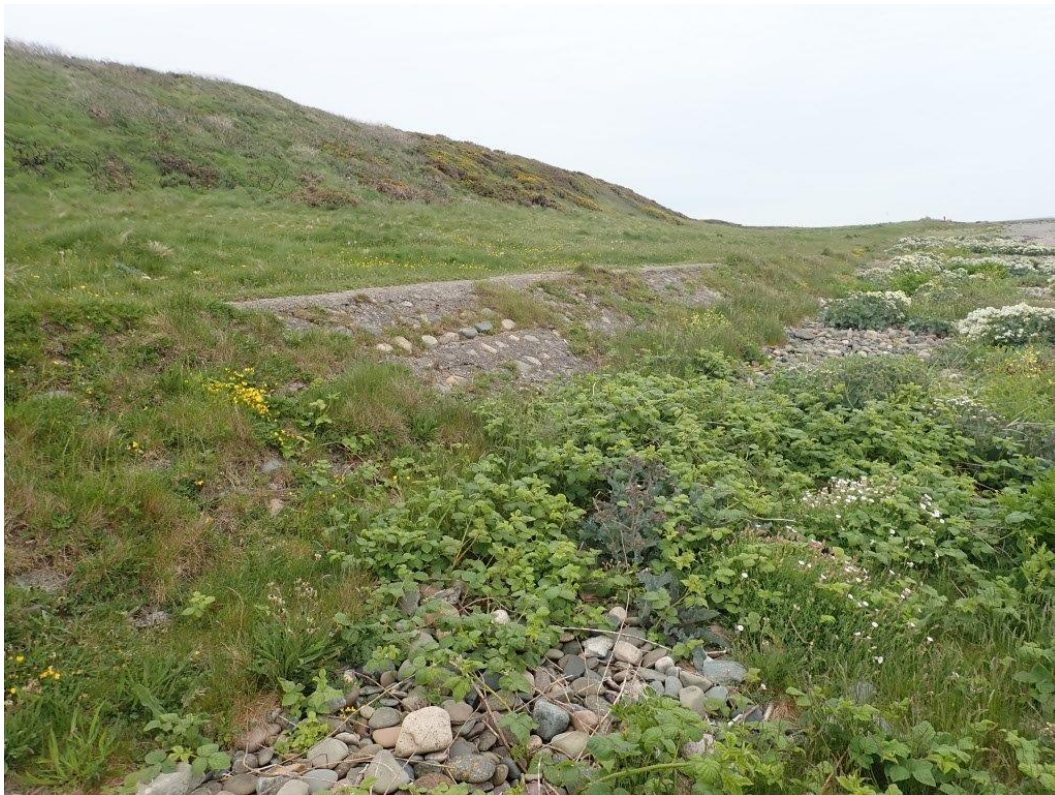
Photo

NFCDD Element and Survey Data								
Inspector	C. Bell						Date	28/05/2021
Element	Type	Sub-type	Material	Revetment	Slope	Width	Condition	Weighting
1	CB		Mud flat				2	2
2	CS	Foreshore	Shingle		15 deg	15m	2	2
3	FI	Revetment	Cobble and concrete	Cobble	35 deg	3m	3	6
4	C	Crest	Unmade track			2.5m	3	5
Residual Life		5-10	Urgency	No repairs required		Overall Condition		3
						Data Quality		1
Comments and Recommendations <p>There is well-established vegetation with occasionally missing blocks. Small sections have some undercutting to the revetment toe, however there are no visible signs of any major deterioration occurring over recent years, and no urgent repairs are deemed necessary at this stage. Vegetation has become further established on the foreshore in places at the toe of the revetment.</p>								
Indicative sketch of cross-section

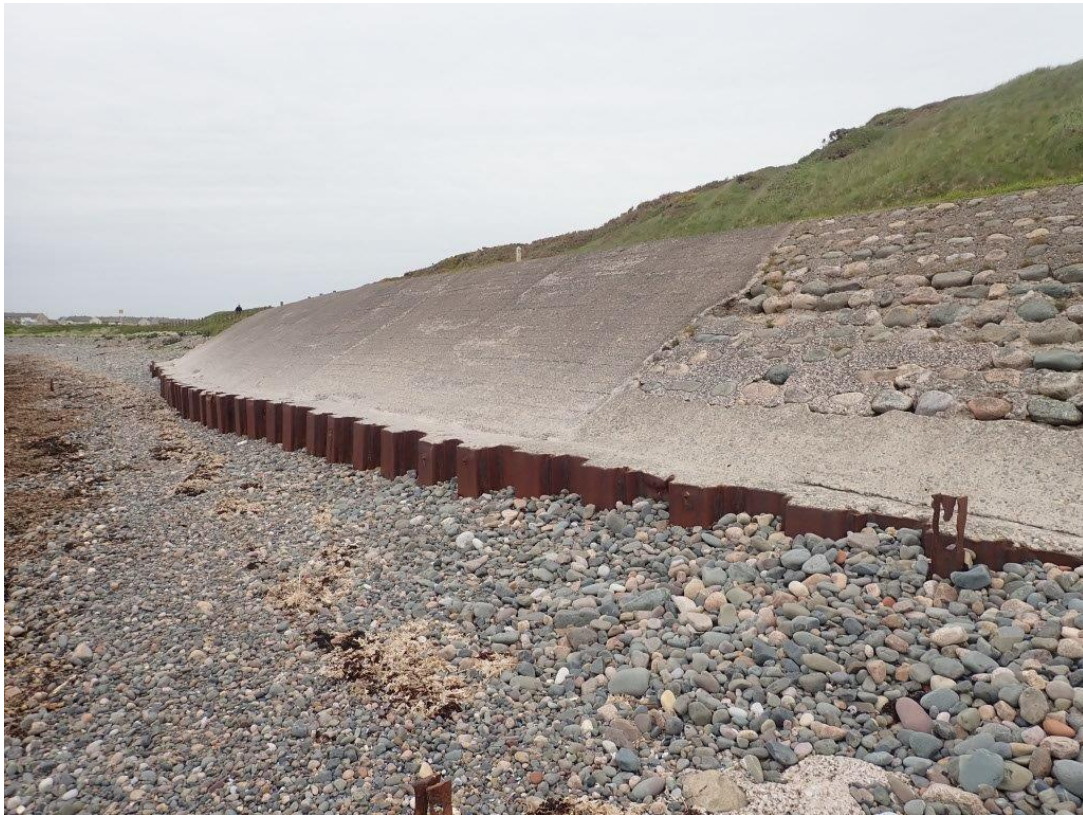
Photo

NFCDD Element and Survey Data								
Inspector	C. Bell						Date	28/05/2021
Element	Type	Sub-type	Material	Revetment	Slope	Width	Condition	Weighting
1	CB		Mud flat				3	2
2	CS	Foreshore	Shingle		15 deg	15m	3	2
3	CS	Toe	Steel piles and concrete			1m	3	5
4	FI	Revetment	Poured concrete	Concrete	35 deg	3m	3	6
5	C	Crest	Unmade track			2.5m	3	5
Residual Life		5-10	Urgency	No repairs required		Overall Condition		3
							Data Quality	1
Comments and Recommendations <p>The toe of revetment has become more exposed by lowering of foreshore levels at the toe in recent years, and there is minor spalling to the poured concrete revetment. However, there are no visible signs of any deterioration since the previous inspection.</p>								
Indicative sketch of cross-section

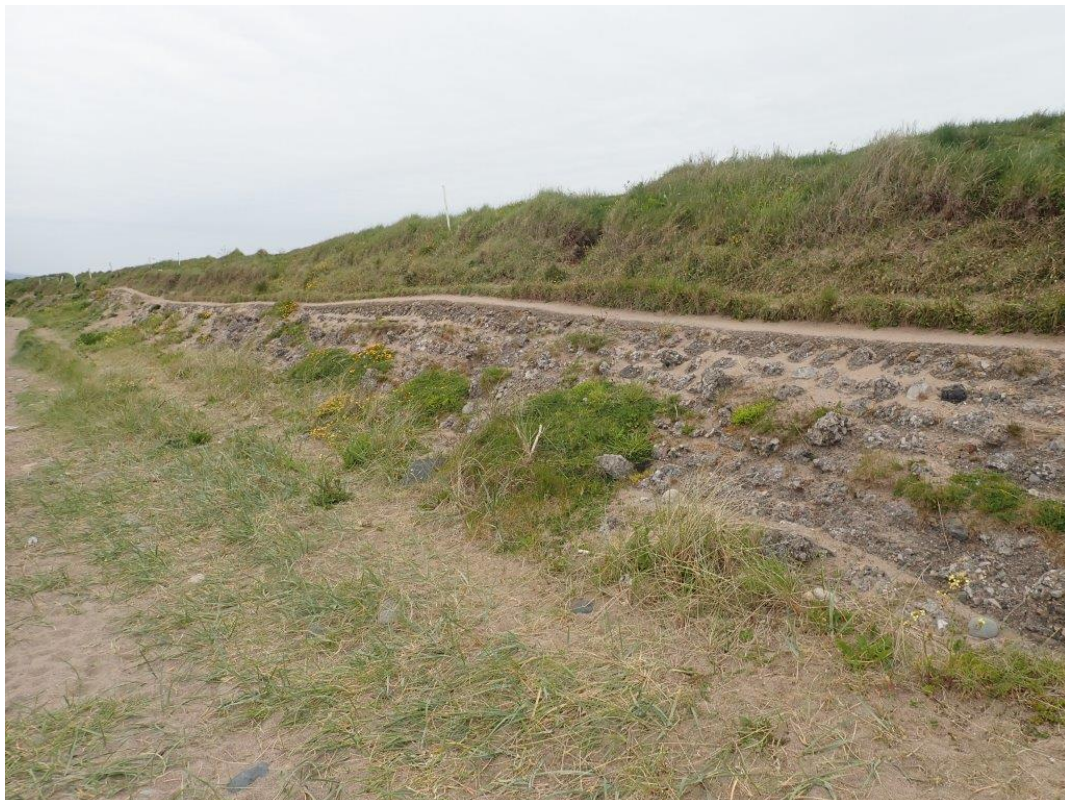
Photo

NFCDD Element and Survey Data								
Inspector	C. Bell						Date	28/05/2021
Element	Type	Sub-type	Material	Revetment	Slope	Width	Condition	Weighting
1	CB		Mud flat				3	2
2	CS	Foreshore	Shingle		15 deg	15m	2	2
3	FI	Revetment	Rocks set into poured concrete	Concrete	35 deg	4m	3	5
4	FI	Revetment	Embankment	Grass covered	35 deg	4m	3	6
Residual Life		5-10	Urgency	No repairs required		Overall Condition		3
						Data Quality		1
Comments and Recommendations <p>There continues to be vegetation growth within the revetment and on the foreshore at the toe of the revetment. Small rocks are missing from the revetment in places, however there does not appear to be any significant deterioration since the previous inspection, and no repairs are necessary at this stage.</p>								
Indicative sketch of cross-section

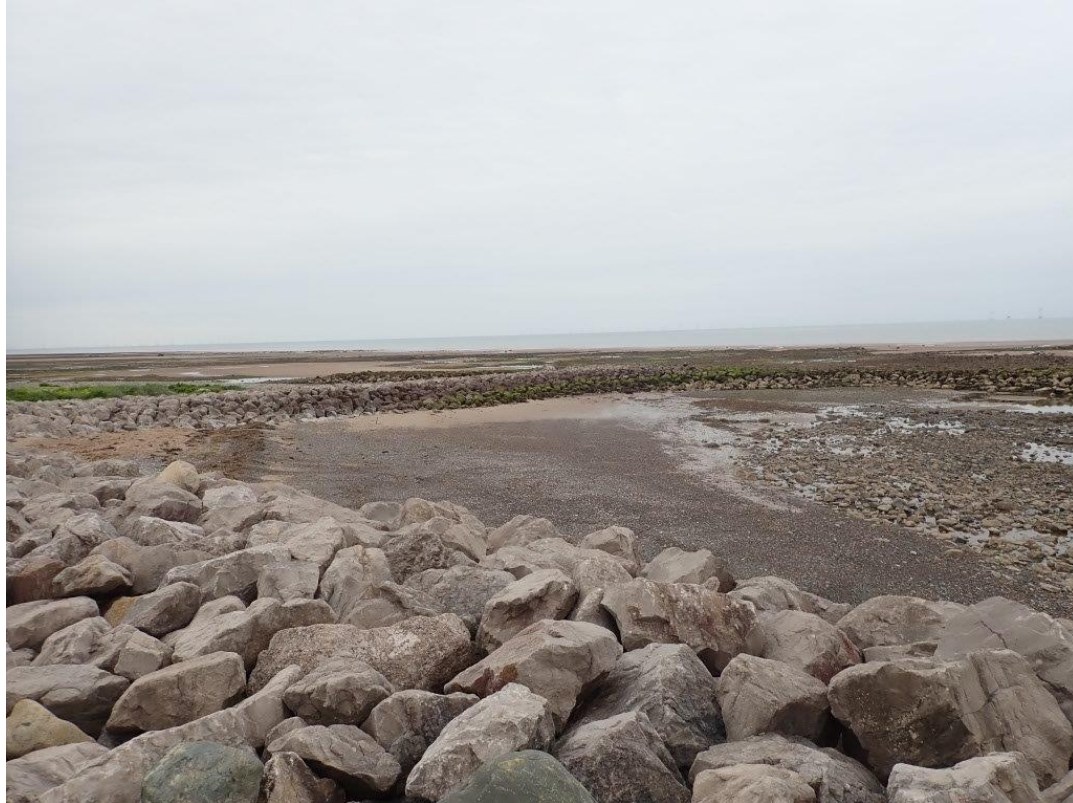
Photo

Risk Assessment			
Risk Score	8	Assessment	Low
Change from previous assessment		Continued increase in amount of shingle protecting the asset

NFCDD Element and Survey Data								
Inspector	C. Bell						Date	28/05/2021
Element	Type	Sub-type	Material	Revetment	Slope	Width	Condition	Weighting
1	CB	sand	1				2	2
2	CS	Foreshore	2				2	2
3	FI	Revetment	3				2	6
4	C	Revetment	4		15 deg	20	2	6
5	B	Berm	5		30 deg	3m	2	6
6	FO	Revetment	6				2	5
7	CS	Foreshore	7				2	2
Residual Life		5-10	Urgency	No repairs required		Overall Condition		2
						Data Quality		1
Comments and Recommendations <p>The fishtail groyne is in good condition with some minor displacement of rocks. As with previous years, there continues to be build up in shingle on the southern side further reinforcing the groyne, and vegetation continues to establish itself on the foreshore.</p>								
Indicative sketch of cross-section

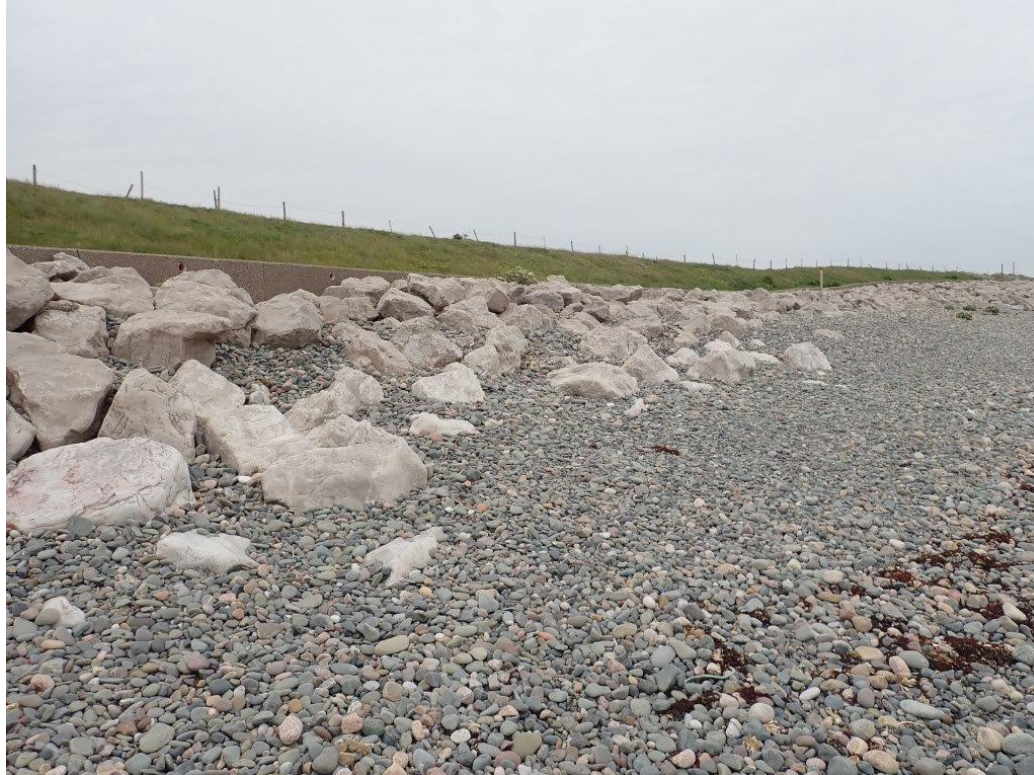
Photo

Risk Assessment			
Risk Score	8	Assessment	Low
Change from previous assessment		Continued displacement/settlement of rock armour in places

NFCDD Element and Survey Data								
Inspector	C. Bell						Date	28/05/2021
Element	Type	Sub-type	Material	Revetment	Slope	Width	Condition	Weighting
1	CB		Mud flat				3	2
2	CS	Foreshore	Shingle		10 deg	15	3	2
3	FI	Rock armour	Rock		30 deg	5m	3	5
4	C	Crest	Track				2	6
Residual Life		10-20	Urgency	Routine repairs		Overall Condition		3
						Data Quality		1
<p>Comments and Recommendations</p> <p>The revetment is made up of rock armour and is in good condition overall. However there has been some displacement/settlement of rock in places to the south of the fishtail groyne. Albeit in isolated locations, this appears to have worsened slightly since the previous inspection. There is a small area where the toe of the wall at the crest of the revetment has become exposed.</p> <p>It is recommended that annual inspections continue, with the area to the south of the fishtail groyne in particular being monitored closely.</p>
