Barrow Coastal Inspections 2020

Barrow Borough Council

May 2021

Title	Barrow Coast Protection Inspections
Creator/Author	Craig Bell/Mark Ellis, Capita
Publisher	Barrow Borough Council, Town Hall, Duke Street, Barrow-in-Furness. LA14 2LD
Date of Publication	01/06/2021
Contact	Chris Jones, Barrow Borough Council
Subject – keyword	Survey and monitoring – coastal defence inspections
Description/Abstract	Report detailing the results of an inspection of coast defences along Barrow Borough Council's coastline completed in 2021
Identifier	CS063836/002
Coverage – spatial	Barrow Borough Council coastline – from Peasholmes Lane A5087 to Mere Beck, Askam-in-Furness
Coverage – temporal	2018
Format	documentDigital
Type	Report
Subject – category	Coastal Defence
Subject – project	Cell 11 Regional Monitoring Strategy
Language	English
Rights – copyright	Map data copyright Ordnance Survey licence
Rights – disclosability	Yes
Rights – FOIA	Yes
Postal Address	Barrow Borough Council, Town Hall, Duke Street, Barrow-in-Furness

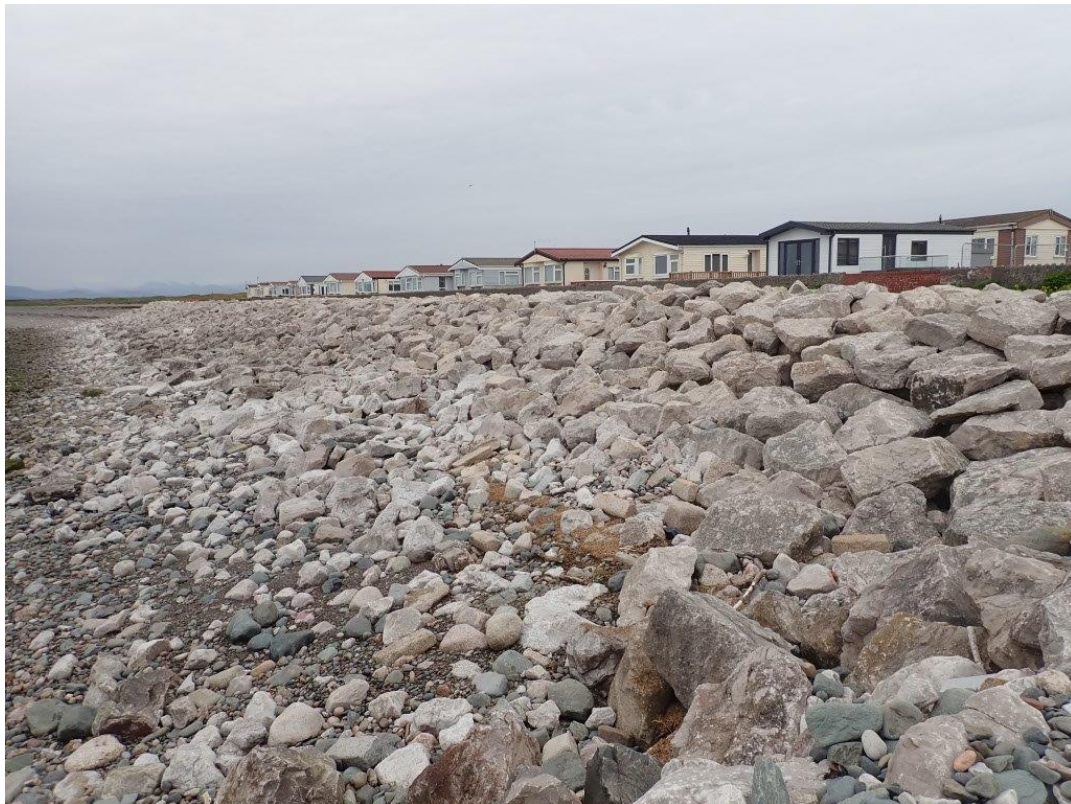
Photo

NFCDD Element and Survey Data								
Inspector	C. Bell						Date	28/05/2021
Element	Type	Sub-type	Material	Revetment	Slope	Width	Condition	Weighting
1	CB		Mud flat				2	2
2	CS	Foreshore	Shingle		10 deg		2	2
3	FI	Rock armour	Rock		30 deg	5m	2	5
4	C	Crest	Rock				2	6
Residual Life		20	Urgency	No repairs required		Overall Condition		2
						Data Quality		1
Comments and Recommendations The previous defence was not maintained by the owner and during tidal surges on 5 th December 2013 and 3 rd January 2014 the defence and the road it protected were washed away. With further tidal surges predicted in February and March 2014 a temporary defence was reinstated with emergency powers. In 2015 a new rock armour defence was constructed and remains in very good condition. The defences are temporary as they are due to be removed after 20 years to allow for the Park owners and residents to develop and implement an adaptation strategy in conjunction with the Council.

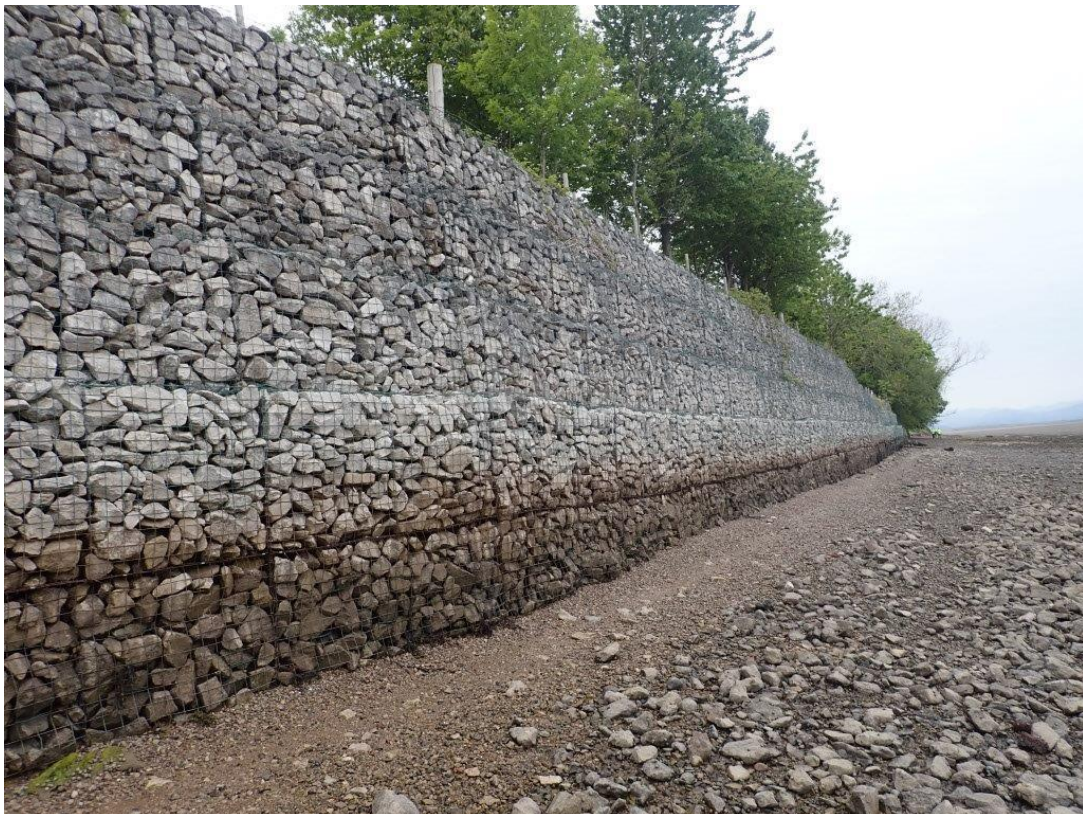
Photo

NFCDD Element and Survey Data								
Inspector	C. Bell						Date	14/05/2021
Element	Type	Sub-type	Material	Revetment	Slope	Width	Condition	Weighting
1	CB		Mud flat	-	-	-	-	-
2	CS	Foreshore	Shingle	-	-	-	3	1
3	FI	Gabions	Rock	-	-	-	3	8
4	C	Gabions	Rock	-	-	-	3	8
5	F	Flap Valve	Metal				3	6
6	OF	Culvert	Unseen				3	6
Residual Life		20-50	Urgency	Routine		Overall Condition		3
						Data Quality		3
Comments and Recommendations There remains some small distortions in the baskets but they are generally well packed and free from corrosion. Previous repairs to failed baskets are holding well. There does appear to be some bulging of the structure but this does not appear to have deteriorated any further since the previous inspection.								
Indicative sketch of cross-section

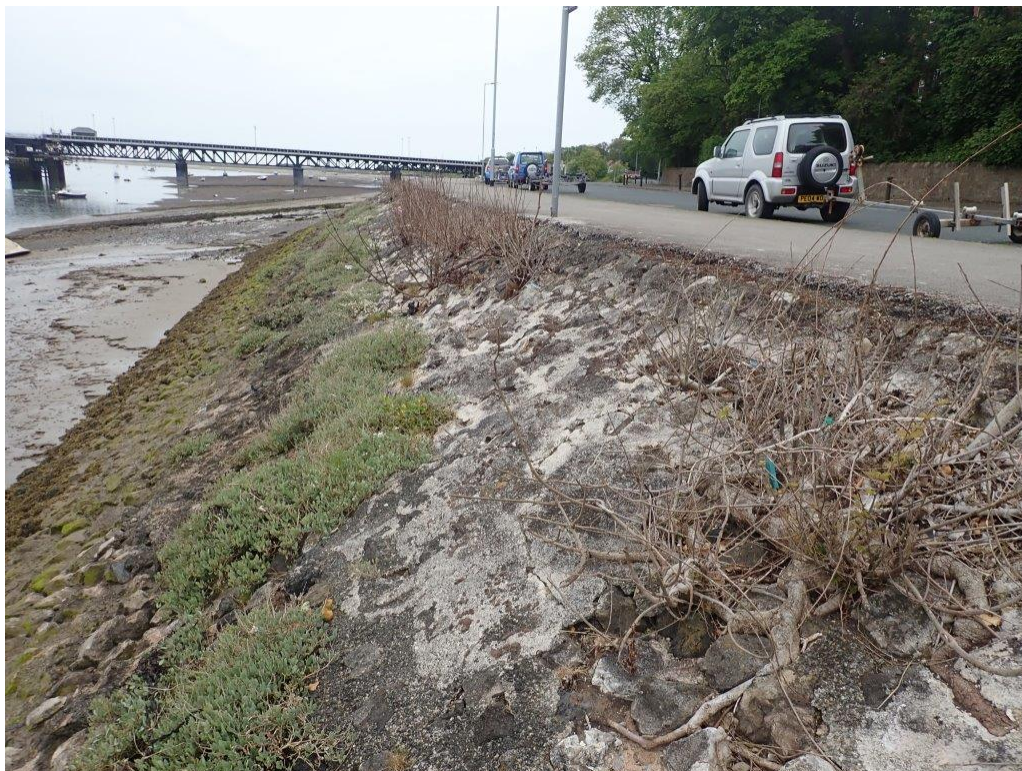
Photo

NFCDD Element and Survey Data								
Inspector	C. Bell						Date	14/05/2021
Element	Type	Sub-type	Material	Revetment	Slope	Width	Condition	Weighting
1	CB		Mud flat				3	2
2	CS	Foreshore	Shingle				2	2
3	FI	Revetment	Masonry and poured concrete		35 deg	5m	4	6
4	C	Crest	Bitmac footway			4m	3	6
Residual Life		5-10	Urgency	Repairs required		Overall Condition		3
						Data Quality		1
<div>Comments and Recommendations</div> <div>In recent years, CCC have undertaken repairs to the worst sections of the revetment. There are still locations with severe cracking, loss of joint material and loss of stone from the revetment, however these areas do not appear to have deteriorated significantly over the last few years. Natural ground is exposed in a number of locations with signs of erosion. There is also vegetation causing root damage in the revetment and these should be removed. Increased undercutting at the toe is also evident in areas. Despite no major deterioration occurring since the last inspection, repairs are still required.</div>

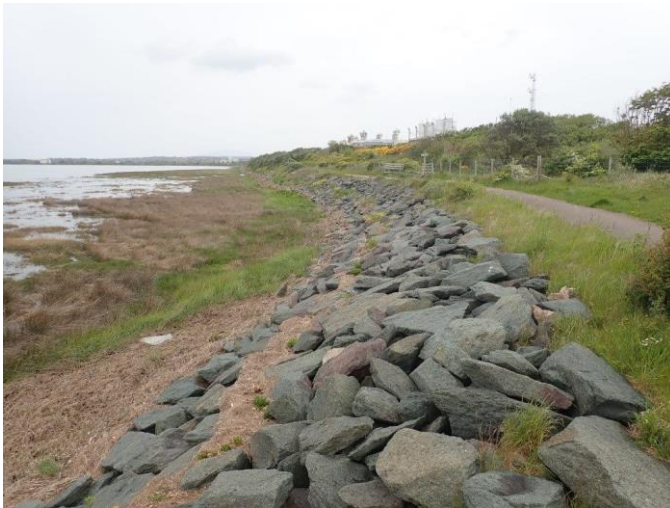
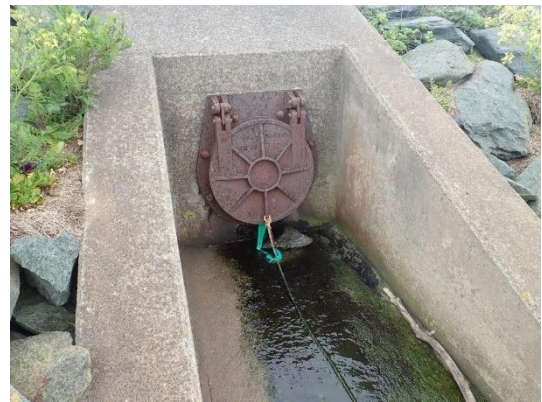
Photos

NFCDD Element and Survey Data								
Inspector	C. Bell						Date	14/05/2021
Element	Type	Sub-type	Material	Revetment	Slope	Width	Condition	Weighting
1	CB	-	Mud flat	-	-	-	3	2
2	CS	Foreshore	Shingle and sand	-	10 deg	20m	4	2
3	FI	Revetment	Rock armour		35 deg	4m	2	5
4	FI	Sea cliff	Sandstone		35 deg	6	3	5
Residual Life		10-20	Urgency	No repairs		Overall Condition		3
						Data Quality		1
Comments and Recommendations The sand and shingle foreshore are becoming heavily vegetated. There is a mixture of granite and slate rock armour layer in good condition protecting the toe of the sea cliff, with the upper section of sea cliff heavily vegetated and in good condition. Some sections show subsidence of cliff at crest. There is an outfall comprising of concrete head and wing walls and a metal flood gate. Hinges are in a good state of repair allowing flow from outfall (flowing at time of inspection).

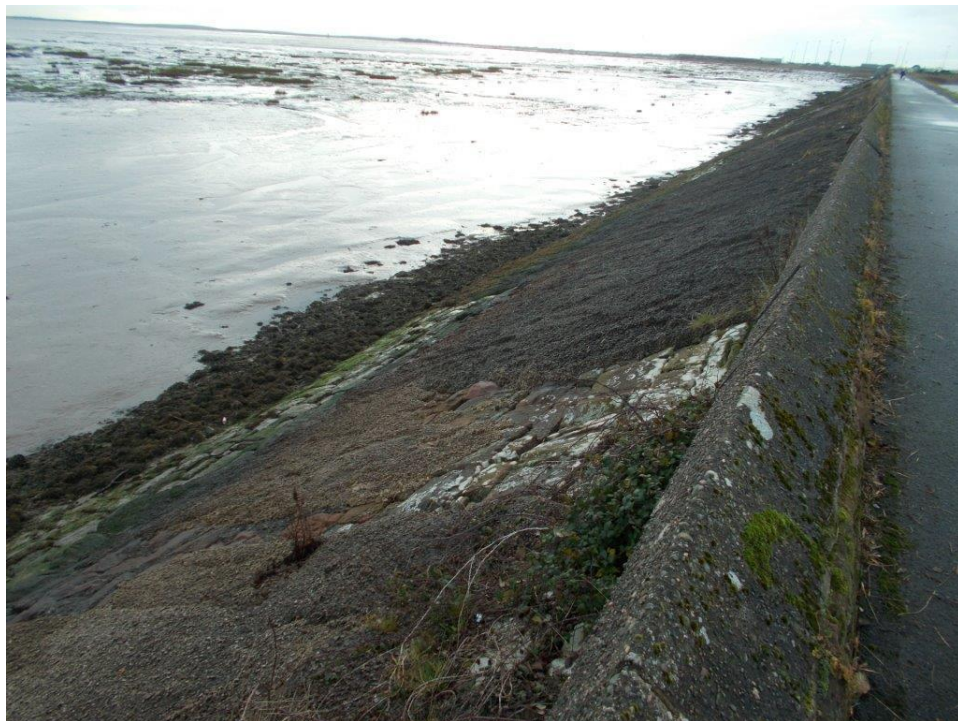
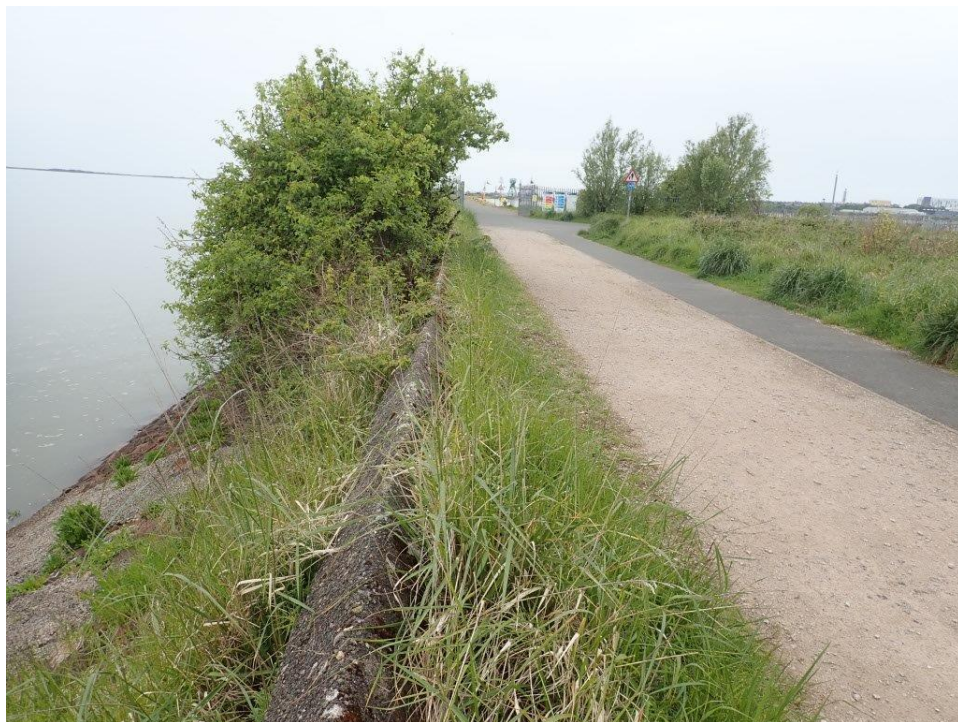
Photos

NFCDD Element and Survey Data								
Inspector	C. Bell						Date	14/05/2021
Element	Type	Sub-type	Material	Revetment	Slope	Width	Condition	Weighting
1	CB	-	Mud flat	-	-	-	3	2
2	CS	Foreshore	Salt marsh	-		8m	3	2
3	FI	Revetment	Sandstone block		40 deg	5m	3	6
4	FI	Wall	Sandstone				3	5
5	C	Wall	Sandstone coping				4	5
6	FO	Wall	Sandstone				3	5
7	B	Footway	Asphalt			3m	2	5
8	B	Berm	Grass verge			2m	3	5
9	FO	Revetment	Sandstone block		45 deg	4m	3	6
10	CB	-	Sand/silt				3	2
Residual Life		10-20	Urgency			Overall Condition		3
						Data Quality		1
Comments and Recommendations								
There is concrete render over the inward face of sandstone block – with up to 50% coverage. Some sandstone areas have no concrete cover. Sandstone blocks and mortar wearing are exposed, with blocks displaced in small areas, however no repairs are currently required. In some areas there are shrubs and vegetation becoming established towards the top of revetment.

Some coping stones that were missing have been replaced in recent years, however there are some small areas of further deterioration.								
Indicative sketch of cross-section

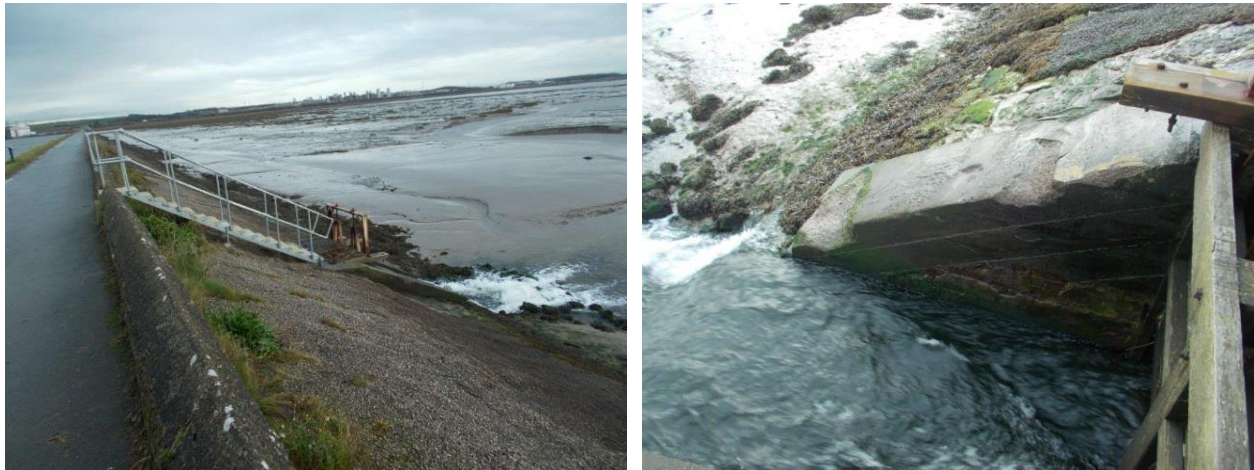
Photos

NFCDD Element and Survey Data								
Inspector	C. Bell						Date	14/05/2021
Element	Type	Sub-type	Material	Revetment	Slope	Width	Condition	Weighting
1	CB	-	Mud flat	-	-	-	3	2
2	CS	Foreshore	Salt marsh	-		8m	3	2
3	FG1	Flood gate	Timber				3	8
4	FI	Head Wall	Masonry				3	6
5	WW1	Wing Wall	Masonry				3	6
6	WW2	Wing Wall	Masonry				3	6
7		Outfall	Cast concrete				3	5
8		Culvert	Cast concrete				3	7
Residual Life		10-20	Urgency	Routine		Overall Condition		3
						Data Quality		1
Comments and Recommendations								
Head and wing walls are constructed of rendered masonry with cast concrete capping. There is some missing render from the wing walls, and spalling of concrete.								
Seaweed build up on outfall but not affecting operation of sluice gate. Water was flowing freely through the gate at the time of the inspection. A handrail has been installed on the access steps in recent years.

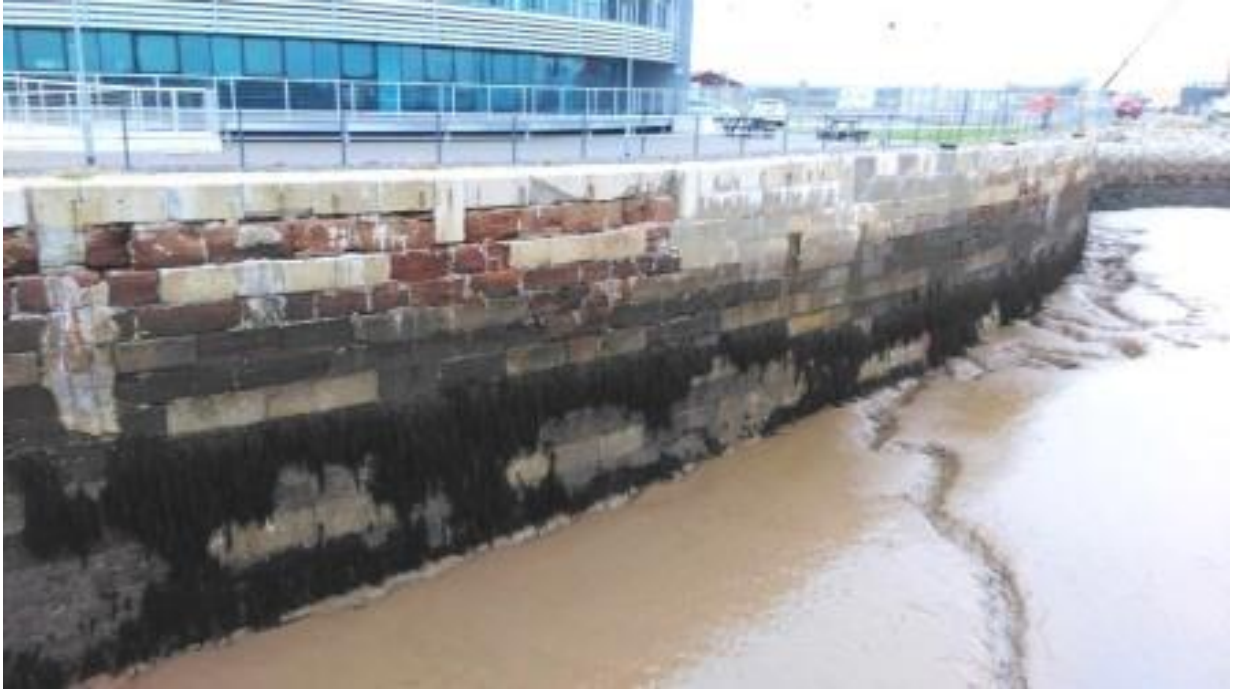
Photo

NFCDD Element and Survey Data									
Inspector	C. Bell						Date	21/11/2016	
Element	Type	Sub-type	Material	Revetment	Slope	Width	Condition	Weighting	
1	CB		Mud flat				3	2	
2	CS	Foreshore	Sand				3	2	
3	FI	Wall	Masonry				3	7	
4	B	Berm	Turf				3	5	
Residual Life		10-20 yrs	Urgency				Overall Condition		3
						Data Quality		1	
<p>Comments and Recommendations</p> <p>Approximately 15-20% sandstone masonry block spalling and open jointed, with minor cracking in masonry visible. Continue to carry out annual review to get an idea of deterioration rate.</p> <p>Unable to inspect since 2016 due to restricted access</p>									
<p>Indicative sketch of cross-section</p>

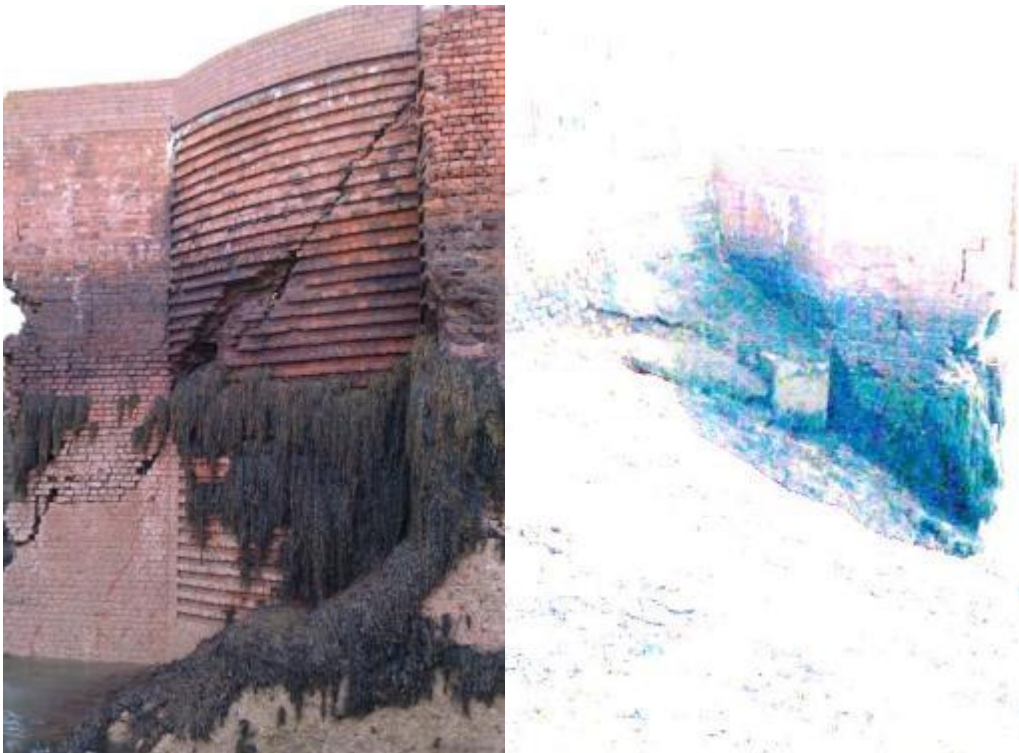
Detail of fractured wall

NFCDD Element and Survey Data								
Inspector	A Buck						Date	16/05/2012
Element	Type	Sub-type	Material	Revetment	Slope	Width	Condition	Weighting
1	CB		Mud flat				3	2
2	CS	Foreshore	Sand				3	2
3	FI	Wall	Brick				4	7
4	B	Berm	Concrete				2	5
Residual Life		10-20 yrs	Urgency				Overall Condition	3
						Data Quality	1	
<p>Comments and Recommendations</p> <p>Severe fracturing of wall through full width at northernmost point of asset. Failure will not affect sea defence but should be referred to maintainer regarding stability issues and consequent safety of persons in the vicinity.</p> <p>Remainder of wall shows fractured and perished brickwork but not yet affecting stability of asset.</p> <p>08/05/12: Fracturing at northernmost point of asset/FO has noticeably worsened. Email sent 13/05/13 to Chris Clouter & Bob Phillips of Associated British Ports (land owner).</p> <p>Not inspected since 2012 as access is restricted.</p>

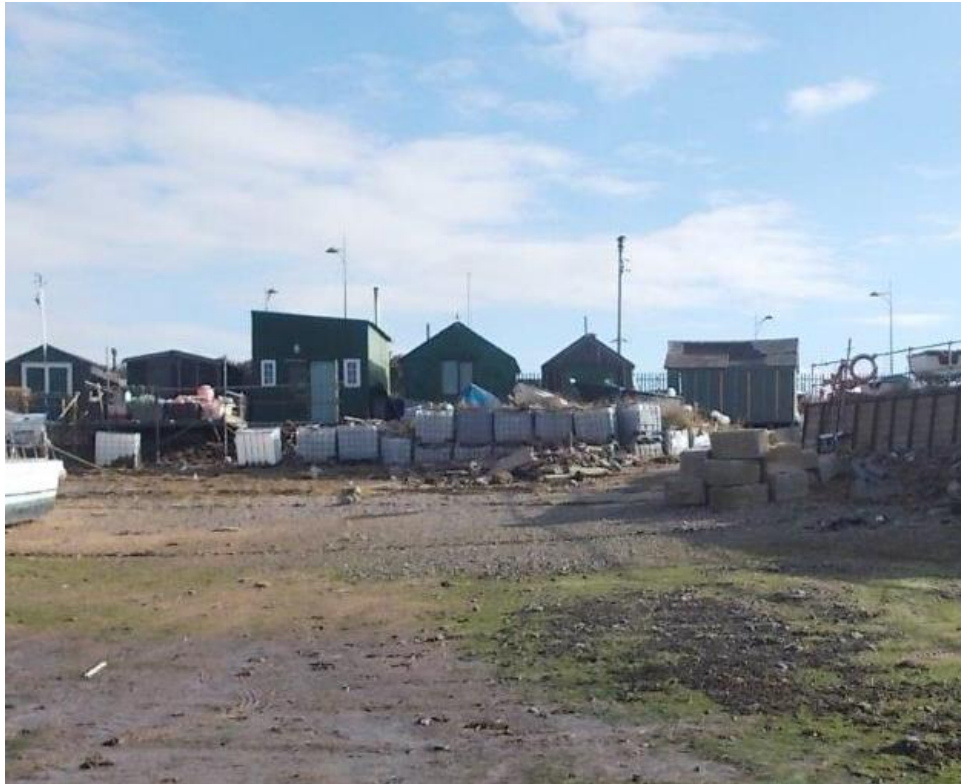
Temporary Remedial Work:

NFCDD Element and Survey Data								
Inspector	C. Bell						Date	23/02/2018
Element	Type	Sub-type	Material	Revetment	Slope	Width	Condition	Weighting
1	CB		Mud flat				3	2
2	CS	Foreshore	Shingle				3	2
3	FI	Revetment	Stone with poured concrete				4	6
4	B	Berm	Turf				3	5
Residual Life		10 yrs	Urgency				Overall Condition	3
						Data Quality	1	
Comments and Recommendations Revetment heavily vegetated with area of stone work missing. At the southern end of the revetment (adjacent to access ramp), a temporary defence erected in front of the revetment to prevent further damage from erosion remains in place.								
Indicative sketch of cross-section

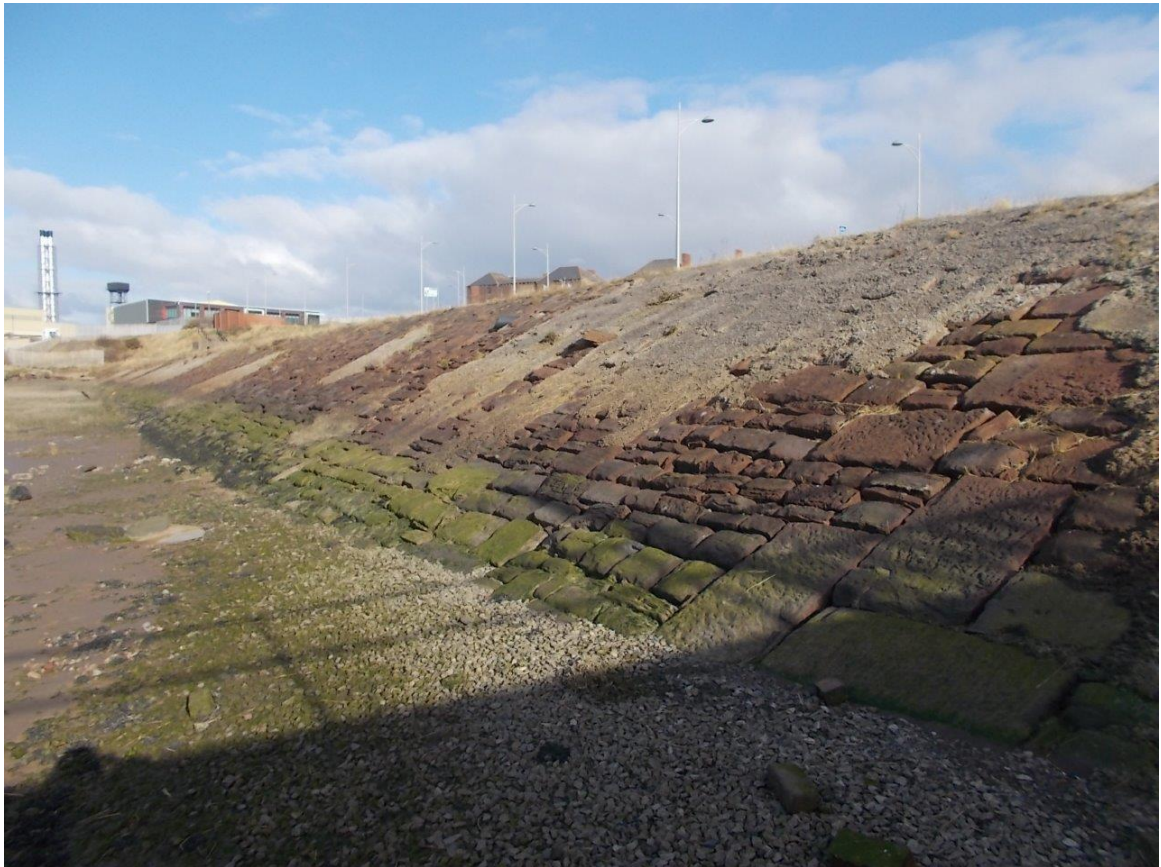
Photo

NFCDD Element and Survey Data								
Inspector	C. Bell						Date	23/02/2018
Element	Type	Sub-type	Material	Revetment	Slope	Width	Condition	Weighting
1	CB		Mud flat				3	2
2	CS	Foreshore	Sand/ shingle				3	2
3	FI	Revetment	Sandstone masonry with poured concrete				3	6
4	B	Berm	Turf				2	5
Residual Life			Urgency				Overall Condition	3
						Data Quality	1	
Comments and Recommendations Areas of open jointed masonry where there is no concrete covering and minor areas of stone loss. Vegetation growth towards the top of the revetment, on berm, and to rear of footpath. No visible signs of deterioration since previous inspection.								
Indicative sketch of cross-section

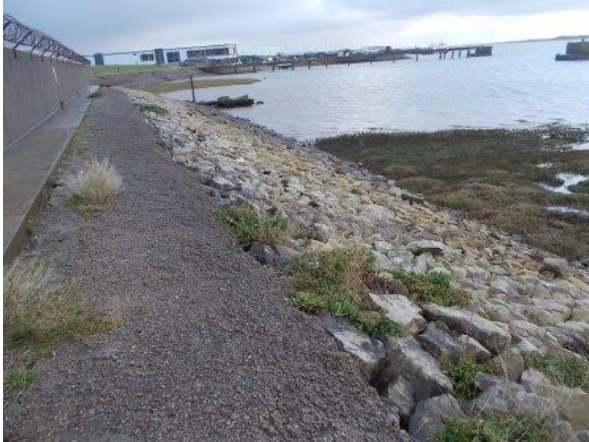
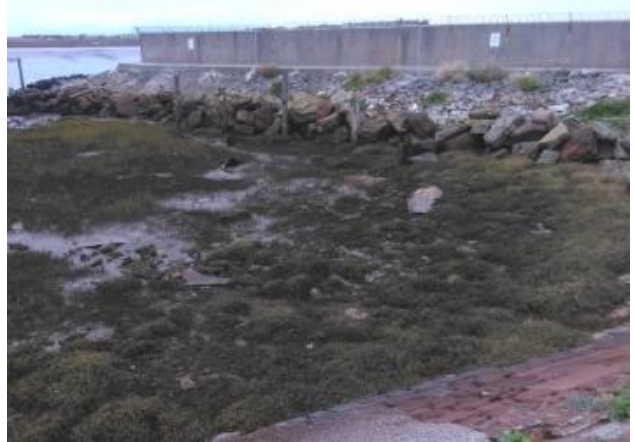
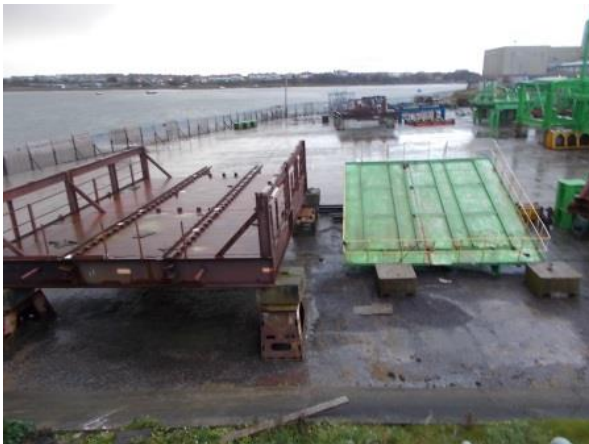
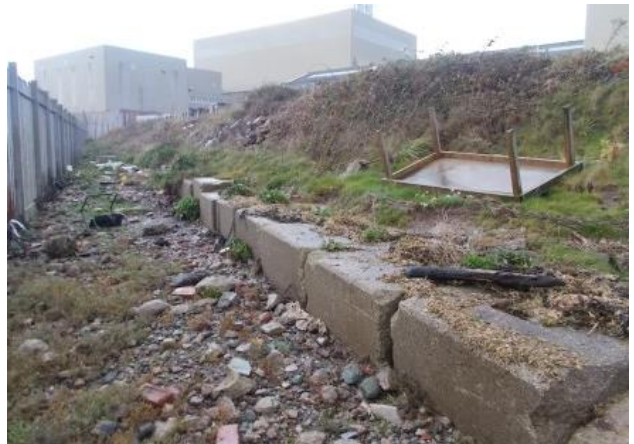
Photos

NFCDD Element and Survey Data								
Inspector	C. Bell						Date	17/11/2016
Element	Type	Sub-type	Material	Revetment	Slope	Width	Condition	Weighting
1	CB		Mud flat				3	2
2	CS		Shingle				3	2
3	FI			Rock armour			3	6
4	B		Concrete (path)				2	5
Residual Life			Urgency				Overall Condition	3
						Data Quality		1
Comments and Recommendations Approx central 70% of length of asset is not a defence asset – shipyard slipway and associated sloping areas of open high ground to water’s edge. Rock armour makes up approx 15% of asset length at south end. Raised land makes up approx 15% of asset length at north end. There appears to have been no visible deterioration to the asset since the previous inspection. Not inspected since 2016 as access to BAE is restricted.								
Indicative sketch of cross-section

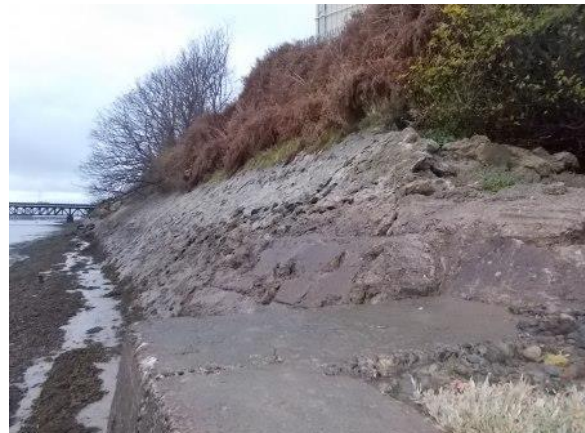
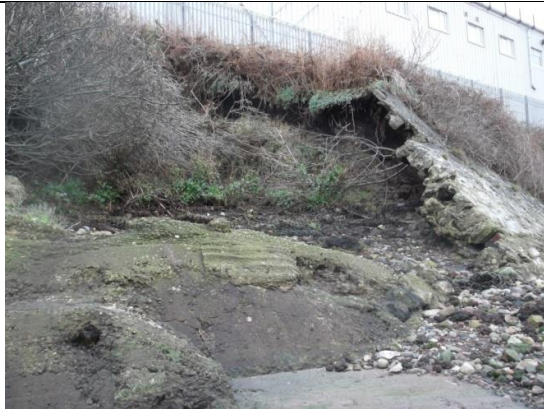
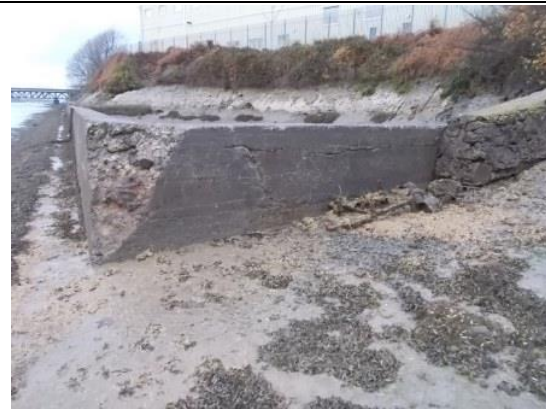
Photos

NFCDD Element and Survey Data								
Inspector	C. Bell						Date	17/11/2016
Element	Type	Sub-type	Material	Revetment	Slope	Width	Condition	Weighting
1	CB		Mud flat				3	2
2	CS		Shingle				3	2
3	FI	Revetment	Grouted stone				3	6
4	FI		Turf				3	5
Residual Life			Urgency				Overall Condition	3
						Data Quality		1
Comments and Recommendations Grouted stone revetment is generally condition 3 but an area approx 5-6m long is missing together with substantial erosion of earth behind. Aerial photographs from 2000 – 2009 show this to be circular in plan and no change in the size of this area. It remains unknown whether this area has been excavated or a previous structure removed. The southern end of the revetment is showing signs of minor undercutting at the toe. Approx 30% of asset length is bounded by a concrete sea wall forming a pond - grouted stone revetment continues around the back of the pond. Spalling and cracking is evident within the Sea wall. Not inspected since 2016 as access to BAE is restricted.

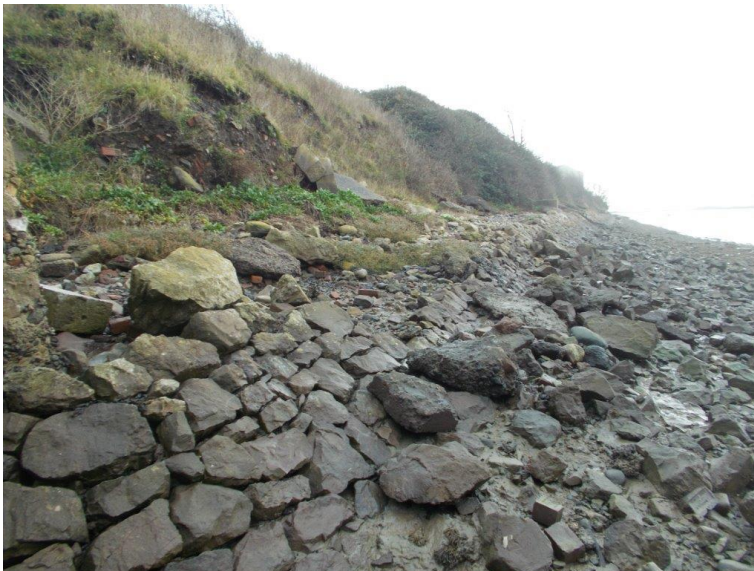
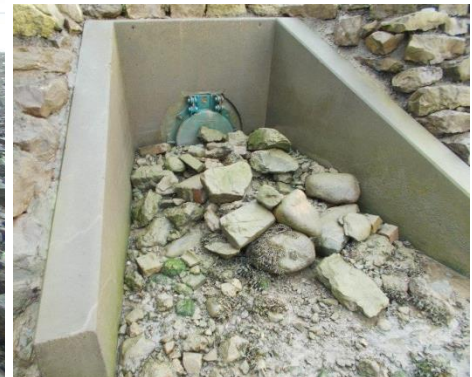
Photo

NFCDD Element and Survey Data								
Inspector	C. Bell						Date	26/11/2019
Element	Type	Sub-type	Material	Revetment	Slope	Width	Condition	Weighting
1	CB	-	Mud flat	-	-	-	2	2
2	FI	Toe	Various	-		8m	3	4
3	FI	Revetment	Limestone pitching		45 deg	2m	4	5
4	B		Various			2m	4	5
5	FI	Cliff			60 deg		4	6
Residual Life		5-10	Urgency	Routine		Overall Condition		4
						Data Quality		1

Some pitching is missing to the limestone revetment mainly towards top of slope. As with recent inspections, the flap valve continues to be unable to operate effectively as it is being prevented from opening by a build-up of debris.

There are increased areas of subsidence of the embankment due to lack of stability at the top of the cliff, however there does not appear to have been any significant deterioration in recent years.

Unable to inspect this asset in detail due to scaffolding works beneath Jubilee Bridge.

A land stability survey is recommended to ascertain the appropriate measures required to stabilise the cliff. It remains unknown whether any action has been taken on this to date.

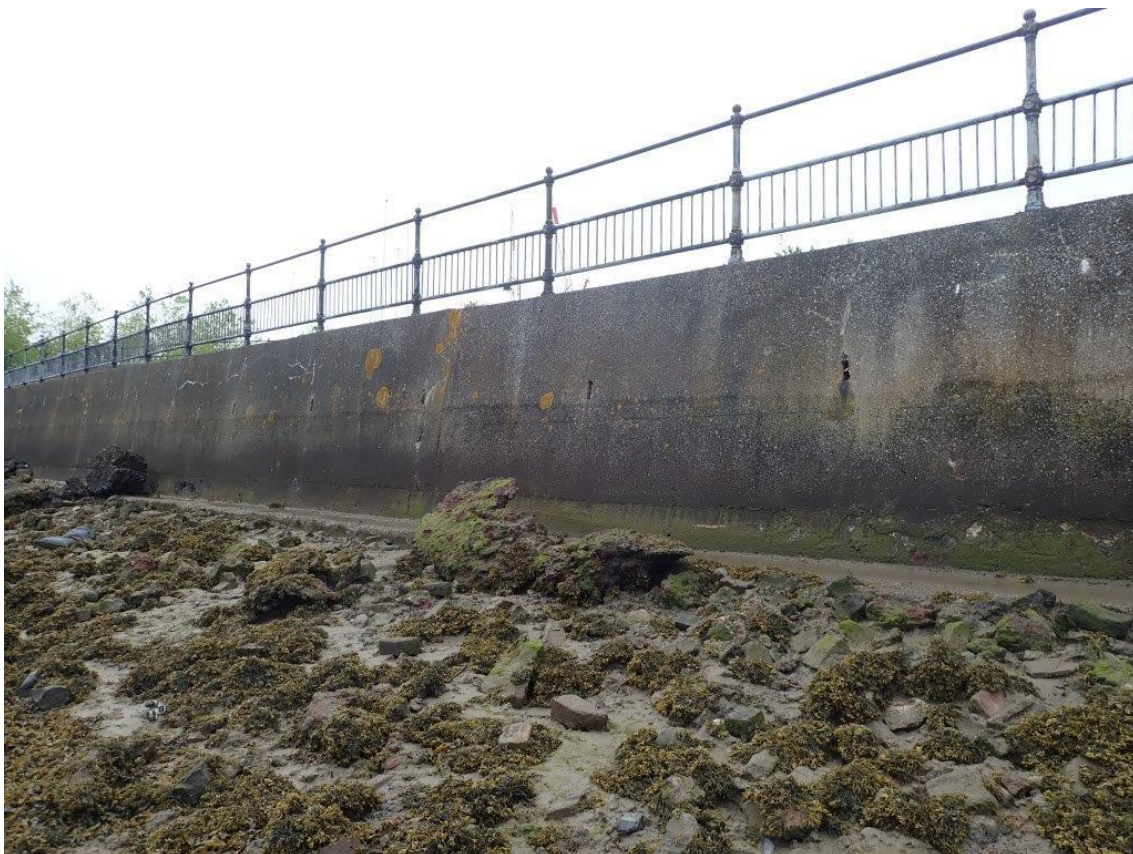
Photo

NFCDD Element and Survey Data								
Inspector	C. Bell						Date	14/05/2021
Element	Type	Sub-type	Material	Revetment	Slope	Width	Condition	Weighting
1	CB		Mud flat				3	2
2	CS	Foreshore	Rubble and shingle		10 deg	5m	3	2
3	Toe		Concrete			600mm	3	5
4	FI	Sea wall	Concrete		90 deg		3	6
5	C	Crest	Concrete			2m	3	5
Residual Life		10-20	Urgency	No repairs required		Overall Condition		3
						Data Quality		1
<p>Comments and Recommendations</p> <p>There is some undercutting of a connecting ramp / revetment and also what appears to be a significant land tip of bricks. The primary structure of concrete wall remains in generally good condition apart from some spalling at the toe. However there are areas of transverse and longitudinal cracking within the concrete wall.</p> <p>As in previous years, there are no visible signs of significant deterioration since the last inspection, however it is recommended that annual inspections continue.</p>

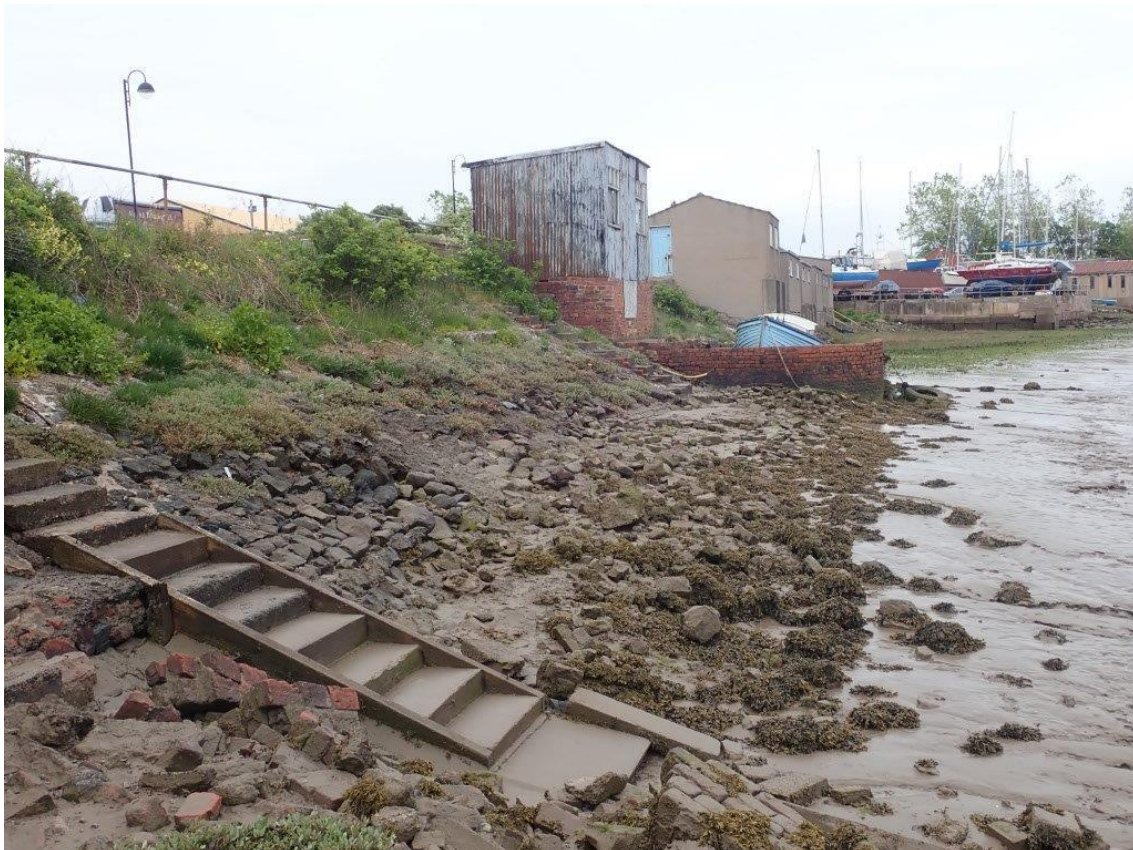
Photo.

NFCDD Element and Survey Data								
Inspector	C. Bell						Date	14/05/2021
Element	Type	Sub-type	Material	Revetment	Slope	Width	Condition	Weighting
1	CB		Mud flat				3	2
2	CS	Foreshore	Rubble		10 deg	5m	3	2
3	Toe	Revetment	Rubble and stone			600mm	4	5
4	FI	Sea wall	Concrete		90 deg		3	6
5	C	Crest	Concrete			2m	3	5
Residual Life		10-20	Urgency	No repairs required		Overall Condition		3
						Data Quality		1
<p>Comments and Recommendations</p> <p>This is a low erosion area but slow deterioration of small sections of the patchwork construction is evident, however there appears to have been no increase in deterioration in the past few years. The site is owned by the boat club and a contact is to be established to notify of recommendations of repairs. It remains unknown whether or not any action has been taken regarding this.</p> <p>A new fence has been installed at the top of the revetment in the last couple of years to prevent unauthorised access.</p>

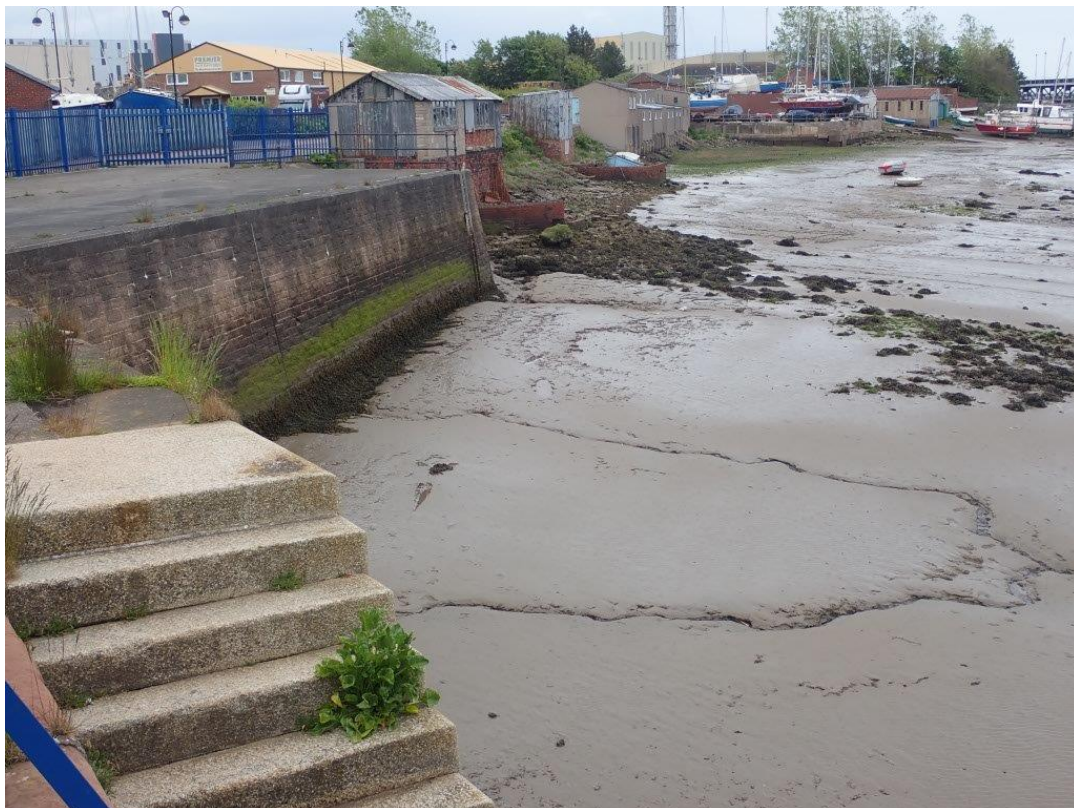
Photo.

NFCDD Element and Survey Data								
Inspector	C. Bell						Date	14/05/2021
Element	Type	Sub-type	Material	Revetment	Slope	Width	Condition	Weighting
1	CB		Mud flat				3	2
2	CS	Foreshore	Rubble and shingle		10 deg	5m	3	2
3	Toe		Sandstone	Heavily vegetated		600mm	4	5
4	FI	Sea wall	Sandstone		90 deg		3	6
5	C	Crest	Sandstone			2m	3	5
Residual Life		10-20	Urgency	No repairs required		Overall Condition		3
						Data Quality		2
<p>Comments and Recommendations</p> <p>This is a low erosion area, although it is recommended that annual reviews continue to be undertaken to monitor any deterioration. However there are no visible signs of deterioration in recent years.</p> <p>The toe is heavily vegetated making thorough investigation difficult and there is some spalling of the sandstone. All joints appear in good order with only a few minor cracks at corners. There is some minor spalling to the copings on the top of the sea wall.</p> <p>A new fence has been installed at the top of the revetment in recent years to prevent unauthorised access.</p>

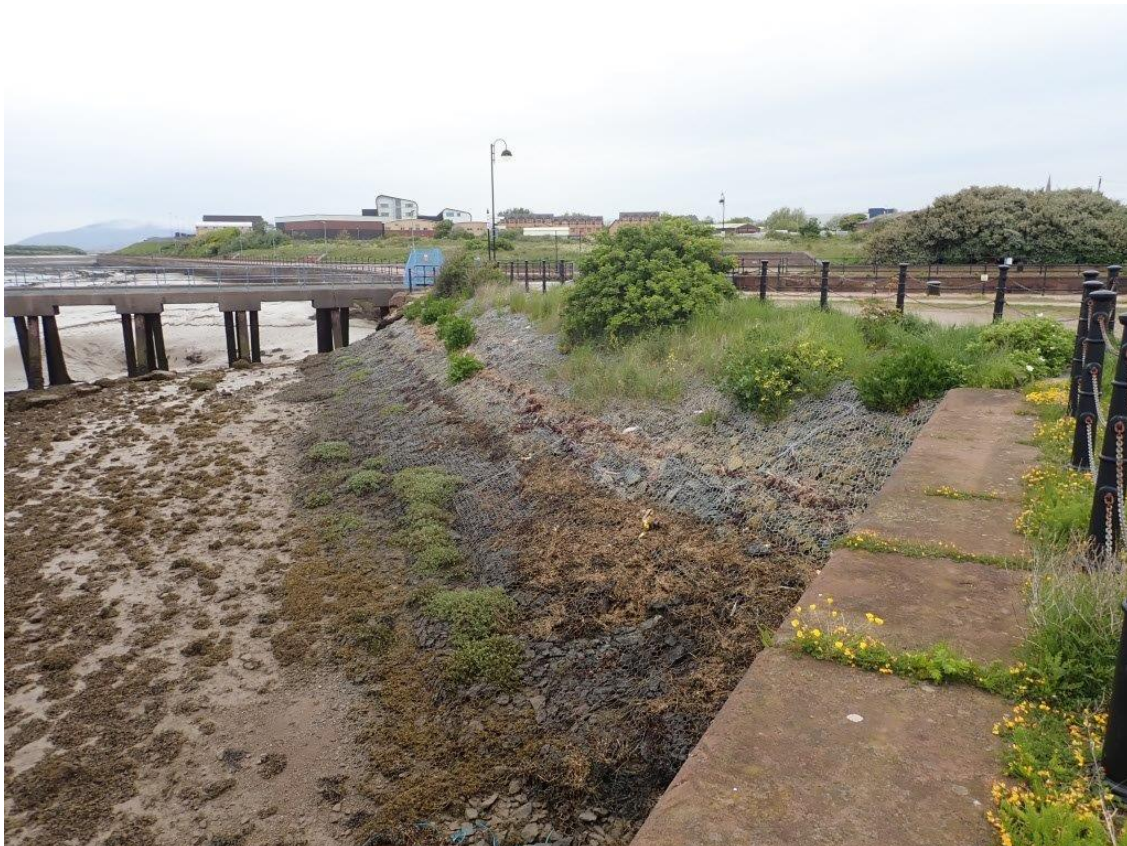
Photo.

NFCDD Element and Survey Data								
Inspector	C. Bell						Date	14/05/2021
Element	Type	Sub-type	Material	Revetment	Slope	Width	Condition	Weighting
1	CB		Mud flat				3	2
2	CS	Foreshore	Mud Rubble		10 deg	5m	3	2
3	FI	Revetment	Rock reno Mattress		30 deg	4m	3	5
4	FI	Sea cliff	Cage and grass		30 deg	2m	3	6
5	C	Crest	Cobble and gravel			4m	3	5
Residual Life		10-20	Urgency	No work required		Overall Condition		3
						Data Quality	1	
Comments and Recommendations This section is a stone revetment with wire covering. Deterioration since this asset was first inspected appears to be minimal. There is some undercutting to the side of the mattress but as with previous inspections, it does not appear to have deteriorated significantly over recent years. The toe is heavily corroded and the cages appear deflated leading to the conclusion that there has been significant settling and loss of material even though the wire is in good condition. The top of the revetment is continuing to become well vegetated. It is recommended to continue annual monitoring of the asset.

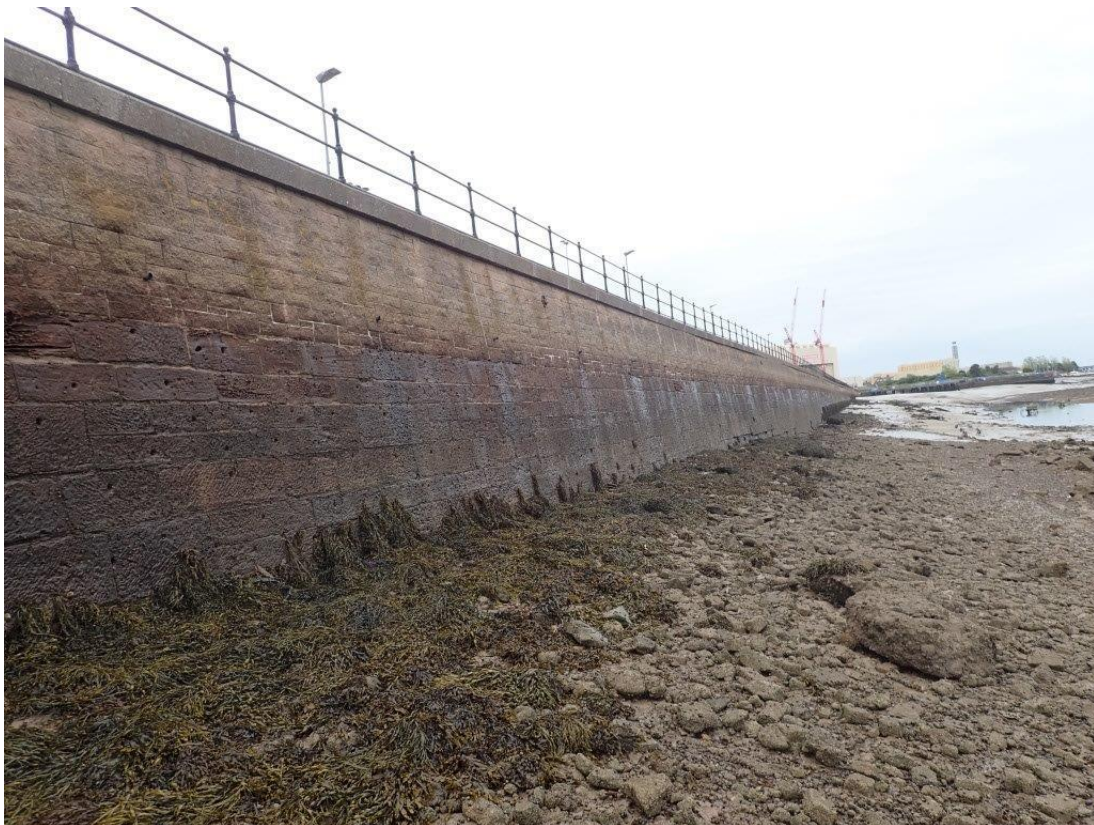
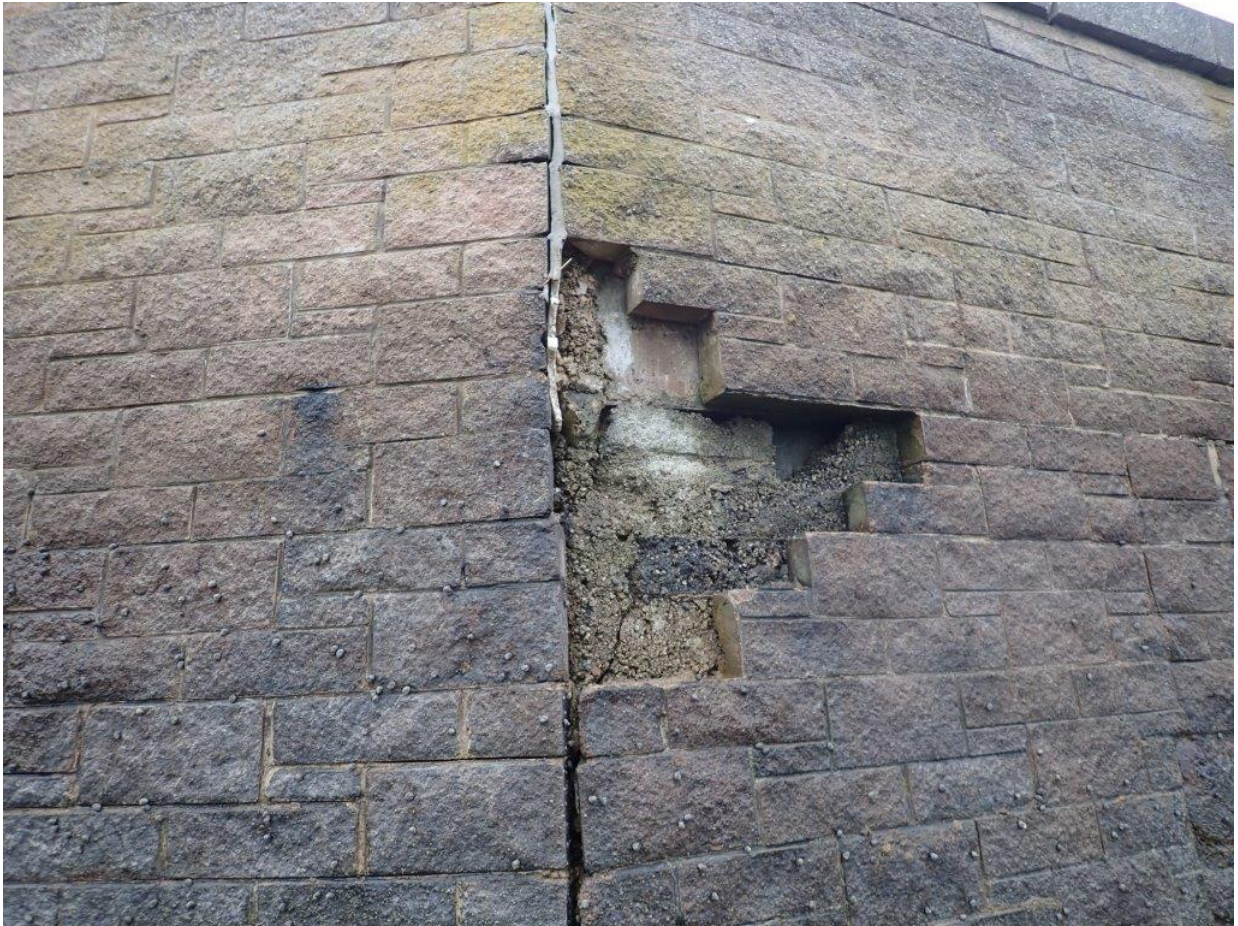
Photos.

NFCDD Element and Survey Data								
Inspector	C. Bell						Date	14/05/2021
Element	Type	Sub-type	Material	Revetment	Slope	Width	Condition	Weighting
1	CB		Mud flat				3	2
2	CS	Foreshore	Cobbles and mud		15 deg	5m	3	2
3	FI	Sea wall	Masonry		90 deg		3	6
4	C	Crest	Concrete			2m	3	5
5	Berm	Promenade	Brick setts			5m	3	5
Residual Life		10-20	Urgency	No repairs required		Overall Condition		3
						Data Quality		1
<p>Comments and Recommendations</p> <p>This area includes a couple of flap valves that both had significant pitting of the flaps, hinges were either rusted or covered in vegetation but free water flow was achieved.</p> <p>The wall is in generally good condition overall, however there is spalling of the masonry facing and missing pointing in places. At the northern corner of the wall there is section where the masonry facing has broken away, this area has increased slightly since the last inspection. As with previous inspections, increased seaweed growth at the toe made it difficult to assess the condition in certain areas.</p> <p>The brick setts along the promenade are showing signs of settlement in isolated locations. This should be monitored closely over coming years as remedial works may be required in the future.</p> <p>Continue annual inspections.</p>
