Barrow Coastal Inspections 2020

Barrow Borough Council

May 2021

Title	Barrow Coast Protection Inspections
Creator/Author	Craig Bell/Mark Ellis, Capita
Publisher	Barrow Borough Council, Town Hall, Duke Street, Barrow-in-Furness. LA14 2LD
Date of Publication	01/06/2021
Contact	Chris Jones, Barrow Borough Council
Subject – keyword	Survey and monitoring – coastal defence inspections
Description/Abstract	Report detailing the results of an inspection of coast defences along Barrow Borough Council's coastline completed in 2021
Identifier	CS063836/002
Coverage – spatial	Barrow Borough Council coastline – from Peasholmes Lane A5087 to Mere Beck, Askam-in-Furness
Coverage – temporal	2018
Format	documentDigital
Type	Report
Subject – category	Coastal Defence
Subject – project	Cell 11 Regional Monitoring Strategy
Language	English
Rights – copyright	Map data copyright Ordnance Survey licence
Rights – disclosability	Yes
Rights – FOIA	Yes
Postal Address	Barrow Borough Council, Town Hall, Duke Street, Barrow-in-Furness

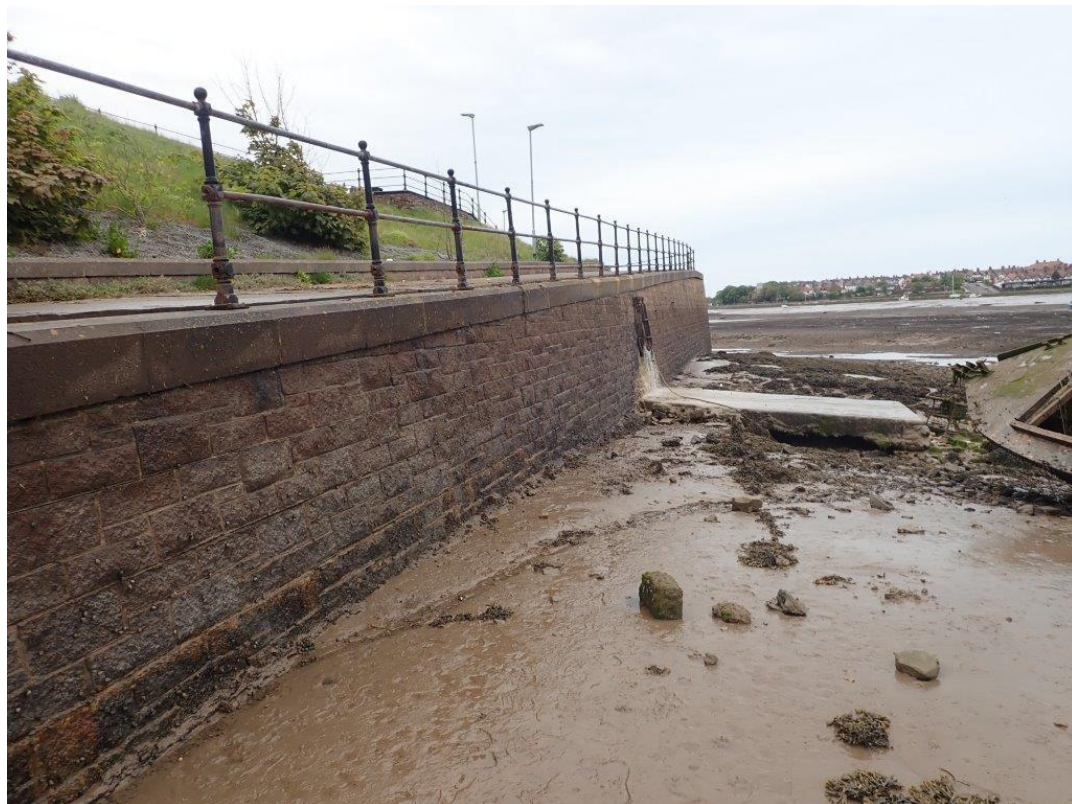
Photo

Risk Assessment			
Risk Score	18	Assessment	Low
Change from previous assessment		Washout beneath concrete spillway

NFCDD Element and Survey Data								
Inspector	C. Bell						Date	14/05/2021
Element	Type	Sub-type	Material	Revetment	Slope	Width	Condition	Weighting
1	CB		Mud flat				3	2
2	CS	Foreshore	Rubble shingle and mud		15 deg	5m	3	2
3	FI	Sea wall	Masonry		90 deg		3	6
4	FV	Flap valve	Steel				3	4
5	C	Crest	Concrete			2m	3	5
6	Berm	Promenade	Brick setts			5m	3	5
7	FI	Wall	Masonry				3	6
8	B	Wall	Concrete coping				3	5
Residual Life		10-20	Urgency	No repairs required		Overall Condition		3
						Data Quality		3

The wall is largely clear of vegetation and only small sections of mortar lost. The flap valve is heavily pitted but the hinges are new and free moving, and water was flowing freely from the valve during the time of the inspection, although there appears to have been further washout from beneath the concrete spillway. There is some evidence that water is penetrating behind the masonry facing at high tide and the water then flows out through cracks in the mortar as the tide goes out, however there does not appear to have been any further deterioration since the previous inspection.

It is recommended annual inspections continue.

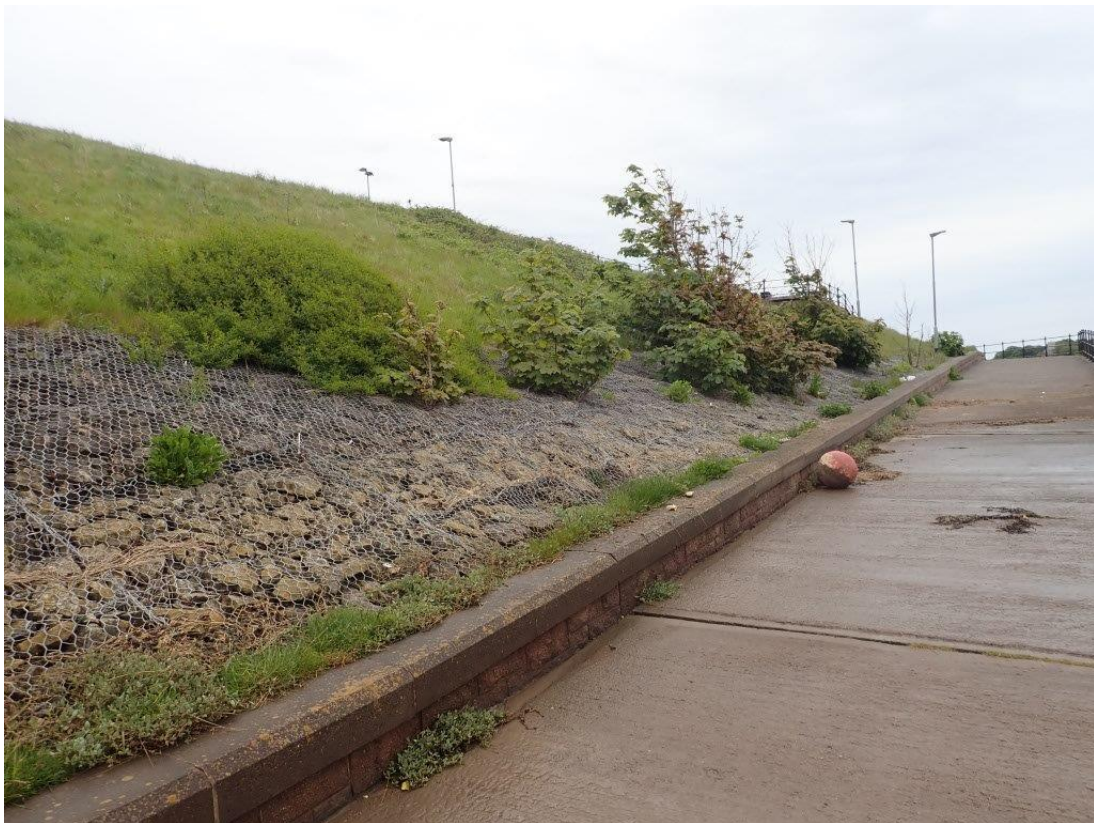
Photo

NFCDD Defence Data			Hindpool
EA Asset Ref.	011KD90250101C10		
Alternate Ref.	210/8025		
Start NGR	E318760 N470600	End NGR	E318902 N470720
Defence Type	Man Made	Protection Type	Sea wall
Asset Type	Wall	Design Standard	99
Maintainer	Cumbria County Council	Year Built	
Crest Level		CL Data Quality	3
Spatial Data Quality	Adequate

Risk Assessment			
Risk Score	12	Assessment	Low
Change from previous assessment		None

NFCDD Element and Survey Data								
Inspector	C. Bell						Date	14/05/2021
Element	Type	Sub-type	Material	Revetment	Slope	Width	Condition	Weighting
1	CB		Mud flat				3	2
2	CS	Foreshore	Rubble shingle and mud		15 deg	5m	3	2
3	FI	Sea wall	Masonry		90 deg		3	6
4	C	Crest	Concrete coping				3	5
5	FO	Wall	Concrete			4m	3	5
6	B	Track	Concrete					
7	FI	Wall	Masonry				3	6
8	C	Berm	Concrete coping				3	5
9	FI	Revetment	Gabion baskets	Rock			3	5
Residual Life		10-20	Urgency	Routine		Overall Condition		3
						Data Quality		1
Comments and Recommendations Some of the gabion baskets are collapsed, with vegetation established within the baskets in areas, however it appears no significant deterioration has occurred to the asset in recent years. The tide line shows that these baskets do submerge at high tides and work to refill them is recommended. It appears no remedial work has been carried out to date.								
Indicative sketch of cross-section

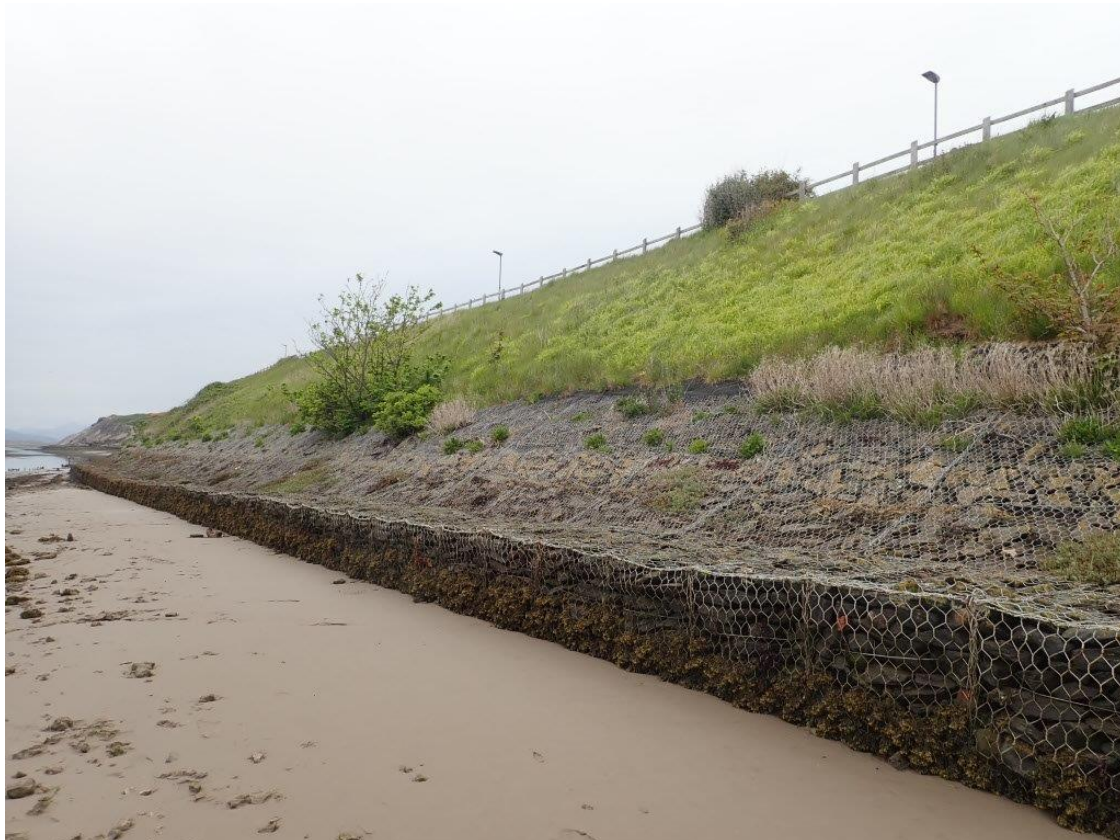
Photo

NFCDD Defence Data			Hindpool North
EA Asset Ref.	011KD90250101C11		
Alternate Ref.	210/8026		
Start NGR	E318741 N470158	End NGR	E318782 N470720
Defence Type	Man Made	Protection Type	Sea wall
Asset Type	Wall	Design Standard	99
Maintainer	Cumbria County Council	Year Built	Not known
Crest Level		CL Data Quality	Missing
Spatial Data Quality	Adequate		
Risk Assessment			
Risk Score	12	Assessment	Low
Change from previous assessment		Increase in vegetation growth in areas

NFCDD Element and Survey Data								
Inspector	C. Bell						Date	14/05/2021
Element	Type	Sub-type	Material	Revetment	Slope	Width	Condition	Weighting
1	CB		Mud flat				3	2
2	CS	Foreshore	Mud cobbles		10 deg	5m	3	2
3	FI	Toe	Gabion baskets		90 deg		3	6
4	FI	Revetment	Gabion baskets		25 deg	8m	3	5
5	FV	Flap valve	Concrete and steel				3	5
6	FI	Embankment	Grass			6m	3	6
7	C	Crest	Bitmac footway				3	5
Residual Life		10-20	Urgency	No work required		Overall Condition		3
						Data Quality		3
Comments and Recommendations								
<p>The gabion baskets remain heavily covered in vegetation as during previous inspections, making it difficult to accurately assess their condition, however no significant deterioration appears to have occurred in recent years. The cage shape and condition of visible wire is generally good. Data quality score is reduced because of lack of visibility. Vegetation growth has increased in areas.</p> <p>As in previous inspections, the flap valve is pitted but the hinge remains clean and moves freely. There is a sapling above the flap valve that continues to grow. This should be removed to avoid damage from root growth, however no action has yet been taken on this.</p>

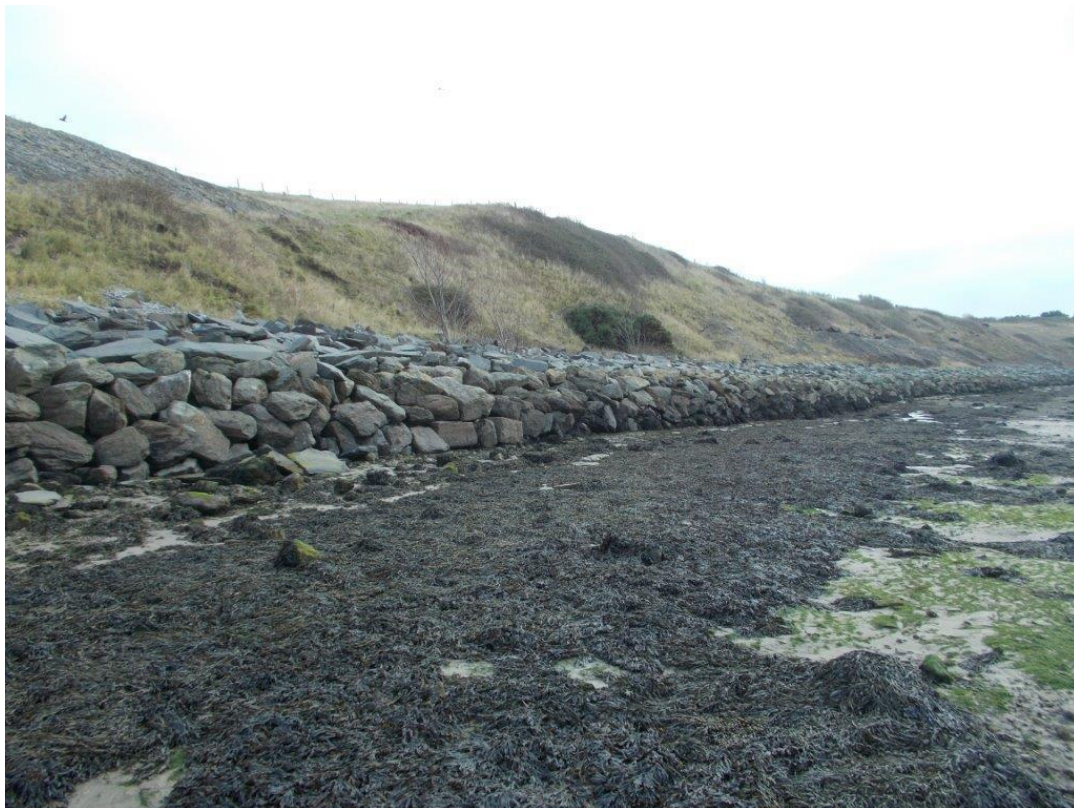
Photo

NFCDD Defence Data			Ormsgill
EA Asset Ref.	011KD90250101C11		
Alternate Ref.	210/8027		
Start NGR	E318760 N470600	End NGR	E318902 N470720
Defence Type	Man Made	Protection Type	Defence
Asset Type	Revetment	Design Standard	99
Maintainer	Cumbria County Council	Year Built	Not known
Crest Level		CL Data Quality	Missing
Spatial Data Quality	Adequate

Risk Assessment			
Risk Score	12	Assessment	Low
Change from previous assessment		None

NFCDD Element and Survey Data								
Inspector	C. Bell						Date	14/05/2021
Element	Type	Sub-type	Material	Revetment	Slope	Width	Condition	Weighting
1	CB		Mud flat				3	2
2	CS	Foreshore	Mud cobbles		10 deg	5m	3	2
3	FI	Revetment	Rock armour		30 deg		3	5
4	FI	Sea cliff	Clay and slag		30 deg	12m	3	6
5	C	Crest	Bitmac footway and grass verge			4m	3	5
Residual Life		10-20	Urgency	No work required		Overall Condition		3
						Data Quality		1
Comments and Recommendations								
There is some subsidence on the cliffs above the revetment but the revetment structure itself remains sound, with no signs of deterioration in recent years.								
Increasing amounts of seaweed collecting at tide line making it harder to assess the revetment in certain locations, particularly the toe.								
Indicative sketch of cross-section

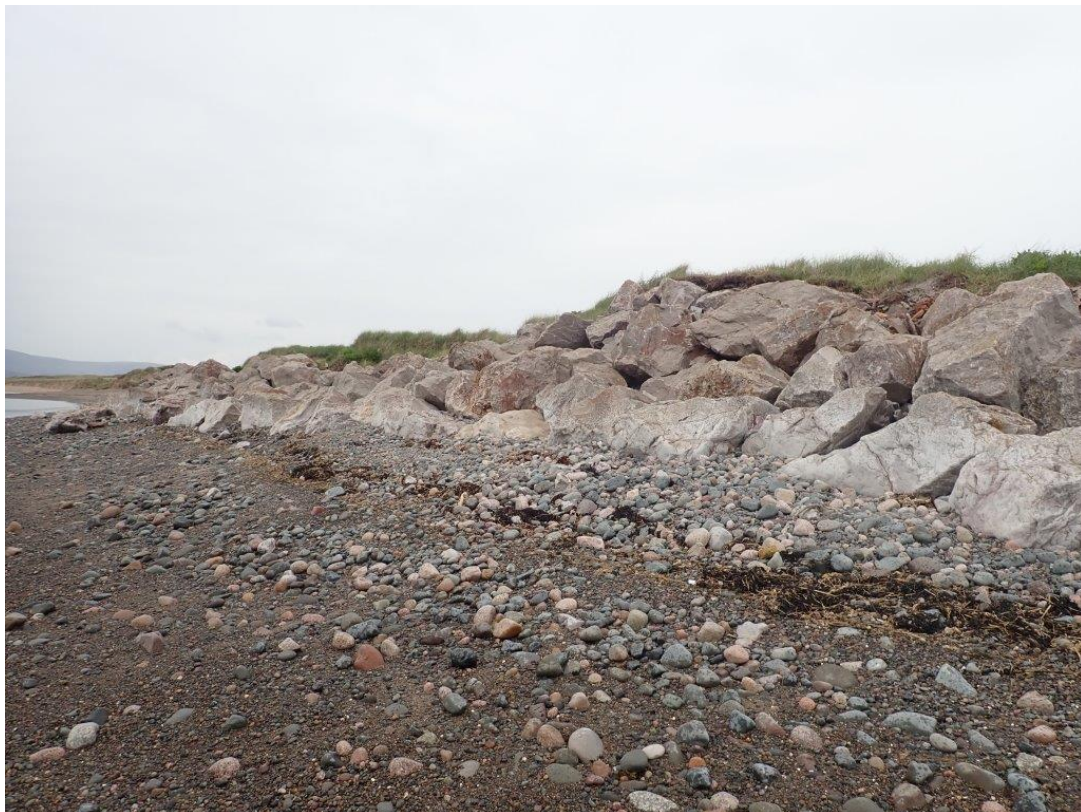
Photo

NFCDD Defence Data			Lowsey Point
EA Asset Ref.	011KD90250401C02		
Alternate Ref.	210/8038		
Start NGR	E318466 N473920	End NGR	E318564 N474024
Defence Type	Man Made	Protection Type	Defence
Asset Type	Revetment	Design Standard	99
Maintainer	Barrow Borough Council	Year Built	1990
Crest Level		CL Data Quality	Missing
Spatial Data Quality	Adequate

Risk Assessment			
Risk Score	24	Assessment	Medium
Change from previous assessment		None

NFCDD Element and Survey Data								
Inspector	C. Bell						Date	14/05/2021
Element	Type	Sub-type	Material	Revetment	Slope	Width	Condition	Weighting
1	CB		Mud flat				3	2
2	CS	Foreshore	Pebbles and sand		10 deg	20m	3	2
3	FI	Revetment	Rock armour		35 deg	4m	4	6
4	C	Crest	Grass				4	6
Residual Life		10-20	Urgency	No work required		Overall Condition		4
						Data Quality		1
Comments and Recommendations <p>The condition of the revetment has not deteriorated since the previous inspection. A scheme to reinstate the land and Marram grass has been drafted by the National Trust, the landowners, following the significant erosion close to the properties as a result of the overtopping of the revetment prior to the 2014 survey. Following the precedent of financial contributions the residents have been asked to contribute to the bid before the work is to be ordered. To date no works have been undertaken, and it is unknown if any progress has been made on this.</p>

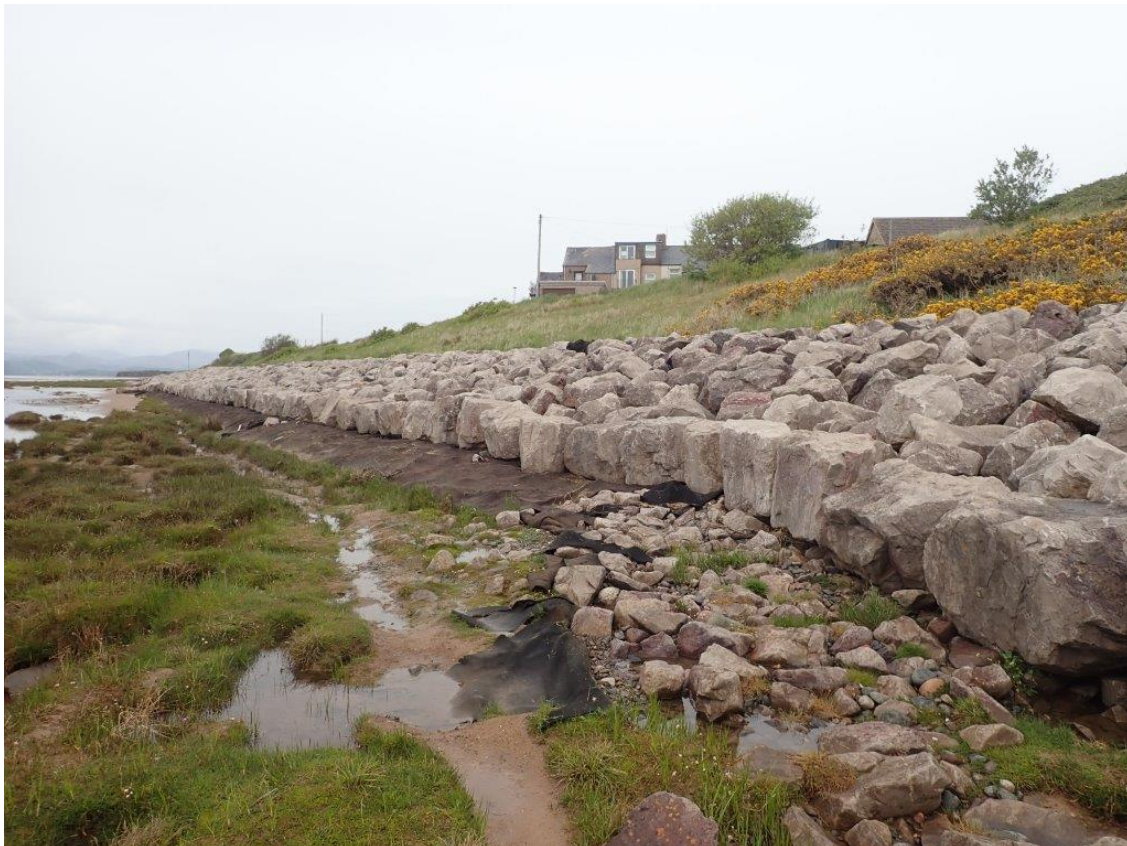
Photo

NFCDD Defence Data			Marsh Street Askam	
EA Asset Ref.	011KD90260401C02			
Alternate Ref.	210/8040			
Start NGR	E320963 N477821	End NGR	E320979 N477984	
Defence Type	Man Made	Protection Type	Defence	
Asset Type	Revetment	Design Standard	99	
Maintainer	Barrow Borough Council	Year Built	1999	
Crest Level	7.0m	CL Data Quality	1	
Spatial Data Quality	Adequate			
Risk Assessment				
Risk Score	18	Assessment	Low	
Change from previous assessment		None

NFCDD Element and Survey Data								
Inspector	C. Bell						Date	14/05/2021
Element	Type	Sub-type	Material	Revetment	Slope	Width	Condition	Weighting
1	CB		Mud flat				2	2
2	CS	Foreshore	Mud and salt marsh		10 deg	20m	2	2
3	FI	Revetment	Rock armour		25 deg	5m	3	6
4	FI	Embankment	Clay	Vegetation	25 deg	10m	3	6
5	C	Embankment	Clay	Vegetation	0		3	6
Residual Life		10-20	Urgency	Routine		Overall Condition		3
						Data Quality		1
Comments and Recommendations As noted in previous inspections, the rock armour revetment has a couple of spaces where rocks have slipped on to the foreshore and need moving back to their original position but stones are otherwise densely packed. The mud flat foreshore level has dropped exposing the foundational Geotextile fabric, and in areas this material is damaged, exposing the bedstone beneath. To date, no remedial works have taken place. The erosion at either end of the revetment: 3m at either end, shows no major sign of deterioration since the previous inspection. There is still over 50m of scrub land to go until the nearest residences are affected.
